1. History of Flight

The aircraft had recently received an annual inspection. The accident flight was the first flight following the inspection. The aircraft was cleared for takeoff from Runway 36 at Tupelo Regional Airport (KTUP) Tupelo, MS, and instructed to depart to the east. According to witnesses, the aircraft climbed to approximately 300-500 feet and made a left turn to the west. Witnesses reported they heard the engine power decrease and saw the aircraft descend. The aircraft struck North Coley Road which is adjacent and parallel to the runway before striking a pick-up truck and impacting a tree in a residential yard.

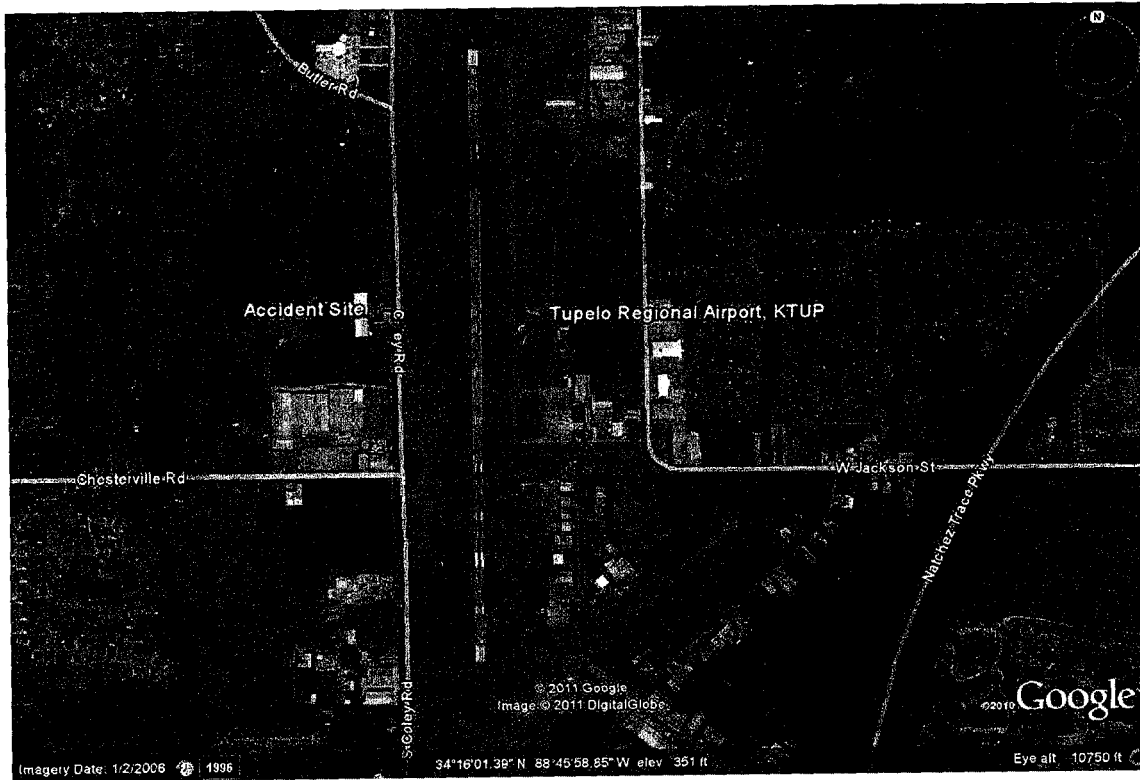
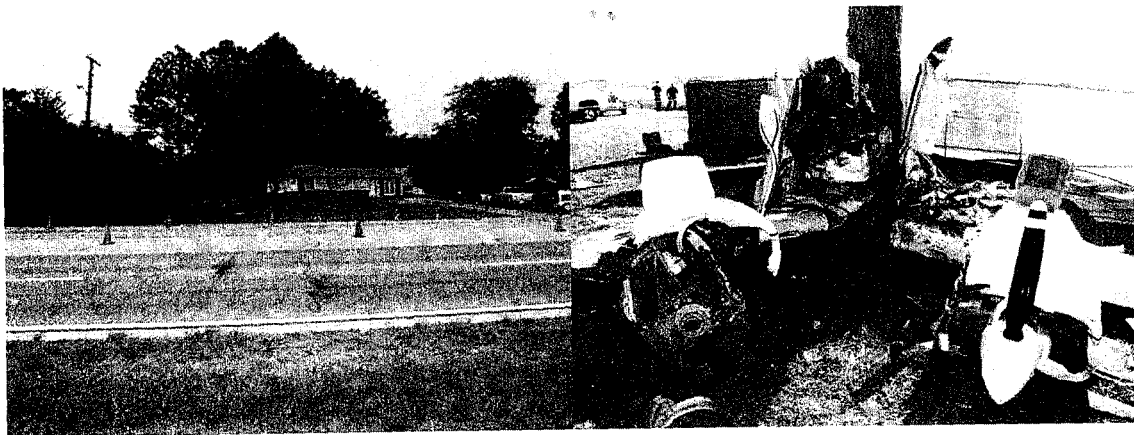
Accident Location Data		
Location: Off airport	Site Street Address: [REDACTED]	Tupelo, MS
Elevation: 333 Feet	Latitude: N 34° 16.104' (GPS)	Longitude: W 088° 46.383' (GPS)
Impact Path Magnetic Heading: ~290°	Obstacles Struck Before Principal Impact: None	
Terrain Conditions and Features: Road and residential property		
Approx. Attitude at Impact: Wings-level, nose-down

The aircraft descended below power lines and impacted a road in a near wings-level flight attitude. The nose wheel and main landing gear separated from the aircraft. The left wing struck a tree and separated the main fuel tank and an approximately 4-foot long section of the outboard left wing. The aircraft then struck a tree with the nose section and came to rest. The forward fuselage and instrument panel were compressed to the aft wing spar.
