Continental Motors, Inc.

ENGINE OPERATIONAL TEST

DATE	October 5, 2011
REGISTRATION #	N444YM
ENGINE MODEL	IO470VO
ENGINE SERIAL	455788
INSPECTOR	Phillip Grice
SEARCH CODE	15-12-68

DATE	October 6, 2011
REGISTRATION #	N444YM
ENGINE MODEL	IO470VO
ENGINE SERIAL	455789
INSPECTOR	Phillip Grice
SEARCH CODE	15-12-68

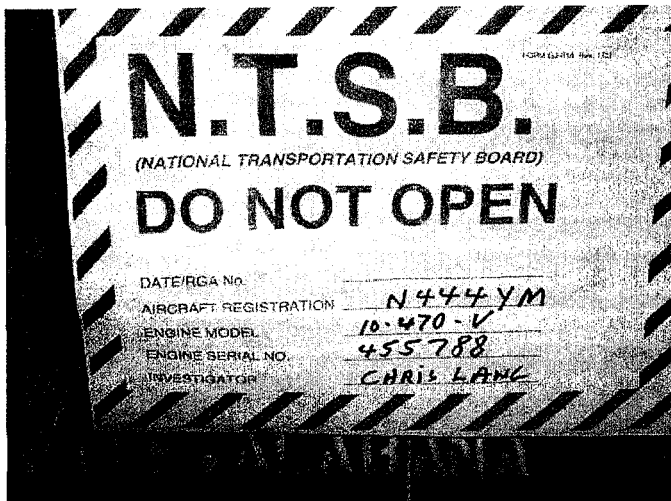
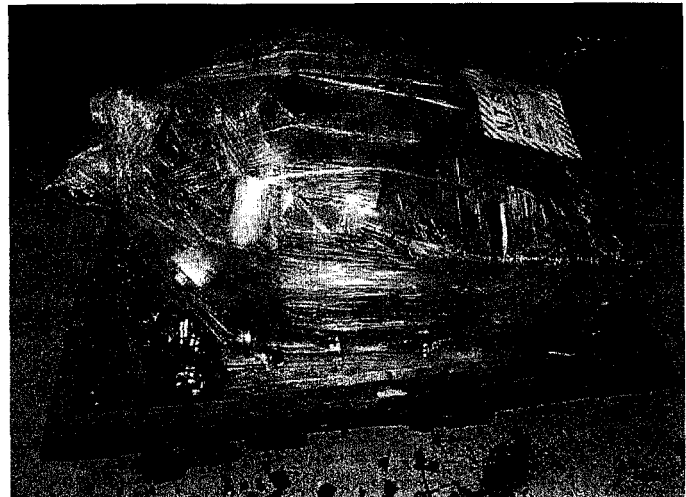
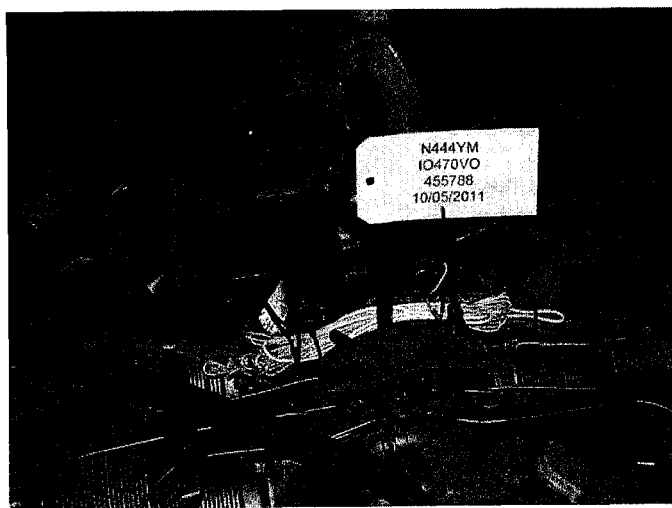
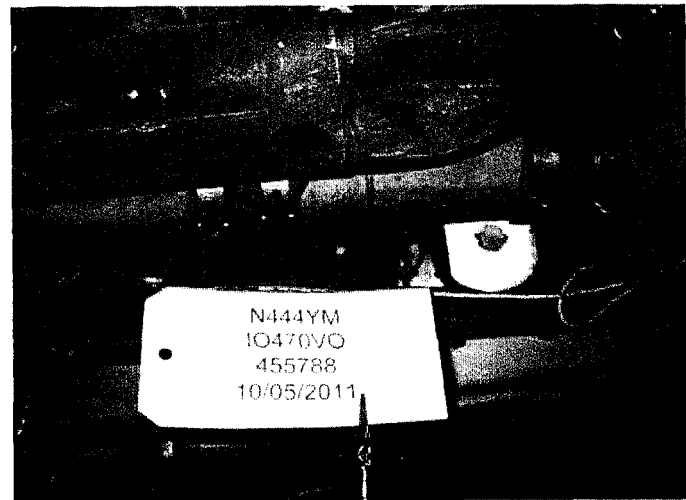
The engine exhibited impact damage concentrated at the bottom of the engine. The oil sump, exhaust runner on the 2, 4, 6 side, induction tube cylinder 6, and the balance tube was replaced before the test run. All engine mount legs were replaced to facilitate mounting to run stand.

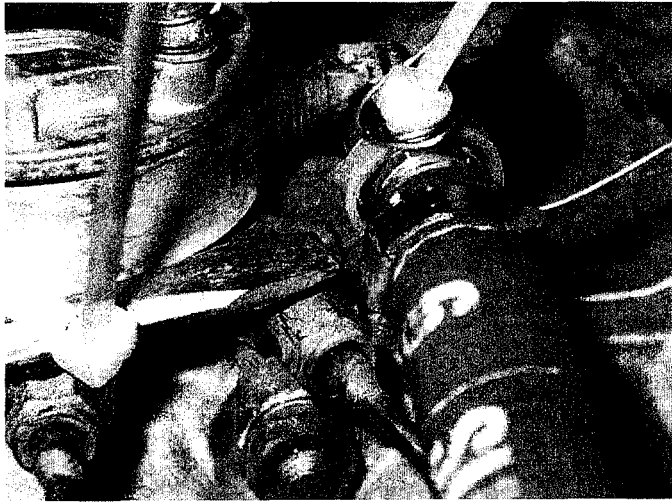
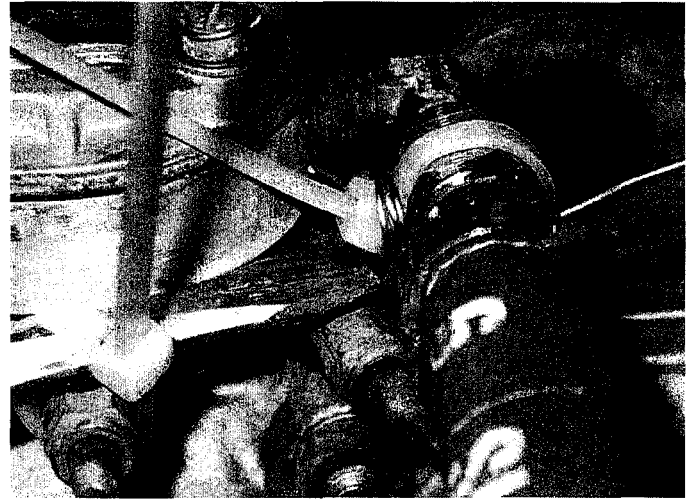
During the on site investigation the fuel line attached to the manifold valve was found loose. After completion of the engine test run the fuel line was set at finger tight torque. A wire was attached to loosen the hose during the engine run. A stop was in place to limit the rotation. Engine was set at full throttle and the fitting loosen to slightly over ¼ turn. When the hose was loosened the engine lost power and shut down.

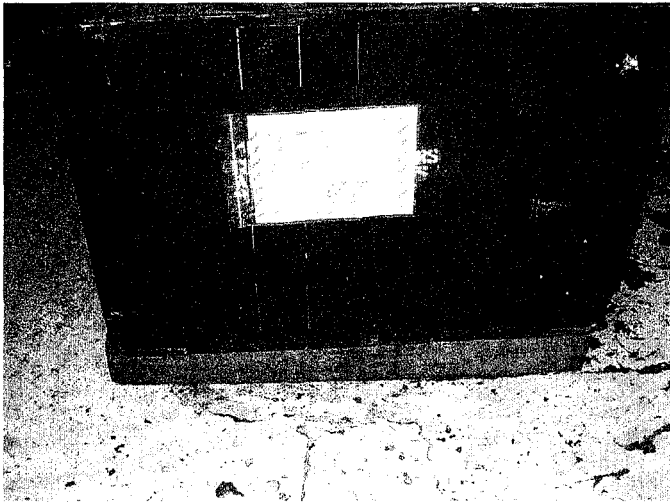
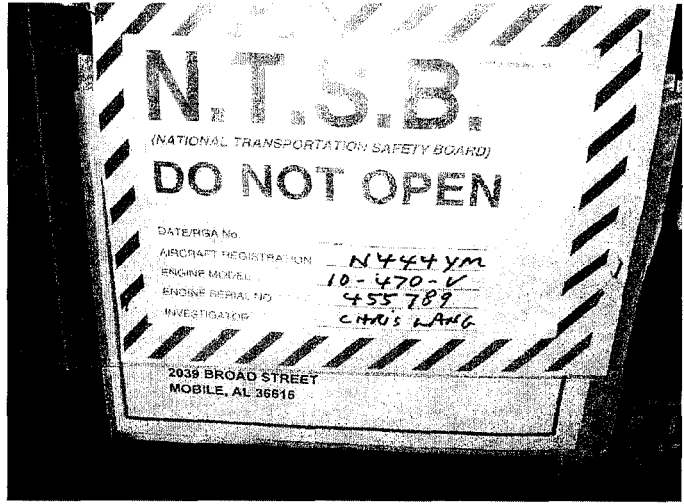
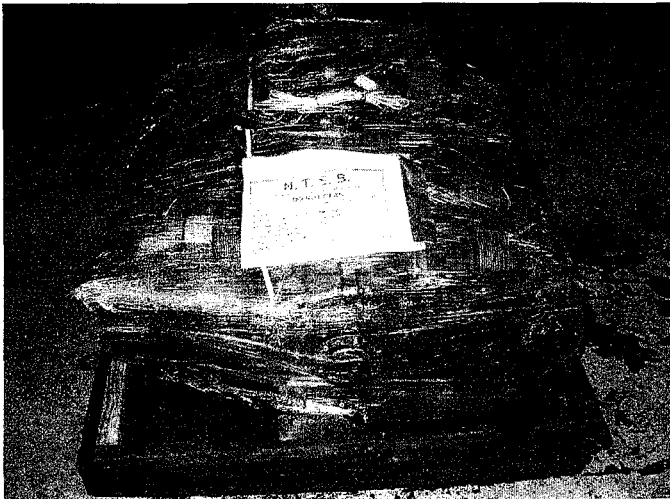
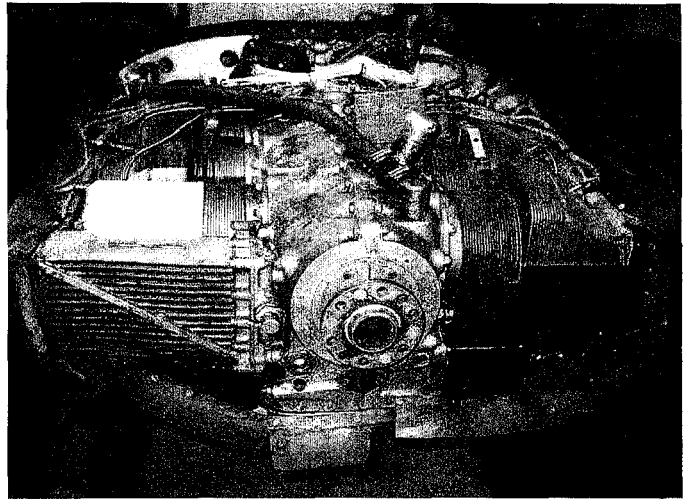
The engine exhibited impact damage concentrated at the bottom of the engine. The external surfaces of the engine were. The oil sump, exhaust runner on the both sides, induction tube cylinder 5, and the balance tube were replaced before the test run. All engine mount legs were replace to facilitate mounting to run stand.

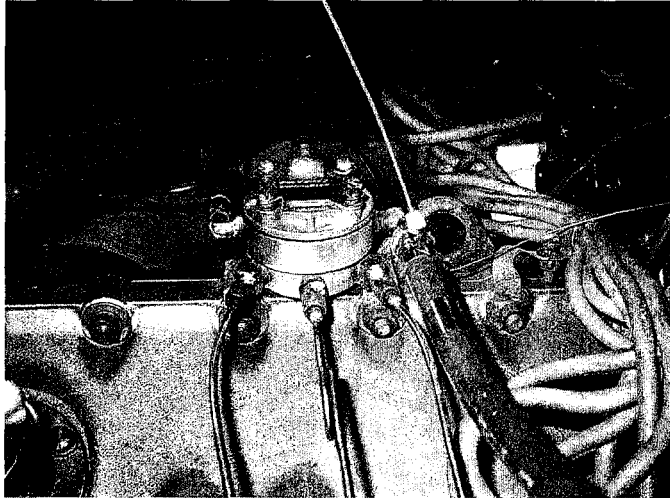
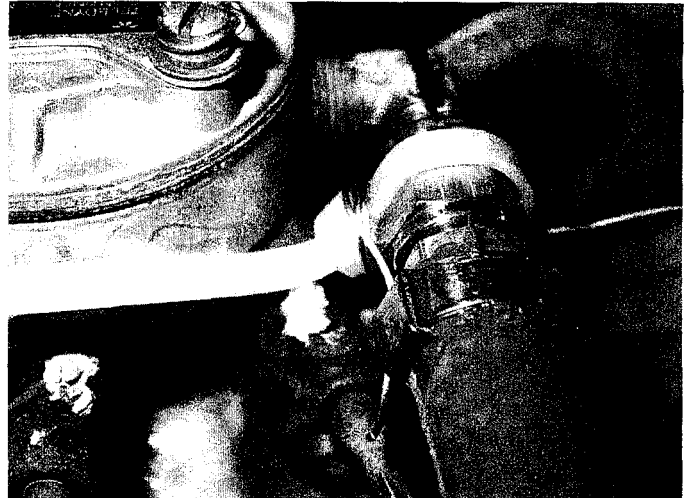
At the request of the NTSB this right engine was tested in a similar manner as the left engine from this aircraft. After completion of the engine test run the fuel line was set at finger tight torque. A wire was attached to loosen the hose during the engine run. Engine was set at full throttle and the fitting loosen to slightly over ¼ turn. When the hose was loosened the engine lost power and shut down.
