PARTY REPRESENTATIVE TECHNICAL REVIEW

OXNARD, CA

HWY15MH006

SCRRA Comments to Draft NTSB Factual Reports

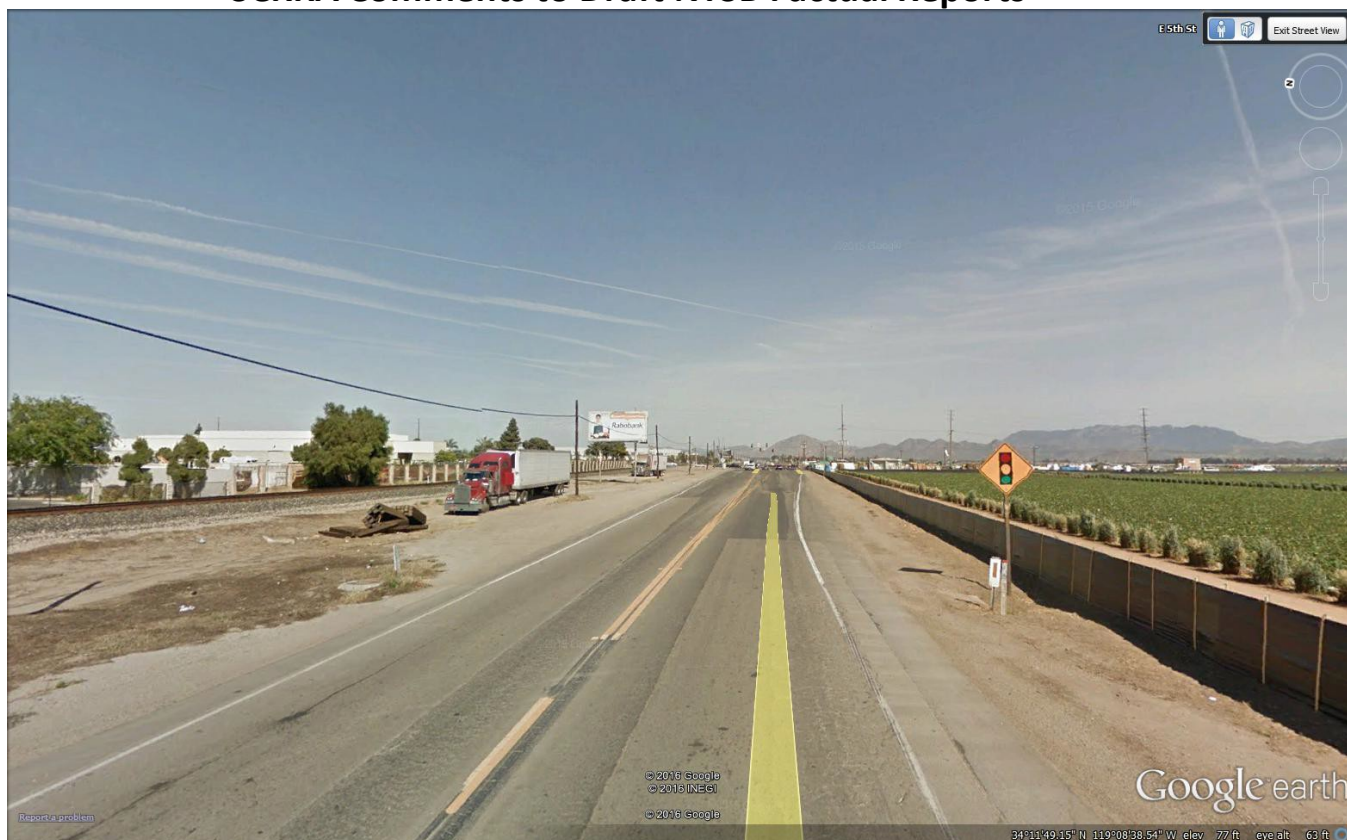
Page 5, line 20: Add "West facing tractor trailer rigs sometimes pull over into the area between East 5th Street and the railroad track near the S. Rice Avenue grade crossing. At the time of the accident, there was a tractor trailer with its headlights off stopped in the area between East 5th Street and the railroad track near the S. Rice Avenue grade crossing. There are two parked tractor trailer rigs in similar locations shown in the Google Earth image below."

Partial change "At the time of the accident, there was a tractor trailer with its headlights off stopped in the area between East 5th Street and the railroad track near the S. Rice Avenue grade crossing." was added to the report.

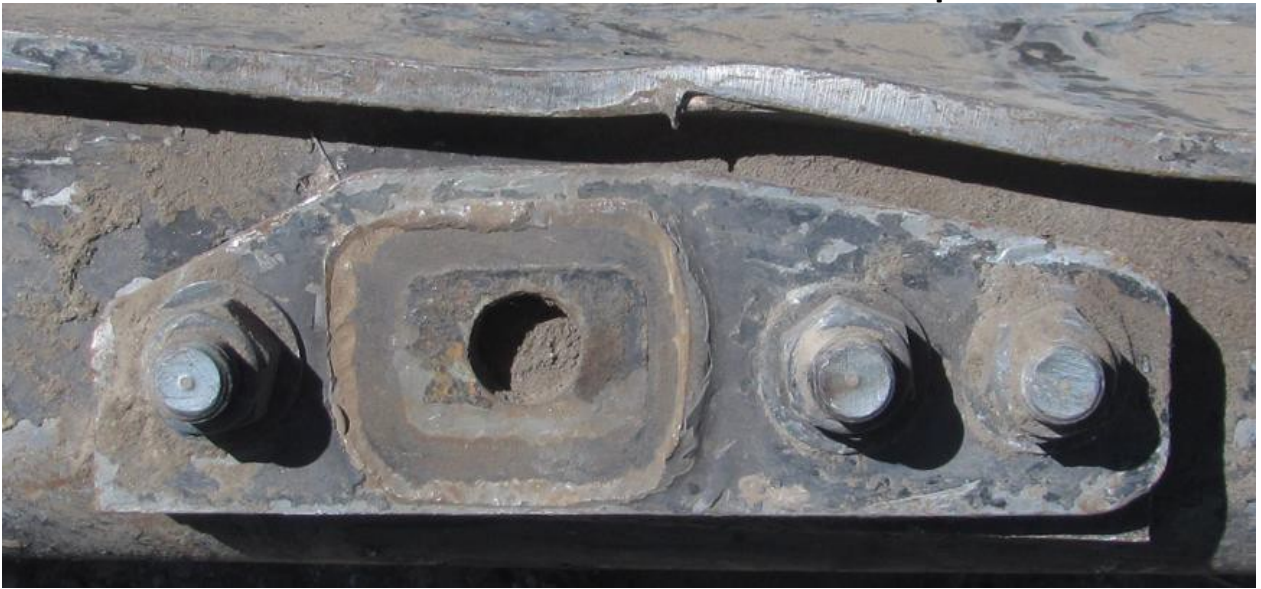
The welds observed between the pilot assembly and vertical connecting tubes of the Hyundai Rotem cab car 645 involved in the Oxnard derailment exhibited poor fusion and lack of penetration. This was evidenced by the smooth and flat fracture surface in plane with the pilot assembly plate as well as the narrow fracture surface of the weld as can be seen in Figure 1.

Figure 1. Fracture surface of Hyundai Rotem cab car 645 vertical tube weld.

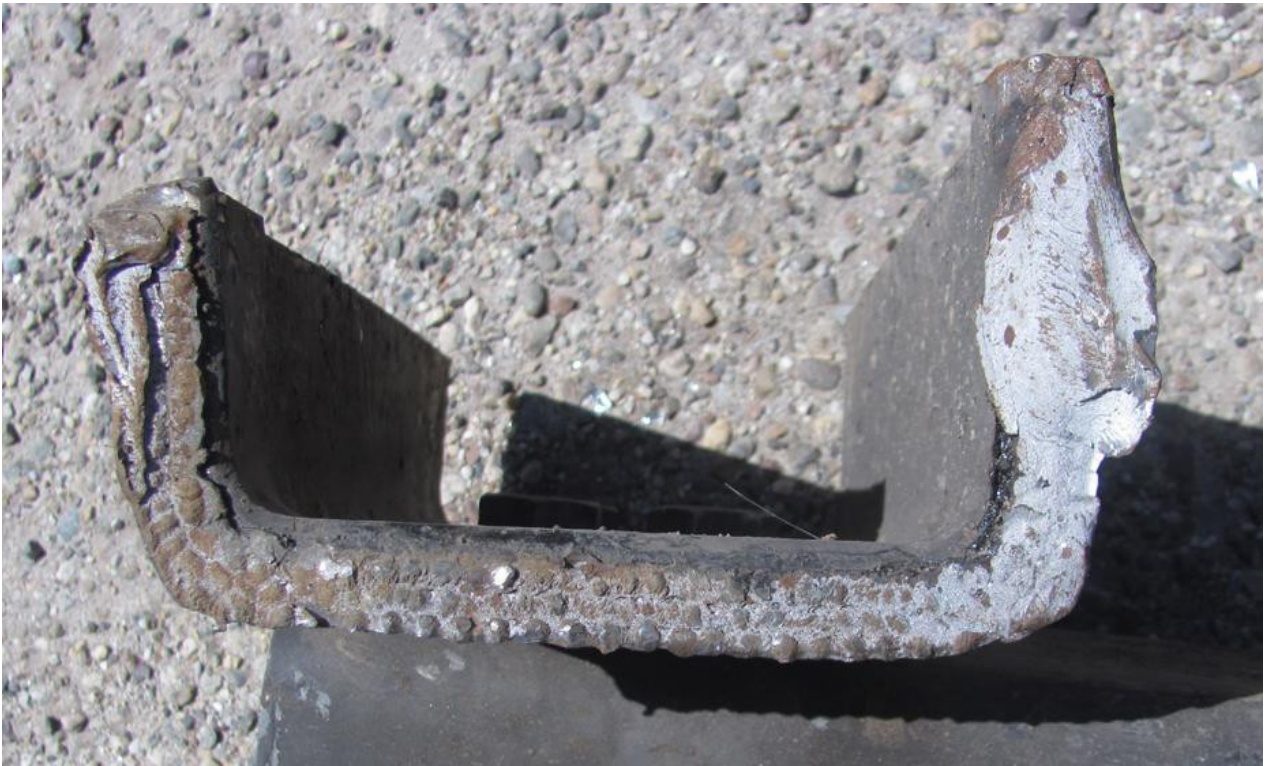
The welds observed on the horizontal channels (both sides) of Hyundai Rotem cab car 645 exhibited poor fusion and lack of penetration. This was evidenced by the rounded features on the weld fracture surfaces representing the poorly fused edges of the individual weld beads as can be seen in Figures 2 and 3.

Figure 2. Fracture surface of the Hyundai Rotem cab car 645 left side horizontal channel weld.

The fracture surfaces of the horizontal channels of Hyundai Rotem cab car 645 in sections had thin areas of overload fracture. The rusted areas on these fracture surfaces were unfused, or insufficiently fused to prevent cracking prior to final fracture as can be seen in Figures 2 and 3.

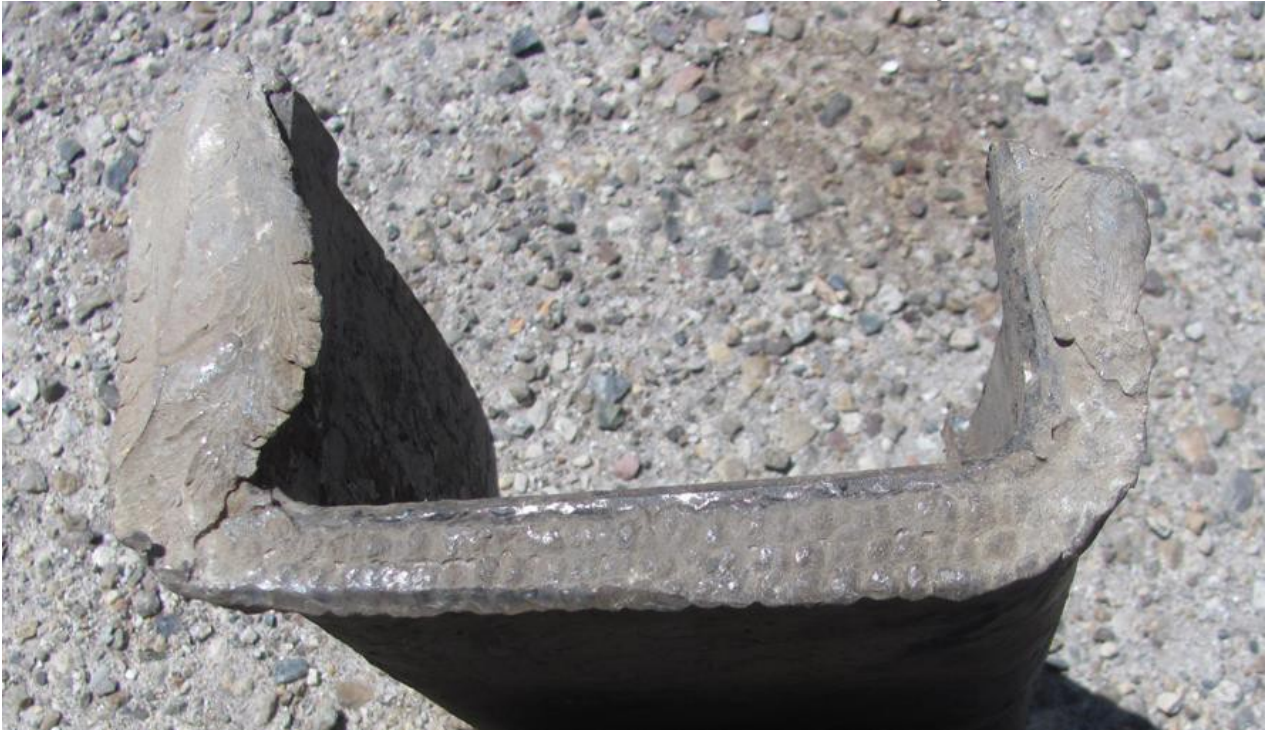
Figure 3. Fracture surface of the Hyundai Rotem cab car 645 right side horizontal channel weld.

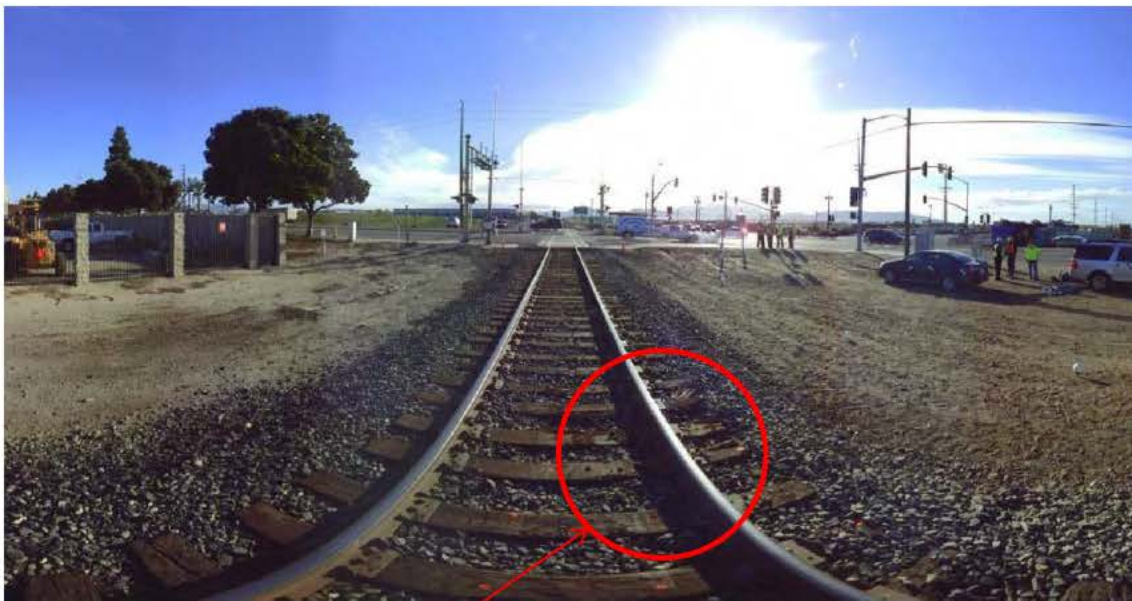
Figure 13 on page 10 of the draft report is reproduced below.

Hyundai Rotem suggests NTSB highlight or otherwise indicate the damage to the track wooden ties around the point of impact as shown in figure 13 of the report. Mention in the text also would help the reader understand the location and context for the related photographs taken by NTSB of the damaged ties. Below is one of the photos taken by NTSB of the damaged ties.

Hyundai Rotem further suggests the caption to Figure 13 be revised to read: “Figure 13: An image from the scanner showing the track near the point of impact and damaged ties. The view is looking east toward the grade crossing.”

Figure 13 - Damaged ties were highlighted and caption was changed.

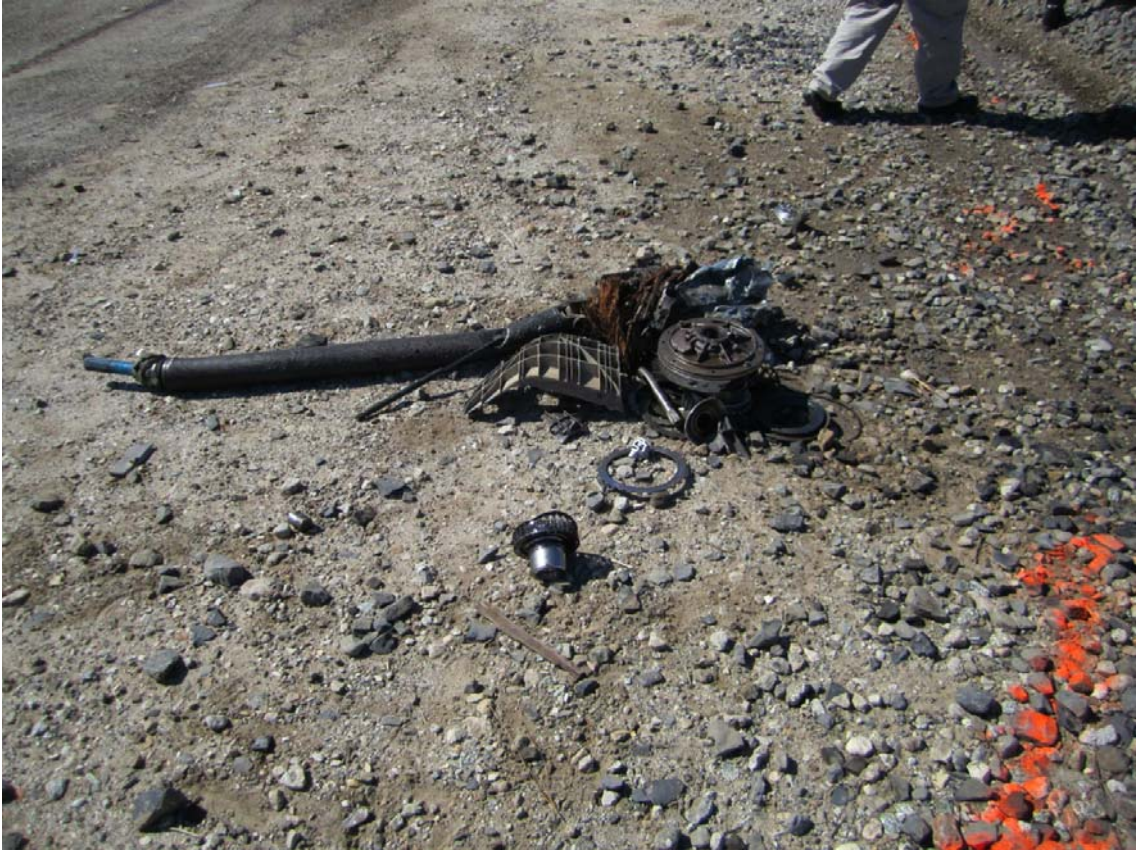
Photographs Oxnard, CA – Vehicle – Scene (13)

This description of the damage to the truck appears accurate. However, NTSB should also mention the kink and the wooden "fibers" embedded in the forward driveshaft leading end as shown in photographs below, all available in the NTSB Oxnard crash workspace in folder entitled "Oxnard, CA - Crash Location Photos." Hyundai Rotem suggests the underlined sentence below be added to Section 1.2 as follows:

"...The forward and rear driveshafts were disconnected from each other at the spline joint. There were wooden fibers embedded in the forward driveshaft leading end, and the driveshaft was kinked. The rearmost portion of the rear driveshaft was broken away from the differential at the universal joint..."

A footnote was added at the end of the previous sentence to include the following language; “There were wooden fibers embedded in the forward driveshaft leading end, and the driveshaft was kinked.”
