Re: Comair Airlines d.b.a. Delta Connection Flight 5191
Accident Number DCA064MA064
Lexington, Kentucky
August 27, 2006

**SUBMISSION OF THE
AIR LINE PILOTS ASSOCIATION, INTERNATIONAL
TO THE
NATIONAL TRANSPORTATION SAFETY BOARD
REGARDING THE ACCIDENT INVOLVING**

**COMAIR 5191
CRJ-100
DCA064MA064**

**LEXINGTON, KY
AUGUST 27, 2006**

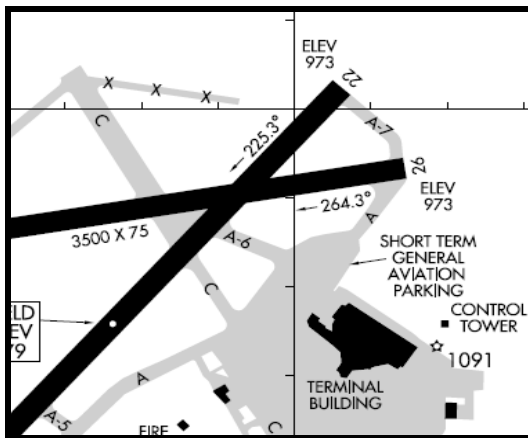
Figure 1- AFD portrayal

The preceding events resulted in several charting and signage discrepancies following the repaving during the weekend of August 20, 2006. The AFD presented an accurate representation of the airport, except north of runway 26 (see Figure 1). In this area the AFD depicted a single “A7” taxiway leading to the runway 22 threshold. In actuality, there were two taxiways north of runway 26; neither of which were “A7”. When sitting on taxiway “A” at the hold short line south of runway 26, the view was as follows: Directly across runway 26 was the closed portion of taxiway “A”. At approximately a 70 degree angle to the left across runway 26 was the re-designated taxiway “A”. This was the taxi route leading to runway 22.

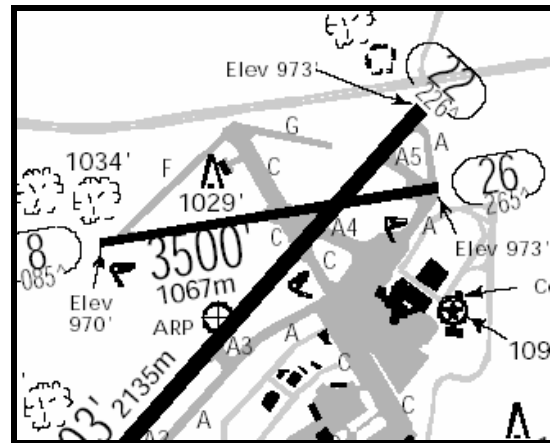
Figure 2: Jeppesen Portrayal

The Jeppesen airport diagram (10-9 chart) presented an accurate representation of only two taxiways along Comair 5191’s taxi route (see Figure 2): Taxiway “C” slightly to the south while exiting the air carrier ramp, and taxiway “A” up to the runway 26 hold short line. Three taxiways were depicted inaccurately. First, taxiway “A4” south of runway 26 was signed as “A6”; Second, taxiway “A5” was depicted as north of runway 26 and was signed as taxiway “A”; and Third, taxiway “A” north of runway 26 was depicted but was actually barricaded closed. On the Jeppesen chart, which the crew had, taxiway “A” north of runway 26 was depicted as an operational taxiway leading to runway 22.

The Jeppesen chart also did not incorporate 2 NOTAMs in effect since 2001. One designating runway 8-26 as unusable for landing or taxiing of aircraft over 12,000 lbs GWT (gross weight) and the other designating runway 8-26 as daytime VMC (visual meteorological conditions) use only.

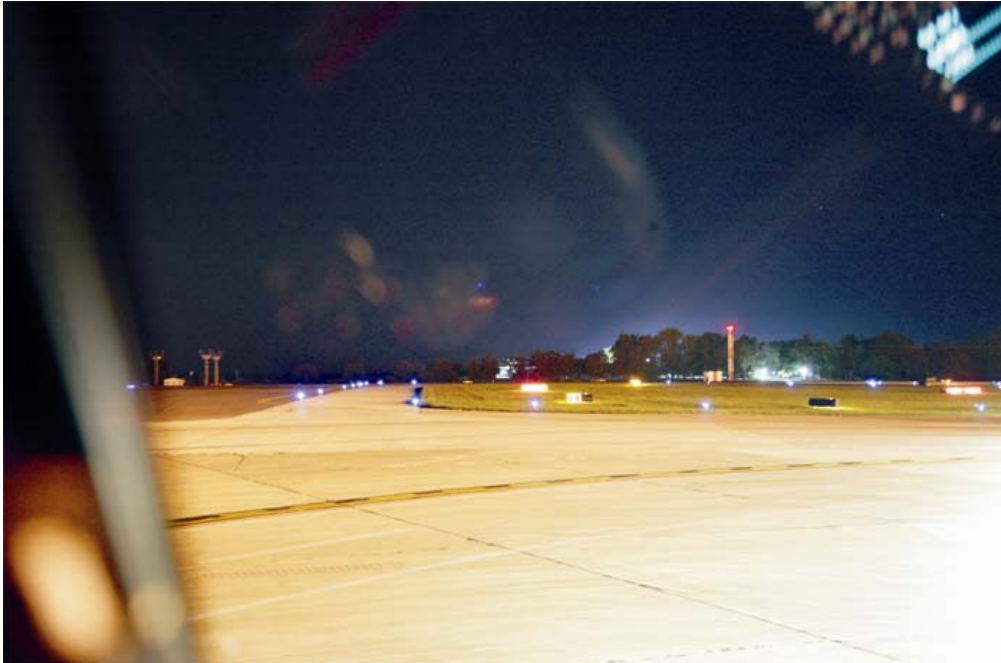
Photo 3: View of Taxiway "C" from Ramp

After pushback and prior to aircraft movement under its own power, the aircraft’s heading was approximately 48 degrees while stationary on the ramp. Due to the lack of sufficient data available to the investigation, the exact aircraft geographical starting point on the ramp is undeterminable. However, based on the normal parking spot for Comair aircraft, ramp interviews and some of the FDR information, reasonable assumptions can be made. It appears that after pushback the aircraft was somewhere on the ramp east of taxiway “A” and abeam taxiway “C”. From this approximate location, the view outside the flight deck windows would be vastly different for each crew member. The captain who is seated on the left side of the aircraft would be provided a much better view of the airport’s taxiway as compared to the first officer. As detailed in the visual study performed after the accident, the captain would have been able to look out his left window and look west down taxiway “C” in addition to seeing several runway 4/22 signs and one runway 8/26 sign. Photo 3 shows this view.

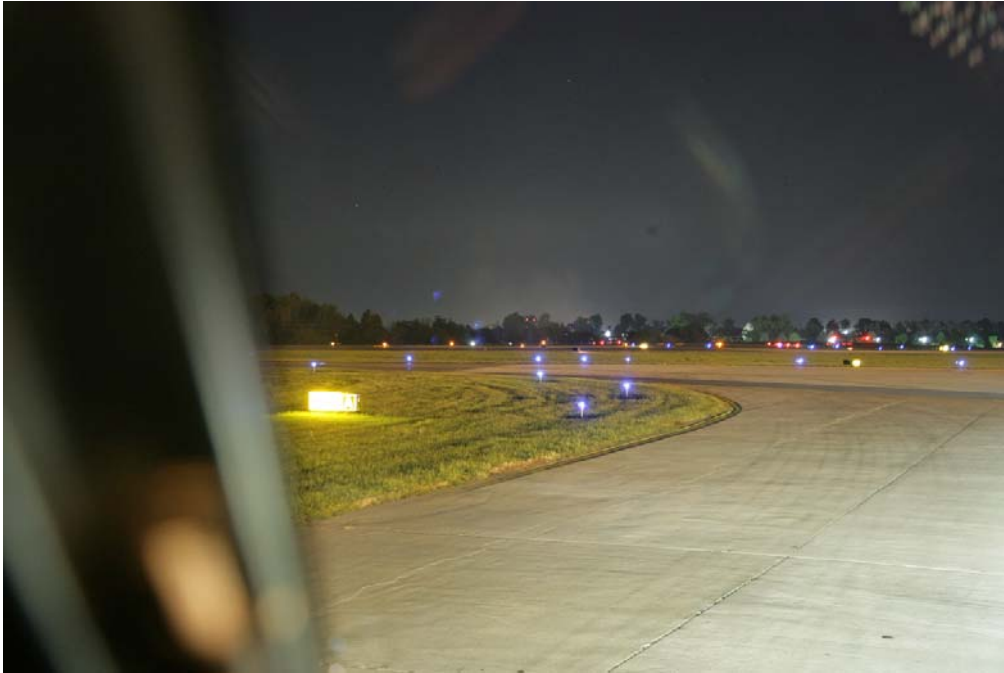
Photo 4: Taxiway "A" Approaching "A6"

This segment of the flight as it curves after intercepting taxiway “A” and continues along taxiway “A” until the final left turn onto the straight portion of taxiway “A” prior to runway 26. This represents a significant segment of the taxi event because this is where the crew has the potential to recognize the mismatch between signage and the Jeppesen chart. There are three considerations related to human performance in this segment; signage, airport charts and the crew’s workload. Photo 4 shows the view as the aircraft approaches the “A6” intersection. The Jeppesen chart shows this as “A4”.

As they approach taxiway "A6" this marks the first known point where there was a specific visual threat to the crew's situational awareness. This was probably the first point where the captain's situational awareness becomes challenged. This point of confusion combined with his original less than detailed mental visual image of the airport layout makes it reasonable to suggest that this is where the captain's altered situational awareness becomes significant. Any previous recent night exposure he had to the airport layout was over a month ago and would not be helpful in resolving this conflict. This crew, like all instrument rated pilots, are quite familiar with the Jeppesen instrument charts and overall general airport design and layout. They understand as a matter of practice taxiway intersections are numbered sequentially from one end of a runway to the other, i.e. A1, A2, A3, etc. See Figure 6.

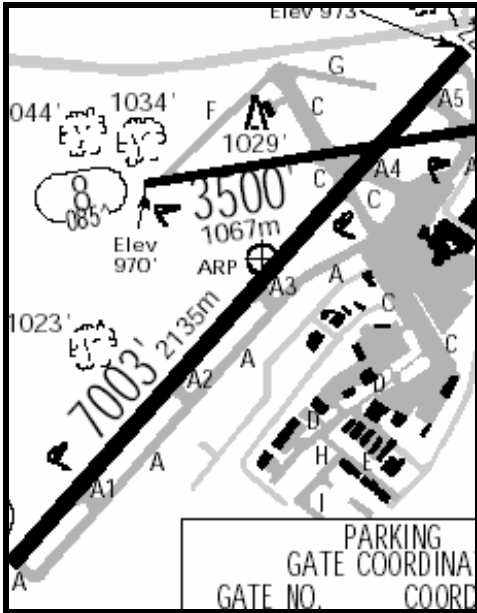
Figure 6: Jeppesen 10-9 Airport Diagram (current at time of accident)

When the captain saw the “A6” sign, this could have been interpreted as placing him north of runway 26 in the area of “A5” as shown on his chart. Additionally, after seeing the “A6” sign and not understanding its geographical relevance on the Jeppesen chart, he would naturally seek another data point in an attempt to clarify his confusion and support his current local rationality. The close proximity of the runway 4/22 and 8/26 sign behind the “A6” sign may have provided this data point. It is conceivable that these two signs suggested that the runway is now behind them and they are now approaching the runway 22 threshold. The crew’s Jeppesen chart shows that after you cross runway 26 there are two paths to runway 22; taxiway “A5” and taxiway “A”. Further supporting this idea could be how the first officer’s taxi briefing explained how they would get there; *“let’s take it out and um, take uuuh, alpha, two two’s a short taxi”*¹⁸. From the captain’s perspective, that is what they were doing, taking “A” to 22. They did not know that the section north of runway 26 was closed so they had no reason to believe that they would not use it to taxi (they never received the local NOTAM via ATIS, the flight release or ATC). The final left turn on “A” approaching 26 is very similar in distance and turn angle as the turn just past runway 26 on “A” to runway 22 (the closed portion). If the captain did have a vague recollection of how the taxiway is designed past runway 26, this section and its design is similar enough to support this idea.

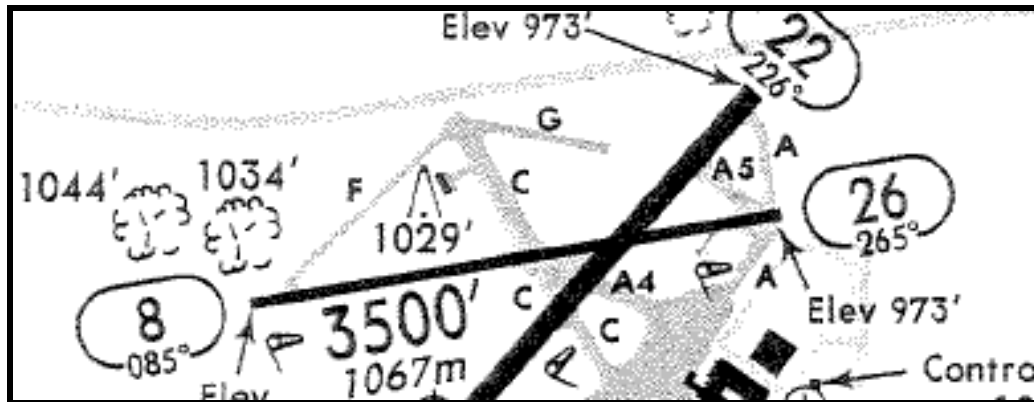
Figure 7: Jeppesen 10-9 Airport Diagram (current at time of accident)

An additional visual clue that might have falsely led the crew to believe their location was correct and support their current belief structure was the barricades that they did not expect to see across runway 26. It would be easy to understand how this could have been misconstrued for the closed section (non-pavement) of taxiway golf on the opposite side of runway 22 across from "A5". This would only further support any situational awareness disconnect already in place and feed into their conformational bias that they were in the correct location. This supported the idea that they had in fact taxied to the end of taxiway "A" at runway 22. As the barricades were not mentioned on the flight release or the ATIS, this would have been an unexpected visual clue. Since the chart shows the pavement non-existent, it would make sense that they would have not expected to receive a NOTAM or hear about this on the ATIS. This would only continue to support their local rationality regarding their correct location. See Figure 7.

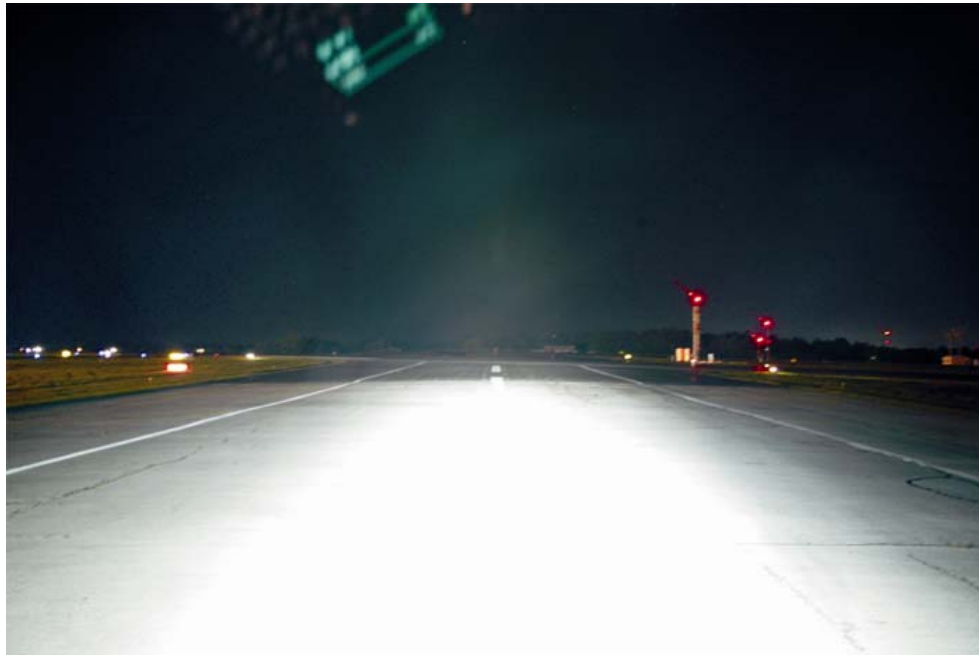
Photo 7: View down Runway 26 From Beginning of Takeoff Roll

In Table 11 above, seven of the eight items are essentially self explanatory. However, item two should be further explored. There were three white runway lights combined with a taxiway sign down field that gave the illusion of a partial string of runway lights. Photo 7 below shows these lights.

On the right side of runway 26 at the intersection of runway 22, there were two runway lights represented in a linear fashion and at a similar angle as to appear parallel to runway 26. On the left side was a single runway 22 light in the southeast corner of the intersection. This gave the opposite side corresponding illusion of a runway 26 runway edge light. It is also obvious that there is another runway up ahead which would not have been a surprise since it is reasonable to assume that both crew

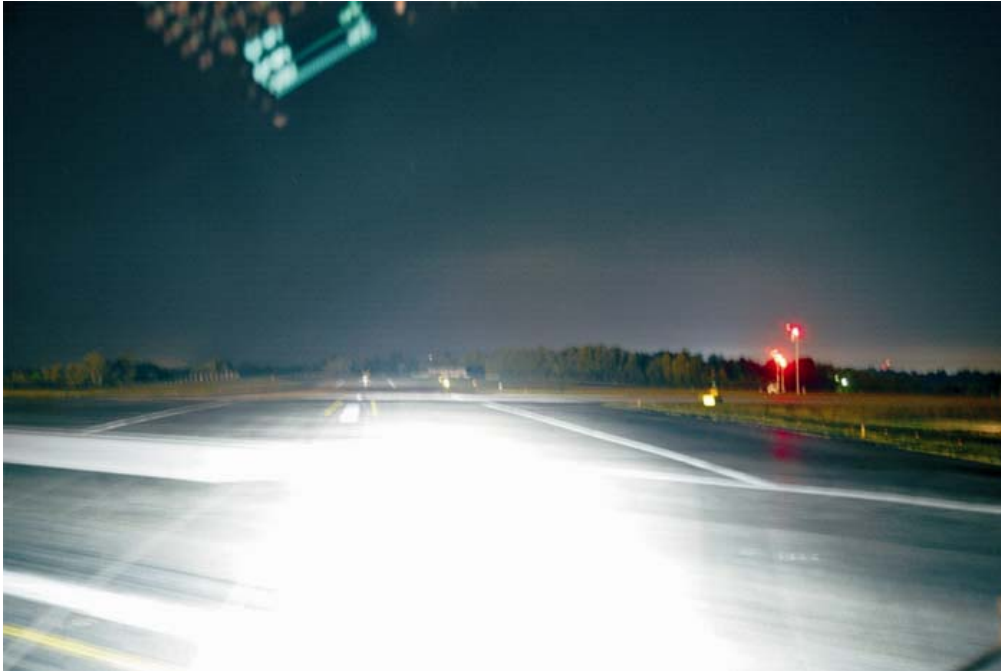
Photo 8: View Down Runway 26 from Runway 22 Intersection

Now, as they are rapidly approaching the intersection of the runway and closer to the crest, more of the runway is visible. In reviewing the table above, they have now lost several of the similar visual cues that might have helped convince them that they were in fact on the correct runway. One of the most compelling is the illusion of partial runway lights. It is important to note that approaching the intersection of the two runways, this illusion disappears and we believe that this change elicits the first officer's comment about things looking "*weird*" without lights. See Photo 8.

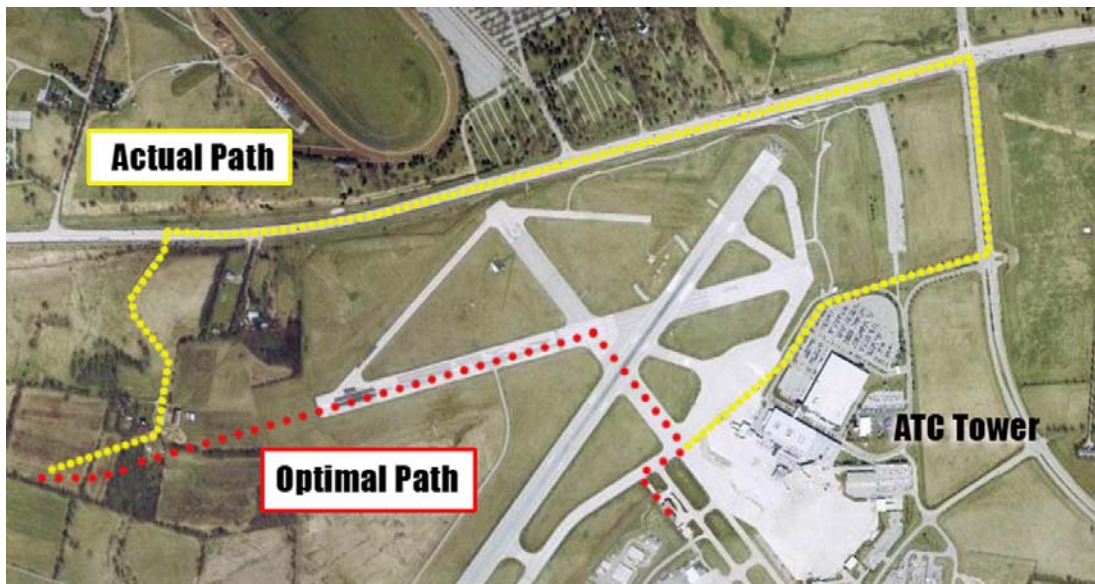
Figure 8: ARFF Response Path - Actual versus Optimal

The response time noted from the Survival Factors factual report for the first ARFF vehicles was approximately 8 minutes. The path taken by the ARFF response vehicles is shown in Figure 8. The response path was noted as going through Gate 2, then via Man O' War Boulevard, onto Versailles Road, then accessing the scene via the first road on the left after the airport. Also depicted is what would have been a more direct path that would have taken the vehicles via taxiway "C" to runway 26 to the gate in the perimeter fence, then through the pasture to the accident scene.

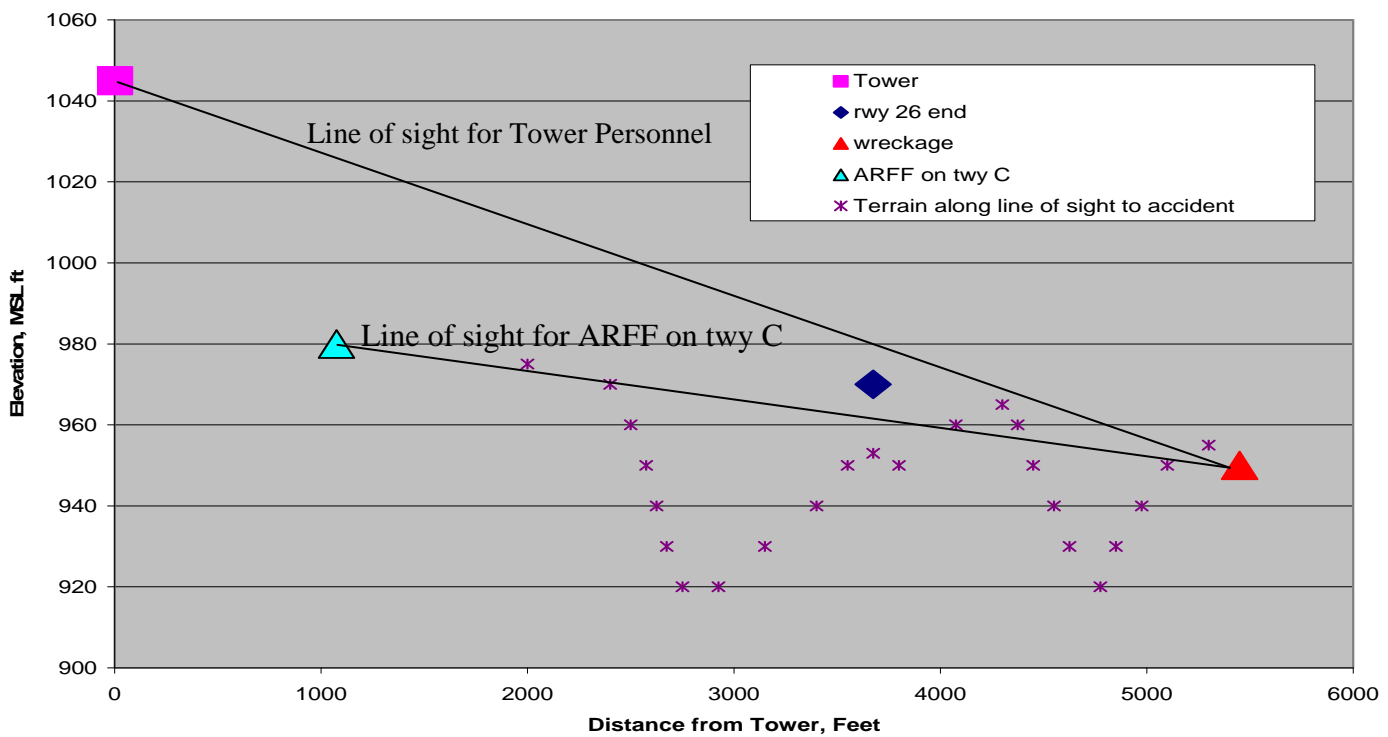
Figure 9: Line of Sight - Tower and Firehouse to Accident Location

Figure 9 shows the estimated line of sight for the controller in the control tower, with the tower floor at an elevation of 1,045' to the accident site, and the view from an ARFF vehicle on taxiway "C" coming out of the fire house. It is apparent that neither point would have a completely unobstructed view of the accident scene. However, it appears that the controller would have had a more direct line of sight.

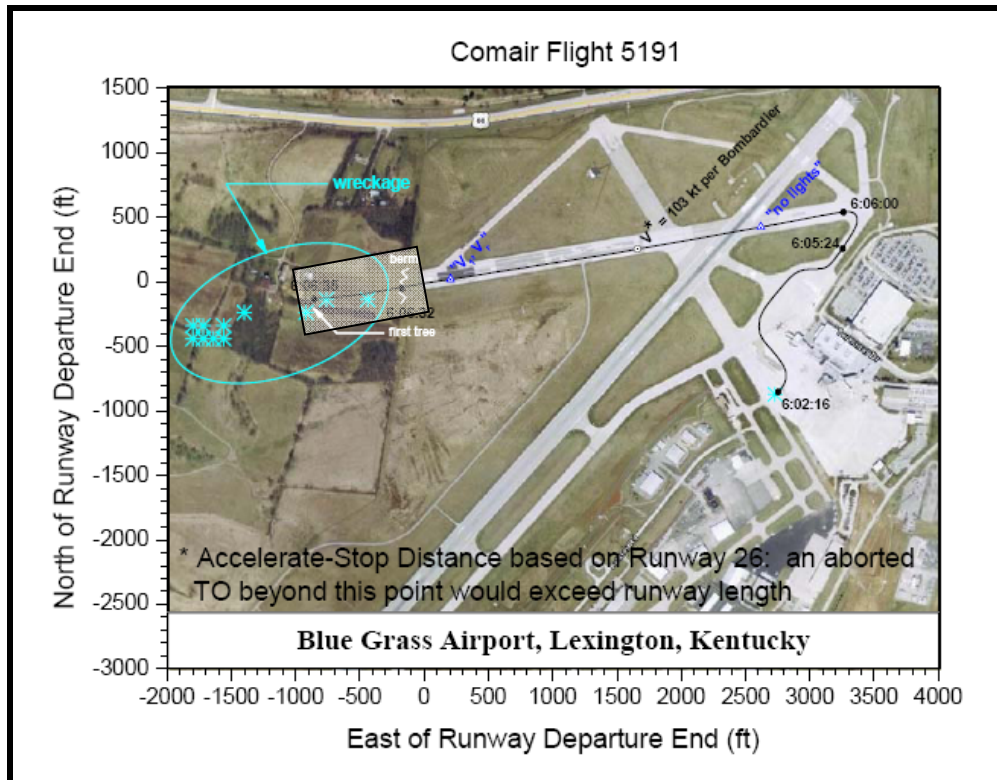
Figure 10: Wreckage Path Overlaid with Standard Runway Safety Area Dimensions (from Aircraft Performance Group Chairman’s Aircraft Performance Study)

impact with the berm would not have occurred. Had the runway safety area been required to be maintained to a standard air carrier runway safety area, less aircraft damage may have occurred.
