**Submission of the
Air Line Pilots Association, International
to the
National Transportation Safety Board
Regarding the Accident Involving**

Delta Air Lines 1086

MD-88

DCA15FA085

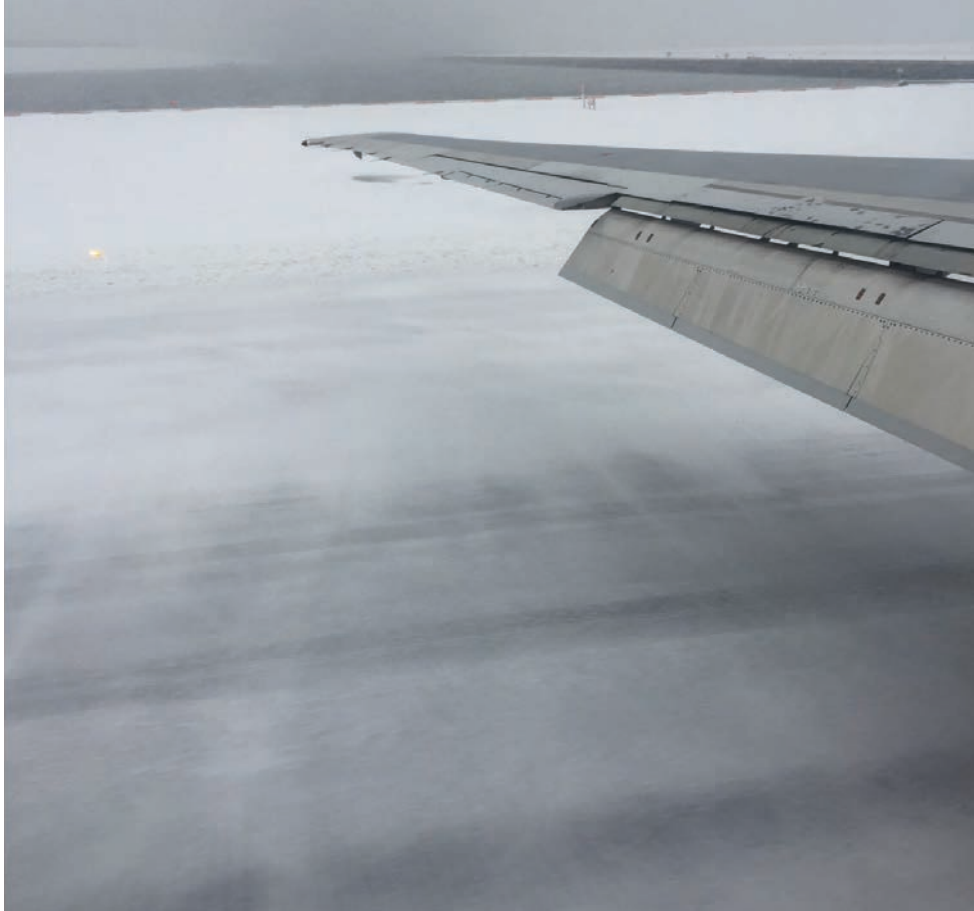
Braking action is a function of downforce on the braking wheels (main) and the surface friction. The failure of the spoilers to auto deploy was most likely the failure of the main wheels to get sufficient traction on the icy surface of the pier section. The subsequent delay in spoiler activation and the further delay in ground spoiler movement would have caused a period after touchdown of reduced downforce. During this time, speedbrake handle movement to the deployed position by the FO would have caused maximum auto brake activation after a 1 second delay. If wheels were subject to brake pressure before adequate rotation speed, they would lock quickly. Locked wheels would not provide useful braking or cornering force. The wheels would stay locked unless rotation and antiskid were regained. In the case of all four wheels being locked, this would require a complete release of the brakes and then reapplication. During testimony for the American Airlines (AA) Flight 1420 accident public hearing, a NASA engineer stated that abnormal antiskid operation would be expected with low to no wheel spin-up accelerations on a low to no traction runway surface and delayed spoiler deployment.

Figure 5: Passenger Photograph out of the left side window at the 500 foot runway marker. Note retracted spoiler panels.

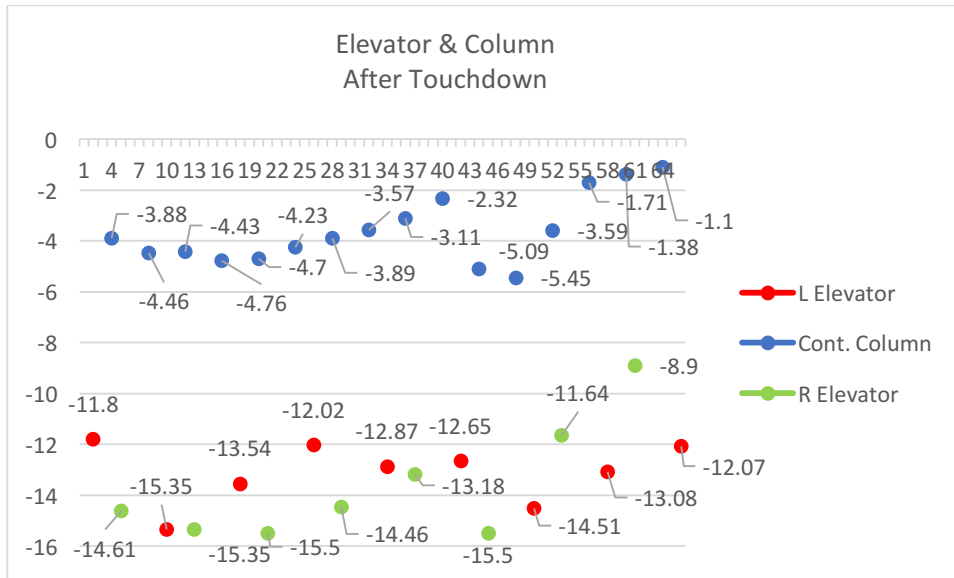
Figure 6: Elevator and Control-Column Position After Nose-Gear Touchdown

The FDR recorded the elevators at a flight position around 2 degrees nose down (-2) moving to a position around -15 degrees after touchdown. At the same time, the control column moved from around 10 degrees nose up to around 5 degrees or less nose down. The maximum parameter for elevator travel is 15 degrees (displayed as minus) trailing edge down, and for control column is 10 degrees (displayed as minus) forward.

This placed the elevators at or near the maximum full-down position for most of the ground roll from ground shift (WOW) leading through loss of heading control. The elevators reached 15 degrees nose down one second before the heading began to move left and varied between 15 and 12 degrees.

The elevators do respond and follow direction of control-column movement during this period. But their movement appears out of proportion to displacement of control-column movement toward nose down. For example, the control column remained within 1 degree of 4 degrees of nose-down column position, about half of its forward travel, for most of the first 10 seconds. However, the elevators remained between 11 and 15 degrees; two thirds to full travel. The left elevator showed greater travel than the right. The left reverse EPR was also higher than the right during this period. The effect seems somewhat diminished when reversers stowed.

The elevator trailing edge in a down position causes a nose-down attitude by creating lift on the tail. On the ground, this will lift the rear section of the aircraft and, therefore, decrease the downward force on the main landing gear. Any loss in downforce reduces the ability of the tires to produce braking and cornering forces. This has a negative impact on the already decreased braking action on the contaminated runway. The Delta FCTM states to “avoid excessive forward control-column pressure in

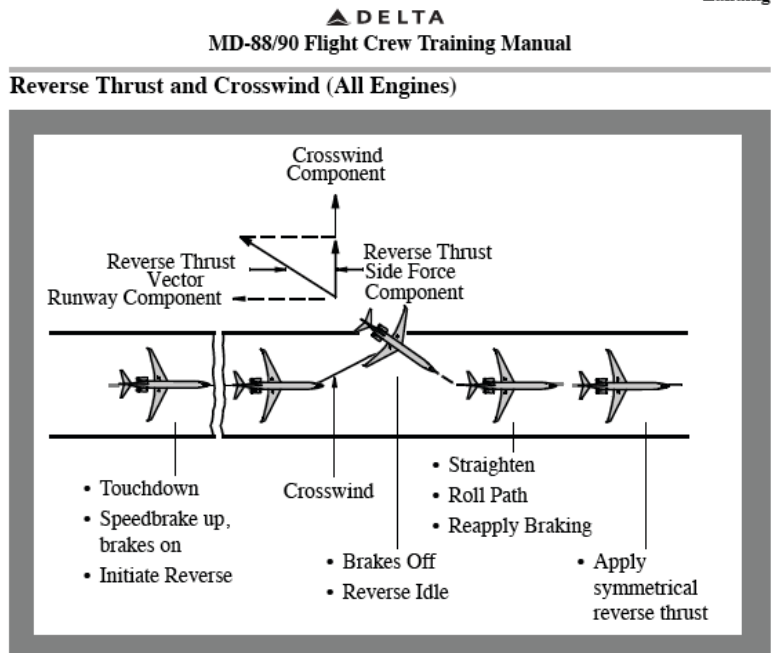
Figure 8: Delta FCTM guidance reverse thrust operations in crosswind conditions

The first point commands the use of reverse idle and does not mention forward idle. It also states to release brakes. These actions are to “return to the centerline.” Returning to centerline is in conflict with the guidance in the FCTM which states that “correct[ing] to runway centerline may delay deceleration efforts and aggravate skid conditions.”

During the accident landing, the aircraft remained near the center of the runway as the heading began to drift left. As the airplane turned, the cockpit approached the left side of the runway. This would be perceived by the pilots as the aircraft drifting toward the upwind side of the runway. This perception would be confusing to the pilots, as guidance in the second bullet, as well as the figure from the FCTM below, would indicate the airplane would drift downwind during reversing on slippery runways.

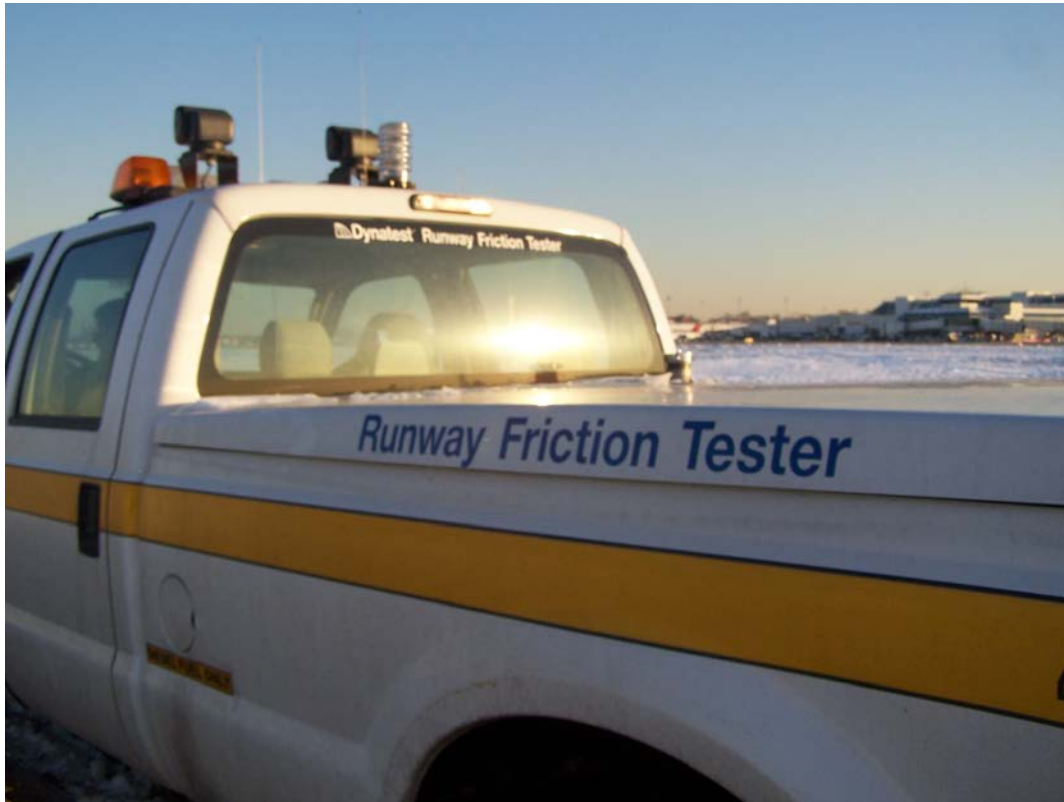
Figure 9: LGA Truck with Runway Friction Tester

During the snow event, LGA Airport did not use continuous friction measuring equipment (CFME) devices, which were purchased and stored at the airport due to nonuse and calibration issues. The use of CFME devices is recommended by the airport to monitor friction trends per AC 150-5300-30C. The airport's operations manager stated that he understood that the CFME could be used as a tool for snow removal trend analysis, but on the day of the accident they were evaluating the runway based on their observations and snowfall rate. This is in contradiction to LGA's Airport Certification Manual (ACM) and training videos,⁵² which stated that LGA utilizes a CFME-type friction tester to conduct friction readings when conditions require trend analysis on a frozen or contaminated surface. The ACM also contained a letter of agreement (LOA)⁵³ with the LGA Air Traffic Control Tower (ATCT) stating that when it becomes apparent that conditions may result in degraded runway surface friction, Airport Operations may conduct friction assessments using whatever techniques the airport duty manager or snow coordinator deem appropriate, to include tactile feel, vehicle braking, and/or use of CFME.⁵⁴ If CFME is used, Airport

Operations will not report Mu values. During the morning leading up to the accident, the runways were only evaluated based on observations of snowfall rates, and no CFME device was used.

The FAA Advisory Circular AC 150-5200-30C is too lax, as it allows a procedure using only braking action reports to qualify as “continuous monitoring” of the runway surface. Other methods are only recommended and not mandated. Use of friction monitoring equipment or decelerometers are only recommended actions for the airport.

In order to provide flight crews with the most current and accurate runway condition reports, it would be good practice to conduct a tactile inspection of the runway condition. This allows the airport operator to distinguish between wet snow or slush and dry snow. No provisions in AC 150-5200-30C require a tactile measurement of snow depths or condition, which allows the airport operator to estimate depths and conditions when issuing NOTAMs; this was admitted by the LGA airport operator as stated in interviews that they just leave “0.25-inch clutter” in every NOTAM issued, unless it gets deeper.
