Our Reference: 420.1261/15 Rev01

USA A320 MSN1141 N113UW flight 1702 - Rejected take-off after rotation at Philadelphia - Airbus submission

On March 13, 2014, about 1830 eastern standard time, US Airways flight 1702, an Airbus A320, N113UW, experienced substantial damage after the captain rejected the takeoff after rotation on runway 27L at Philadelphia International Airport, Philadelphia, Pennsylvania.

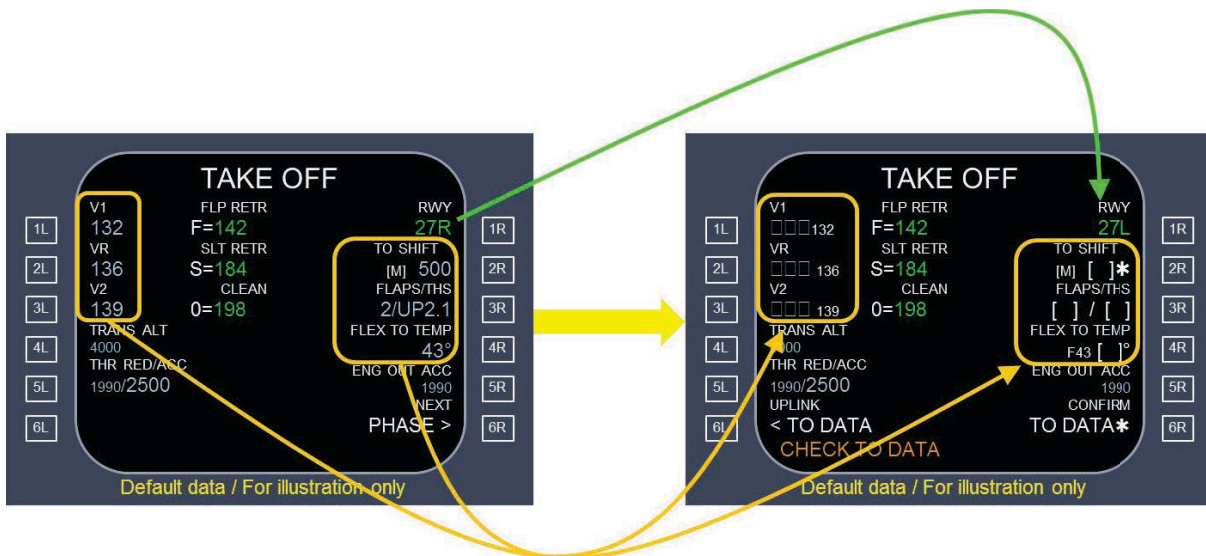
When doing so, FMS performance data was deselected and moved to the adjacent boxes. The amber message **CHECK TO DATA** was displayed. Data was not reentered. The aircraft was aligned for take-off without V-speeds and without FLX TO TEMP selected in the FMS.

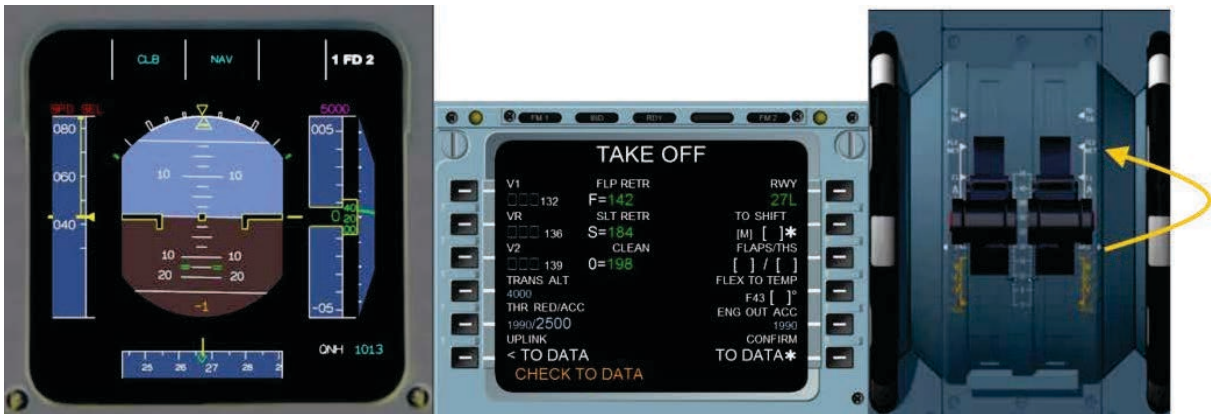
The red memo **SPD SEL** was displayed at the top of the speed scale of the PFD. It indicated the non-availability of V-speeds (V1, VR, V2). This was noticed by the crew who elected to continue with the V-speeds in mind.

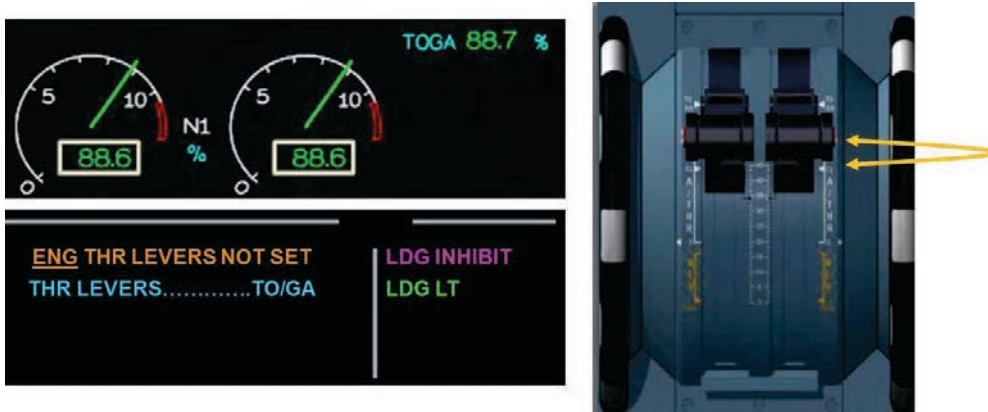
5 seconds later (8 seconds after initial thrust setting), FADEC set TOGA thrust. This automatic function, available on some engine types (refer to §8), provides maximum take-off thrust however does not engage the take-off modes. The crew confirmed that take-off thrust was available and continued.

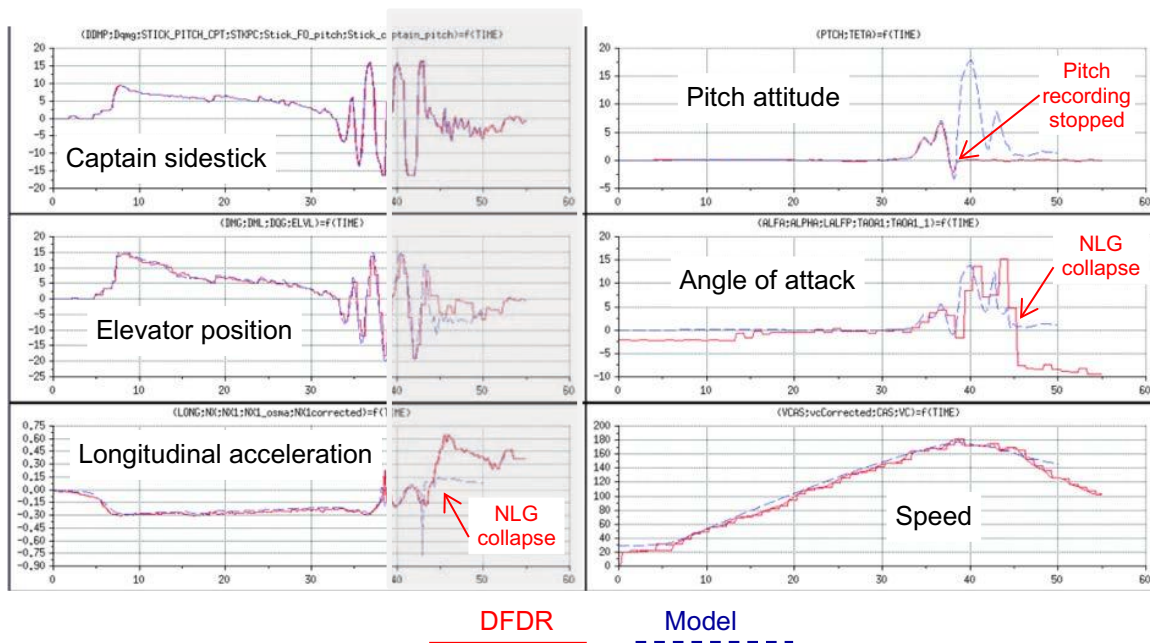
The investigation involved engineering handling qualities analysis. The flight data recordings were reviewed against the certified model. Responses were identical until second touchdown.

The difference with the model appeared after first impact:

- DFDR stopped recording the pitch attitude, still available with the model;
- After second touchdown, the model did not simulate the nose landing gear collapse.

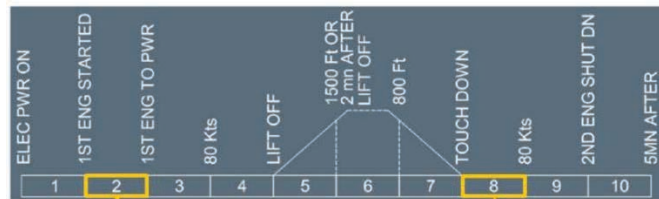
As the aircraft accelerates during the take-off run, FWC does not compute flight phase 3 but stays in phase 2 in absence of corresponding thrust condition (1st ENG TO PWR not met). When aircraft reaches 80kt, FWC computes flight phase 8 on the basis of the 3 conditions:

- GROUND
- NO ENG TO PWR
- SPEED > 80kt.

Accordingly, the aircraft is declared in landing phase whereas it is taking off.

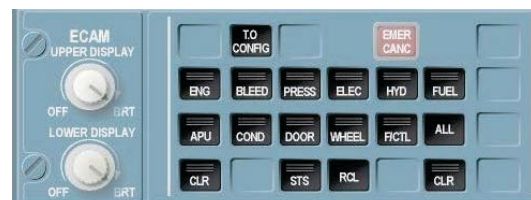
When the aircraft accelerated beyond 80kt, the conditions for triggering the “RETARD” were met:

- LANDING (flight phase 8, refer to §6.2)
- THRUST LEVERS ABOVE IDLE (thrust levers were set to FLX/MCT).

The audio-alert, if considered spurious by the crew, may be stopped by pressing the **EMER CANG** pushbutton at the ECAM control panel.

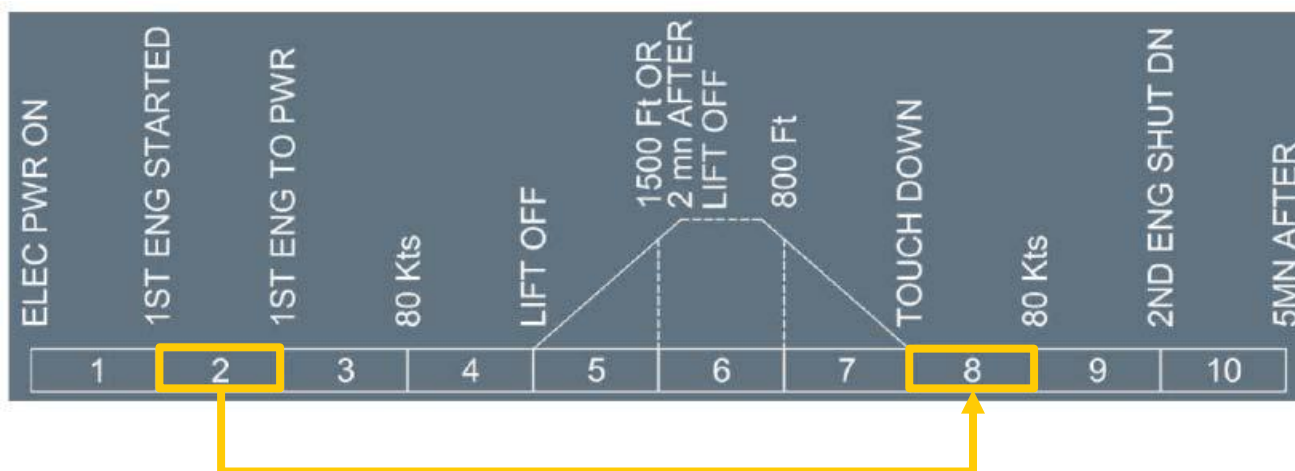
Without take-off thrust setting, FWC did not compute T/O phases (3, 4) but switched from phase (2) to landing phase (8)
