# **BROTHERHOOD OF LOCOMOTIVE ENGINEERS AND TRAINMEN**

## **SAFETY TASK FORCE**

**NTSB Accident Number: DCA16FR008**

**Proposed findings, probable cause, and safety recommendations, in connection with the head-on collision, derailment, and subsequent fire of BNSF Railways Eastbound S-LACLPC1-26K and Westbound Q-CHISBD6-27L, on June 28, 2016 in Panhandle, Texas.**

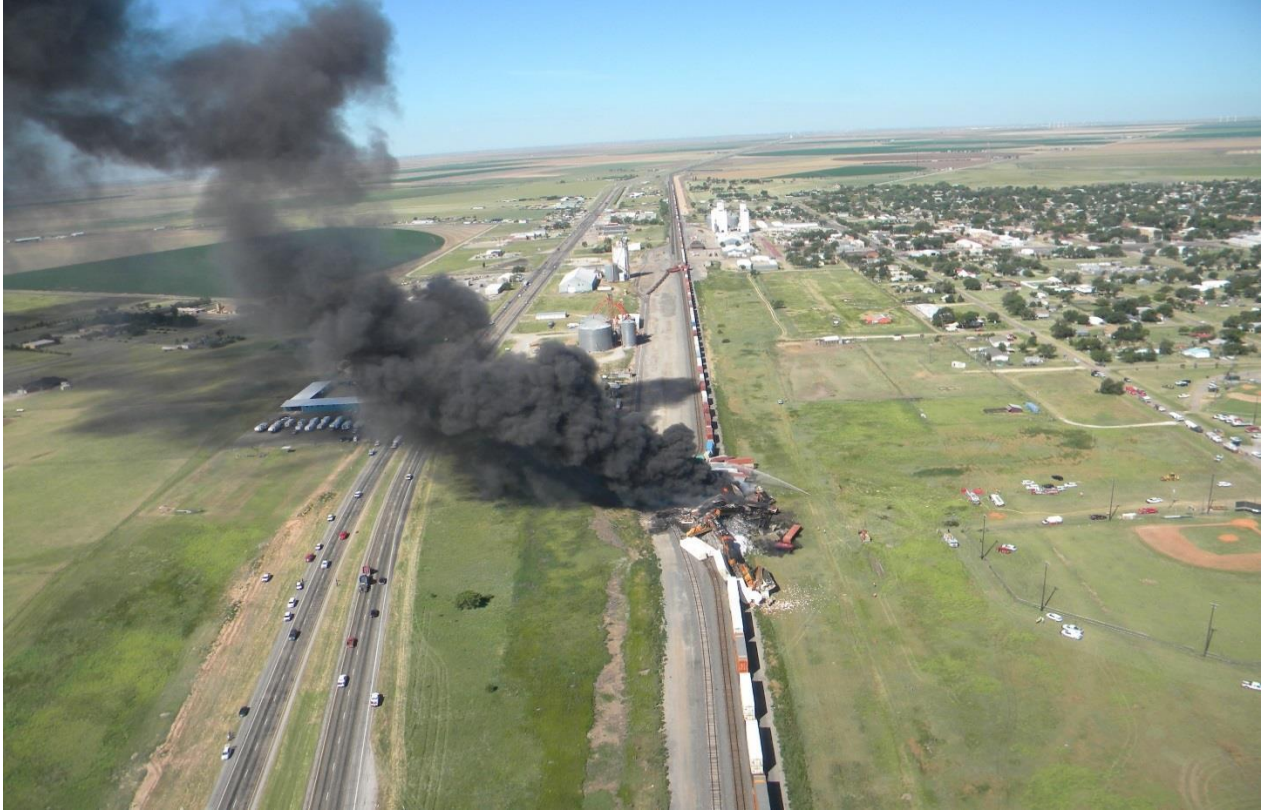
The wreckage blocked Main Track No. 2 and caused a track occupied indication. The BNSF Train Dispatcher saw the indication of the eastbound train pass the Stop signal on Main Track No.1 and the subsequent track indication caused by the debris field on Main Track No. 2, on his screen. Due to the magnitude of the forces exerted in this collision, the frames of both lead locomotives were the only intact components remaining.

Photo above courtesy of The Federal Bureau of Investigations (FBI) aerial photos. The bottom of the photo is direction east and the top is direction west; these directions also correlate to timetable direction of travel.
