# Brotherhood of Locomotive Engineers and Trainmen

Before the National Transportation Safety Board

NTSB Accident Number: RRD19FR010

Proposed findings, probable cause, and safety recommendations, in connection with the collision and subsequent derailment of two CSX Transportation freight trains near Carey, Ohio.

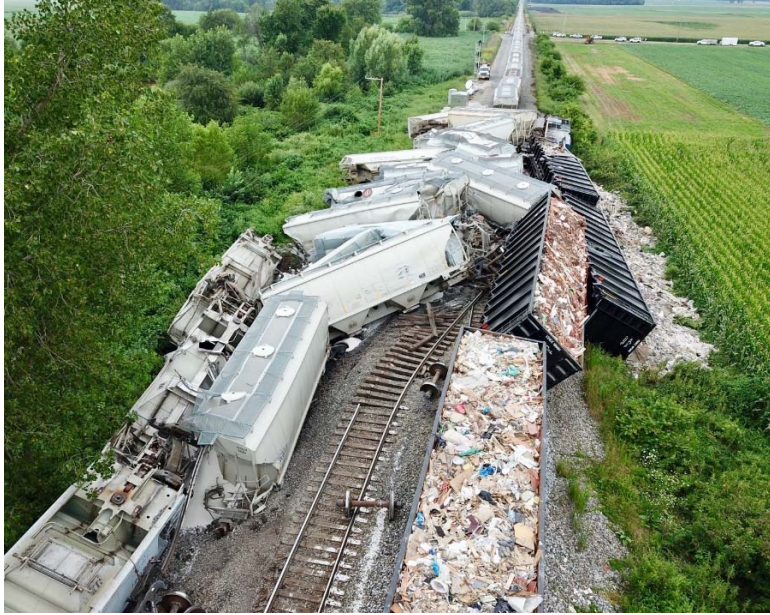
On August 12, 2019, at approximately 5:08 AM Eastern Standard Time (“EST”) <sup>1</sup>, a westbound CSX Transportation (“CSXT”) manifest freight train (H70211) collided with an eastbound CSX manifest freight train (W31411) while operating on the CSX Columbus Subdivision at control point (“CP”) Spring, which is located at milepost (“MP”) CD76.5 near Carey, OH <sup>2</sup>. Two (2) employees were injured in the accident, and both were hospitalized and released. The territory consists of single mainline track, with portions of double track and is governed by centralized traffic control (“CTC”) rules <sup>3</sup>. The territory is under the control of the CSX LF Train Dispatcher in Jacksonville, FL. At the time of the collision, the striking train was operating at nine (9) miles per hour (“MPH”), and the struck train was operating at twenty-four (24) MPH. The controlling locomotive of the striking train (CSXT 736) was equipped with Positive Train Control (“PTC”) <sup>4</sup> and was operational. At the time of the accident, weather was cloudy, with the temperature of 59° F. Damages are estimated at approximately \$4.9 million.

**Figure 1 - Overview of Collision (Photo Courtesy of NTSB)**

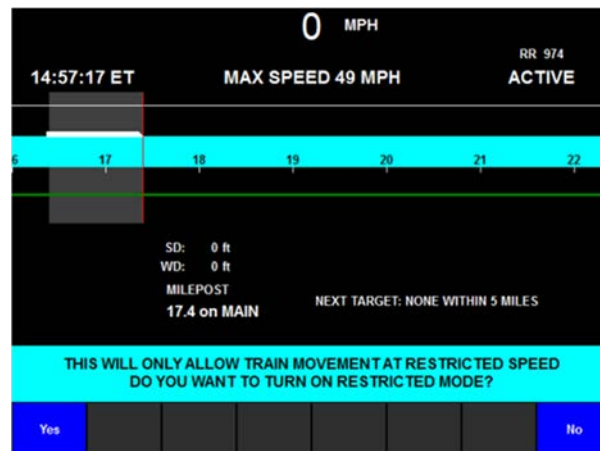
They began their tour of duty by assembling the H70211 in Parson Yard, Columbus, OH, and completing the required air tests. Once arriving at Carey, OH, the crew was instructed to remove the block of cars destined for local industries around Carey from the rear portion of their train. This required the Conductor to dismount the lead locomotive at the eastward absolute signal (“EAS”) at Carey, while the Locomotive Engineer pulled the entire 176 car train past the EAS at Carey and brought the train to a stop. Once the H70211 was entirely past the EAS at Carey, the LF Dispatcher routed the H70211 towards the Center Siding <sup>8</sup> at Carey, where the railcars would be removed from the train for future delivery to local industries. In compliance with CSX rules, the Locomotive Engineer accessed the PTC computer on the CSXT 477 and enabled “Restricted Mode” <sup>9</sup> prior to reversing direction and shoving the train back towards the Center Siding (*See Figure 2 below*).

**Figure 2** - Example of PTC system prompts to enter locomotive into "Restricted Mode"

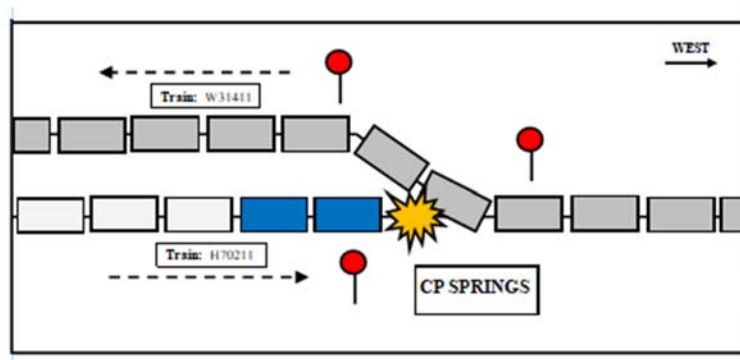
westward absolute signal (“WAS”) displayed a Stop indication. Because the “Restricted Mode” was still active on the H70211, the PTC system was unable to detect the status of the “WAS” at CP Springs. With the PTC neutralized, H70211 was not brake enforced as it approached the WAS at CP Springs which resulted in H70211 striking the side of the W31411 that had already begun to cross over from the Main track to Main Track No. 2 in an eastward direction (*See Figure 3*).

**Figure 3** - Schematic of collision (Courtesy of BLET)

The Brotherhood of Locomotive Engineers and Trainmen concludes that the probable cause of the August 12, 2019 collision near Carey, Ohio was the result of the Locomotive Engineer of the H70211 operating while in “Restricted Mode” after switching moves were completed. As a result of the locomotive remaining in “Restricted Mode”, the PTC System did not recognize the signal displaying a Stop indication at CP Springs which defeated the technology and resulted in the collision with train W31411.

1. Develop and implement a nationwide programming change to the PTC systems that will allow PTC systems to continue to recognize the status of signals and switches while train is operating in “Restricted Mode”.

1. Develop and implement additional PTC training for all employees to accommodate the new requirements.
