Submission of Delta Air Lines, Inc. to the National Transportation Safety Board

Delta Air Lines Flight 1086
Boeing MD-88, N909DL
Runway Excursion
LaGuardia, New York
March 05, 2015
DCA15FA085

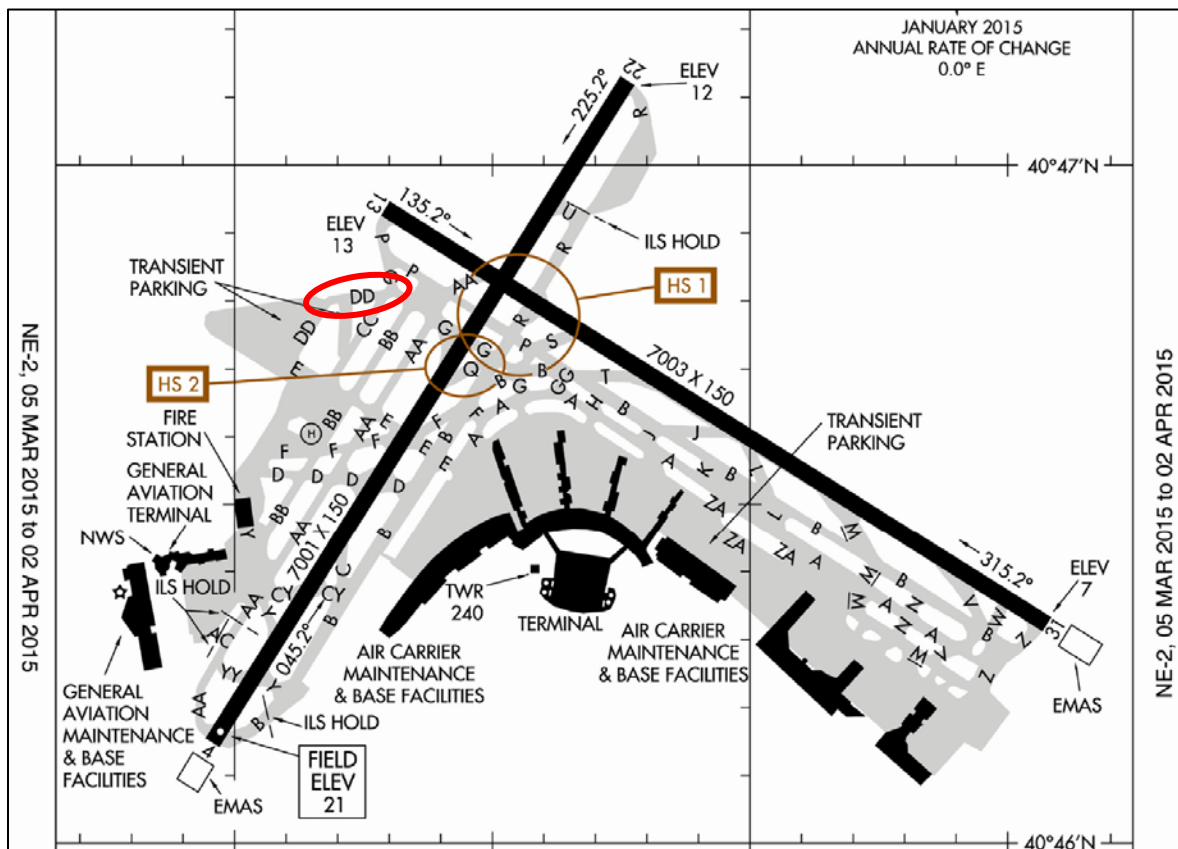
According to the Airport Operations Group Factual Report, runway clearing operations at LGA is performed using “hot runways” during a “gap” in arrivals or departures. It was noted that at the time of the accident, Team Blue was staged on taxiway DD. See Figure 1. At approximately 1051 EST (approximately 11 minutes before the accident), a request was made to the air traffic control tower to provide a gap in arrivals to allow for another clearing of runway 13/31. The LGA snow coordinator stated that they wanted to perform a runway clearing every 10-20 minutes. Prior to the accident, the last clearing operation on runway 13/31 was completed at 1035 EST (approximately 27 minutes prior to the accident).

Figure 1: FAA LGA Airport Diagram (excerpt).
 Note: Red circle highlights taxiway DD.
