**Gulfstream Aerospace Corporation**

**Party Submission**

**Arizin Ventures LLC – SK Travel LLC – Operated  
Aircraft N121JM**

**ERA14MA271**

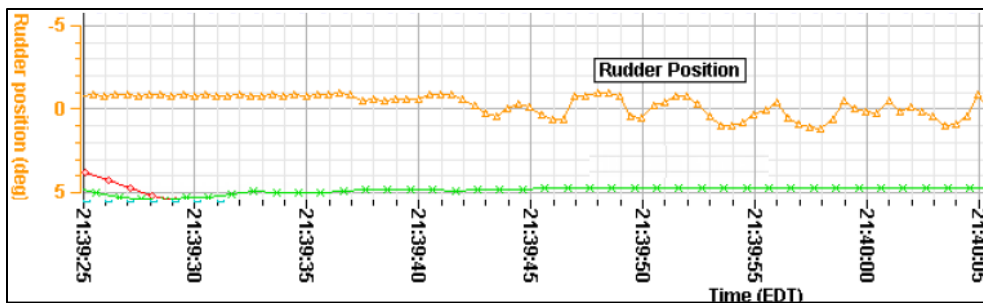
FIGURE 16 – RUDDER POSITION (ACCIDENT TAKEOFF CYCLE)

Based on the NTSB FDR Factual Report, the accident aircraft utilized rudder travels that range from a 4 degree total band during the previous taxi, to a 7 degree band during the previous successful takeoff (see Figure 15). However, during the accident aircraft's attempted takeoff, the rudder travel was within a 2 degree total band during taxi, attempted takeoff, and during the rejected takeoff (see Figure 16). This limited rudder movement is additional evidence that the gust lock was engaged during this timeframe.

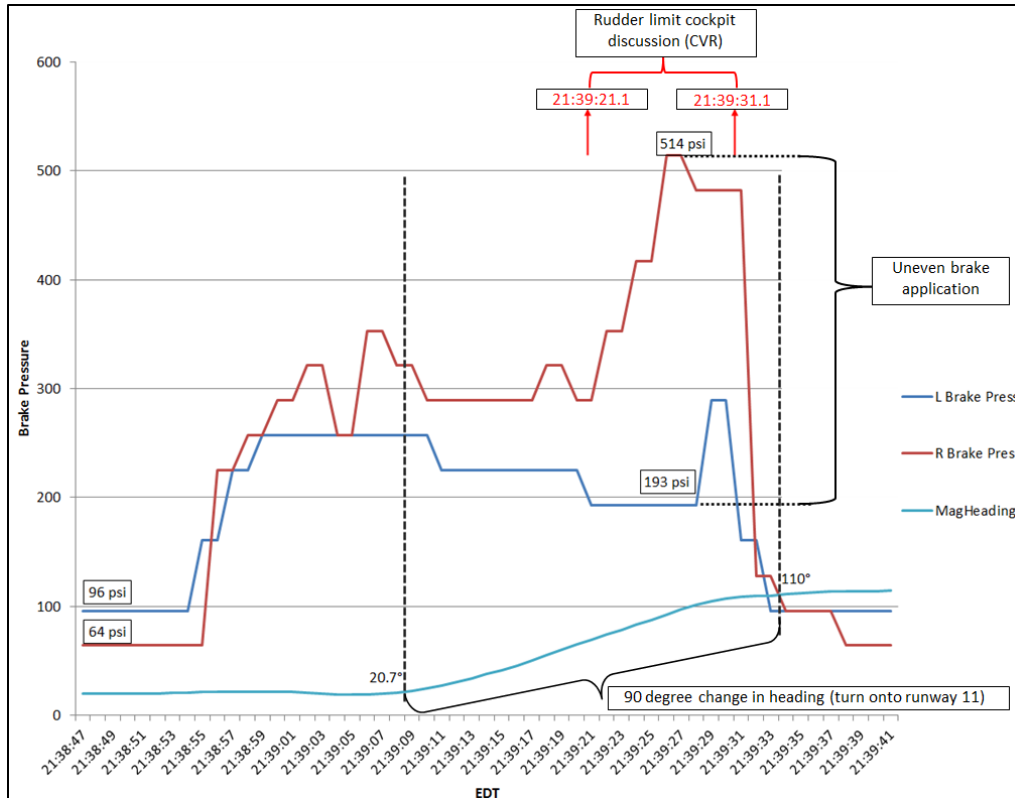
FIGURE 17 – ACCIDENT BRAKE PRESSURE RISE WITH RUDDER LIMIT CAS MESSAGE

The brake and rudder pedals in the G-IV aircraft are attached to the same mechanism and both are manipulated by the pilot's feet. During N121JM's final 90-degree turn onto the active runway, the differential pressure between the left and right brakes was roughly 300 psi (see Figure 17). Gulfstream has concluded that either: 1) the uneven pedal position during brake pressure application resulted in inadvertent rudder pedal input or 2) yaw damper activation during the turn caused some amount of rudder input. With the gust lock engaged, only minimal rudder input is required before the rudder actuator reaches its internal pressure limit and the **[RUDDER LIMIT]** CAS message is displayed. While the PNF asked the PF if he was on the rudder as the first sign of troubleshooting, no further actions appear to have been taken and the crew did not perform a rudder control check. A simple check of the rudder control pedals in response to this CAS message would have demonstrated that the gust lock was engaged and the flight controls were locked, and the takeoff should have been abandoned. This discussion on the blue advisory message over a 10-second period indicates that the crew understood this was an abnormal message at this phase of airplane operation, and the crew's failure to follow up demonstrates poor CRM.

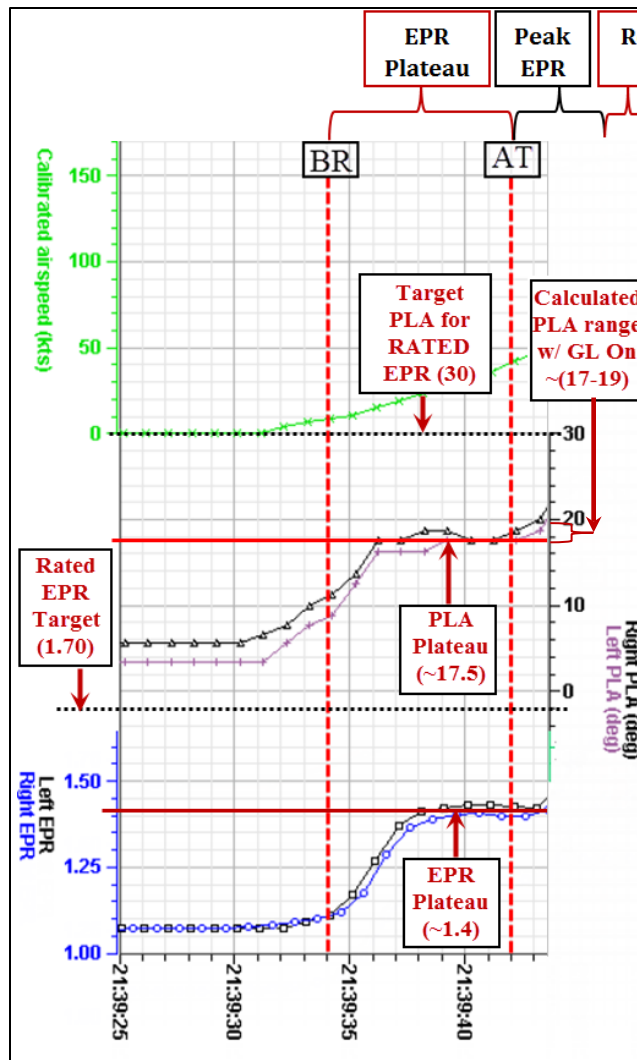
FIGURE 19 – PLA & EPR PLATEAU (PRE-AT ENGAGEMENT)

Based on the data provided in the NTSB FDR Factual Report, the throttles were advanced manually, achieving an initial EPR of approximately 1.4 about 5 seconds after brake release. The corresponding initial PLA achieved at this time was approximately 17.5 degrees, according to the FDR data.

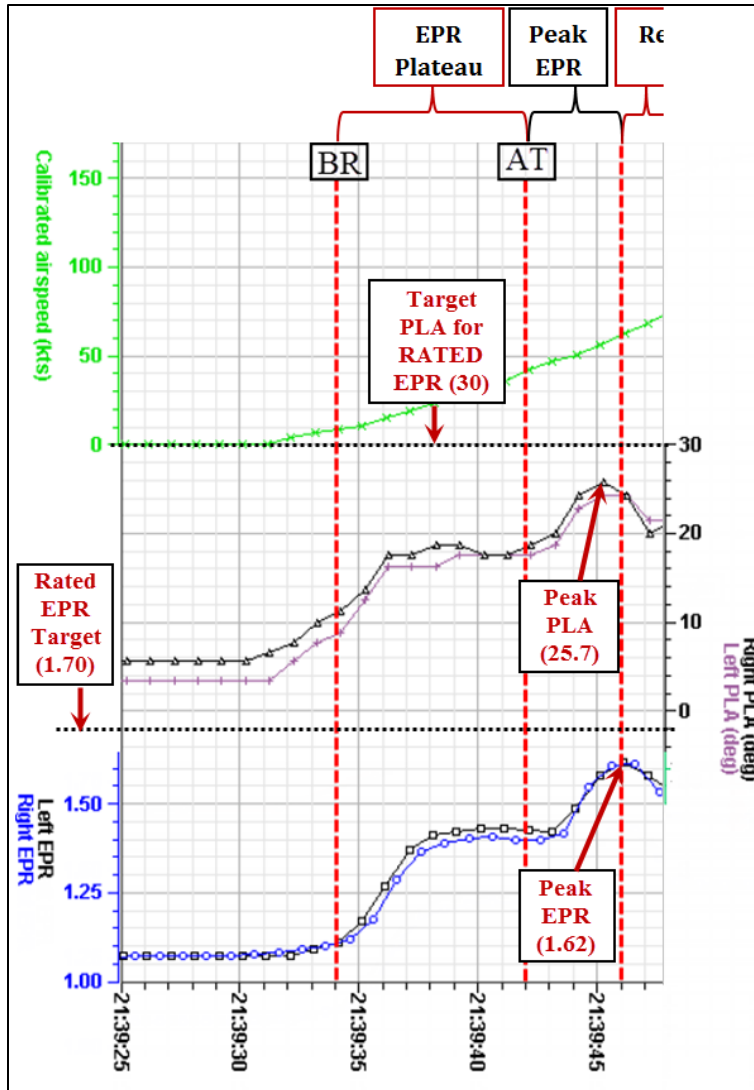
FIGURE 21 – PLA & EPR PEAK (POST-AT ENGAGEMENT)

Gulfstream has concluded that the engagement of the AT was an attempt to achieve the target EPR, and it is at this point that the gust lock handle was released to an intermediate position by either the flight crew manual input, forced by the AT, or a combination of AT and manual throttle advancement. The last two scenarios involving AT or combination of manual and AT engagement, would only be possible if there were further deformation or damage to a previously compromised gust lock handle detent pin (see NTSB Airworthiness Factual Report & Materials Laboratory Factual Report (Reference 8) for further details of the damaged pin).

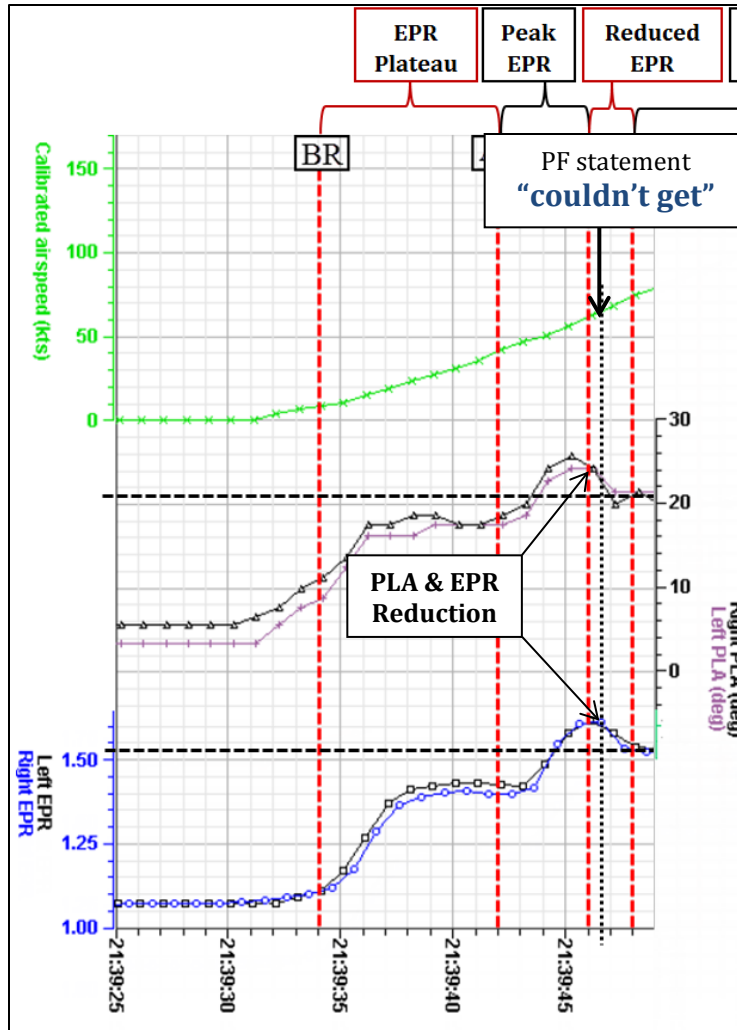
FIGURE 22 – PLA & EPR REDUCTION

Based on the data provided in the NTSB FDR Factual Report, and per its intended function, the AT 'HOLD' mode was engaged at 60 KCAS on the accident aircraft takeoff attempt. At this time, the AT system removed electrical power to the AT servos while keeping the AT servo clutches engaged. Per aircraft design, the AT system maintained the EPR achieved at that time. By design, the AT system does not input any commands that alter the EPR levels at this point, however any physical movement of the throttles, including movement induced by abnormal gust lock handle position and aft manipulation, will change the PLA and EPR.

Gulfstream has concluded that the PNF was likely moving the gust lock handle in the aft direction in an attempt to release it from its position. In tandem with the AT system being in 'HOLD' mode, this aft movement of the gust lock handle resulted in the reduction in throttle position, which due to being in 'HOLD' mode, remained constant until the throttles were reduced when the takeoff was aborted.

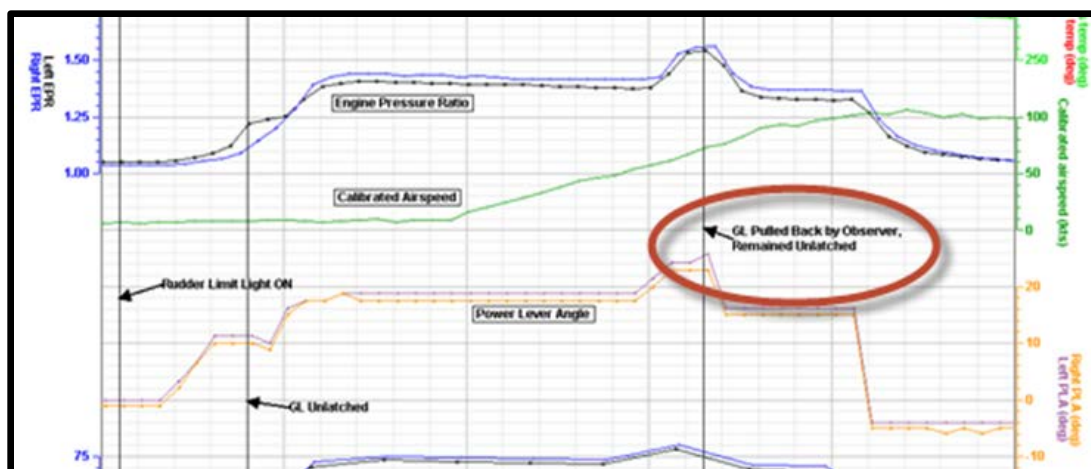
FIGURE 23 – RECREATED PLA/EPR REDUCTION (GUST LOCK PULL BACK TEST)

Gulfstream testing, documented in Reference 9 simulated the accident conditions and was able to achieve a reduction in EPR of this magnitude only by a manual input to the gust lock handle, which due to the throttle interlock would also move the throttles. Direct movement of the throttles would have the same effect, but it is very unlikely that a crew member would reduce throttles at this point in the takeoff. Figure 23 below shows the results of the Gulfstream test (Reference 19), in which the gust lock handle is moved to an unlatched/intermediate position, the autothrottles engaged, and then the gust lock handle pulled aft in an attempt to release the gust lock mechanism. The peak in PLA/EPR can be clearly seen, as well as the subsequent reduction in PLA/EPR. During this test, the gust lock mechanism did not become released until the aircraft was turning onto the taxiway at the end of test.

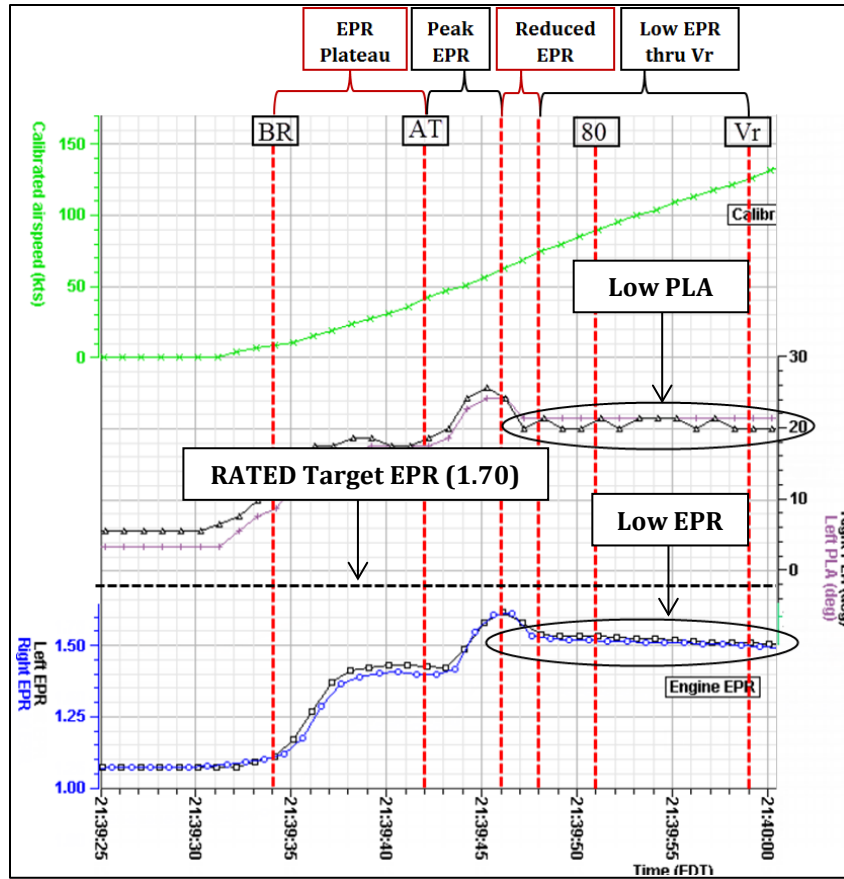
FIGURE 24 – STABILIZED PLA/EPR BELOW MINIMUMS

Based on this information, it is reasonable to conclude that the crew was targeting a RATED EPR of 1.70 for this takeoff. The FDR data shows that the peak EPR of 1.62 was reached at about 62 knots, but by 70 knots and less than 2 seconds later, it had reduced to 1.53. As previously noted, the crew likely acknowledged the difficulties in achieving EPR, but there is no subsequent evidence in the CVR of the crew either verbalizing or noticing the power reduction. There is also no indication on the FDR of any action being taken to correct the low EPR by disconnecting the AT system and manually increasing power. Figure 24 below shows the data from the FDR and the absence of PLA inputs.

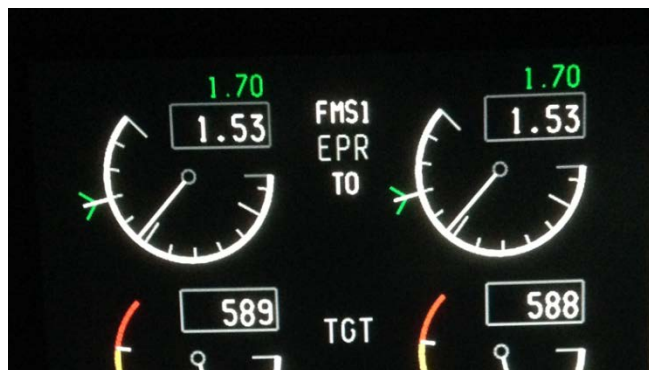
FIGURE 27 – SIMULATED STABILIZED ACCIDENT EPR VALUE NOT REACHING RATED EPR TARGET

Figure 27 shows what the crew would have seen at stabilized EPR values (1.53) compared to the 1.70 RATED EPR target.

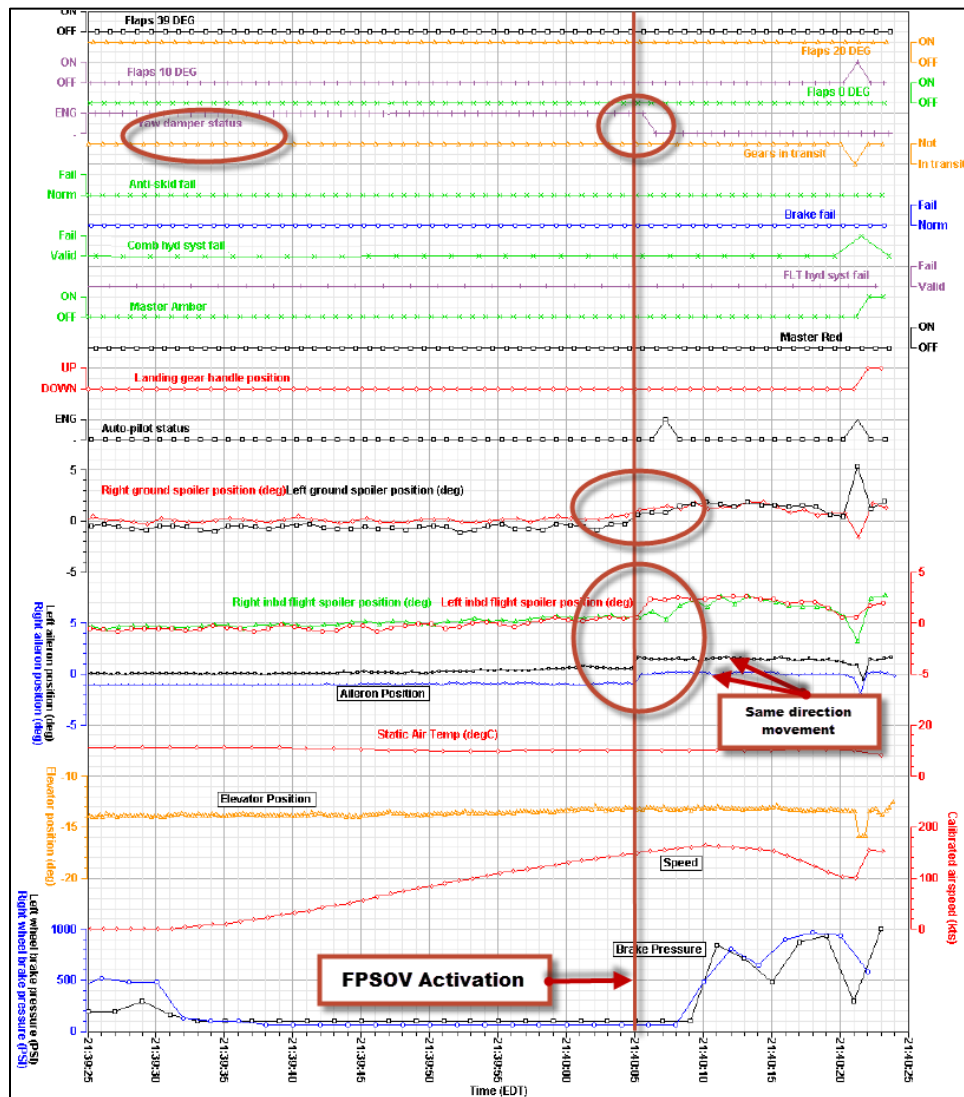
FIGURE 30 – FPSOV ACTIVATION-FDR EVIDENCE

The FPSOV and the handle were both found in the post-accident wreckage review to be in positions consistent with FPSOV activation.

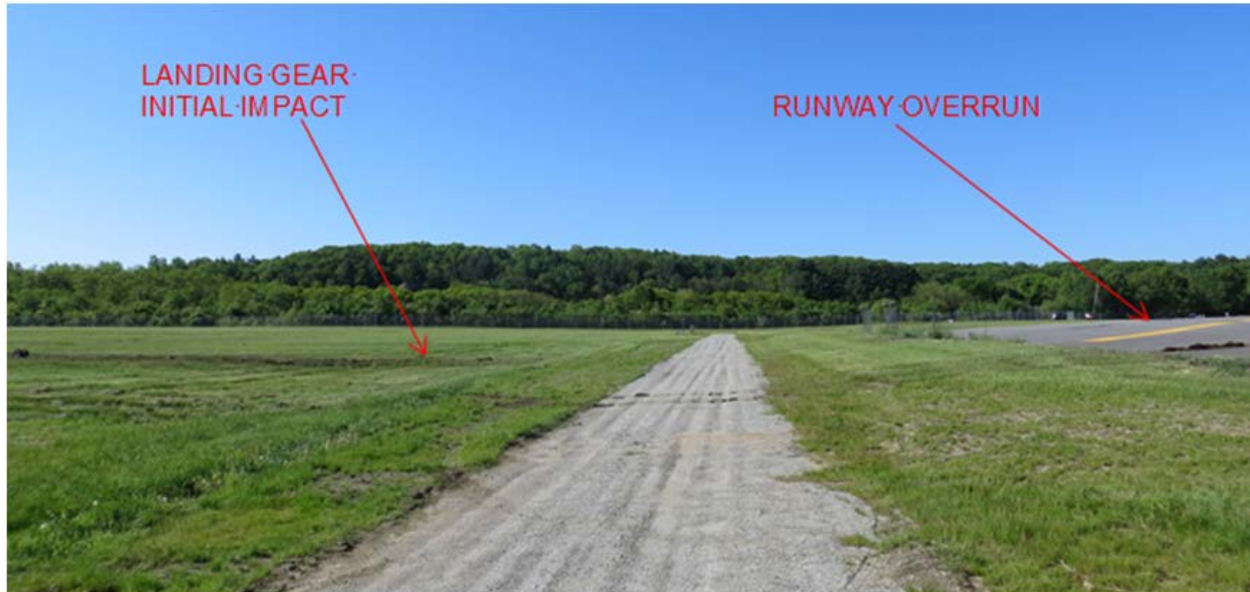
FIGURE 32 – VIEW FROM RUNWAY SERVICE ROAD

The aircraft continued beyond the runway and departed the paved overrun area at an approximate speed of 105 knots. Past the runway overrun area, the unpaved ground slopes downward below the level of the main runway surface. At this point the aircraft became briefly airborne as the terrain below it sloped away. As the aircraft departed the paved overrun surface, it arced over the perimeter roadway impacting the soft ground on its landing gear. This is demonstrated by the absence of ground contact marks from aircraft tires past the pavement until they appeared approximately 55 feet past the paved overrun area (see Figure 32).

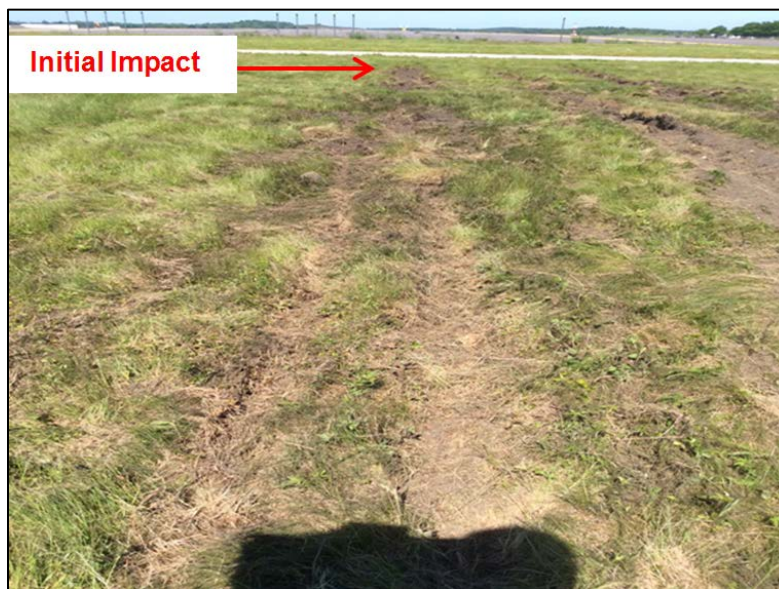
FIGURE 34 – RIGHT MLG RUT, AFTER INITIAL IMPACT – VIEW TOWARD RUNWAY

Ground scarring formed by the right MLG would indicate that the landing gear sponson plates deformed while still being attached to the wing. Initially, the ruts formed by the left and right main landing gear look similar. Later along the path of the right MLG, the appearance of the scarring changes indicating that the right MLG, although collapsed to a degree and at an uncertain angle, was still attached to the aircraft (see Figure 34).

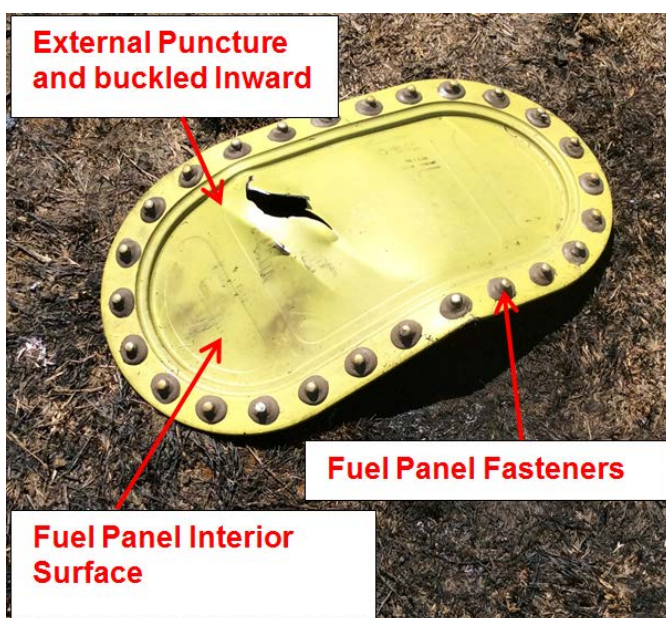
**FIGURE 35 – WING FUEL TANK ACCESS COVER**

A ruptured wing fuel access panel was found in the charred area a distance past the localizer antenna array (see Figure 35). The fuel tank access panels are mounted inside the wing, covering the openings, and are retained by fasteners to the wing structure. The damage indicates the puncture and separation from the wing occurred from a source external of the wing most probably when the aircraft struck the localizer array. The now open fuel tank allowed fuel to be discharged from the wing. The grass between the localizer antennas and the ravine was blackened and charred from fire. There is no visual evidence of fire spreading backward from the localizer array along the aircraft track. This demonstrates that the first spill of fuel occurred after the localizer array, where the array came in contact with the wing.
