NTSB Accident Investigation File: DCA13MA133

Party Submission

Investigation of Accident Involving UPS Flight 1354

May 1, 2014

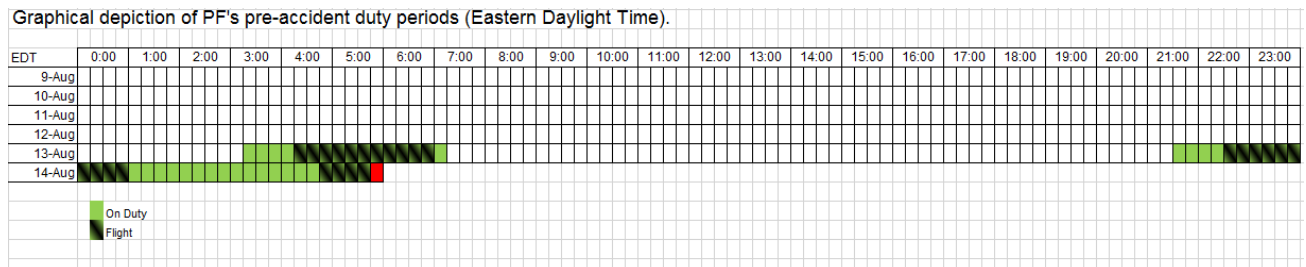
Chart 2

The PF's operating schedule and rest opportunities are depicted in Chart 2.²⁴ As is represented, the PF's schedule provided a 14+ hour opportunity for rest during the layover in KRFD on August 13, 2013.

Proposed Finding: The Captain/PF had adequate rest opportunities for the intended schedule.

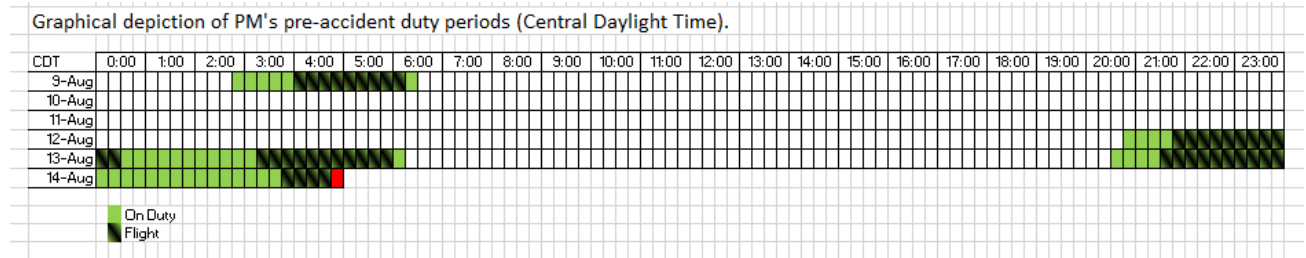
Chart 3

The PM's operating schedule and rest opportunity is depicted in Chart 3.²⁵ As is represented, the PM's known schedule provided a 60+ hour layover opportunity for rest during the layover in KSAT beginning August 9, 2013, and a 14+ hour opportunity for rest during the layover in KRFD on August 13, 2013.

Proposed Finding: The FO/PM had adequate rest opportunities for the intended schedule.

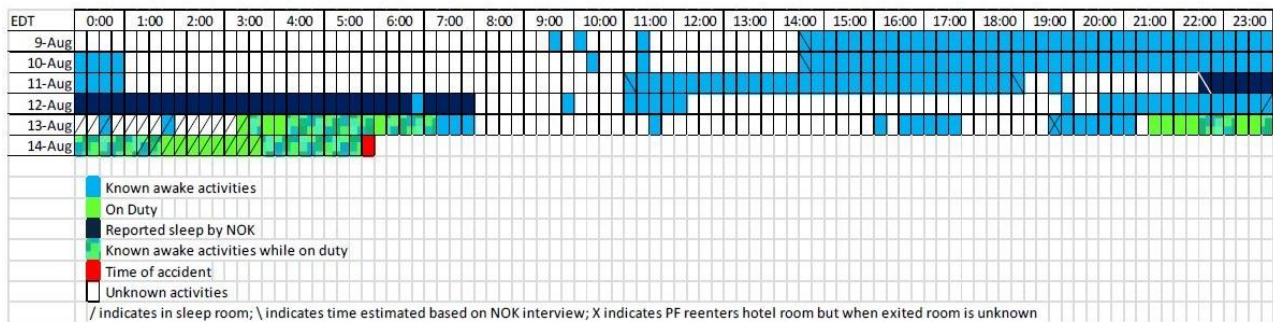
Chart 4

Chart 4²⁶ provides the PF's graphical data of pre-accident (both known and Personal Electronic Device (PED)) activities during the same period. To the extent the PED analysis can reliably correlate PED activity to non-sleep activity, as the PED Factual Report represents, it appears the PF managed his sleep opportunities well and showed no signs of chronic or acute fatigue. The only decrement to alertness would be the normal circadian issues associated with operating in the WOCL during the approach into KBHM. UPS mitigates the effects of operating in the WOCL by maintaining high levels of cockpit standardized procedures, redundant call-outs, fatigue management guidance and training, and written professional expectations.

Proposed Finding: The Captain/PF took full advantage of his sleep opportunities.

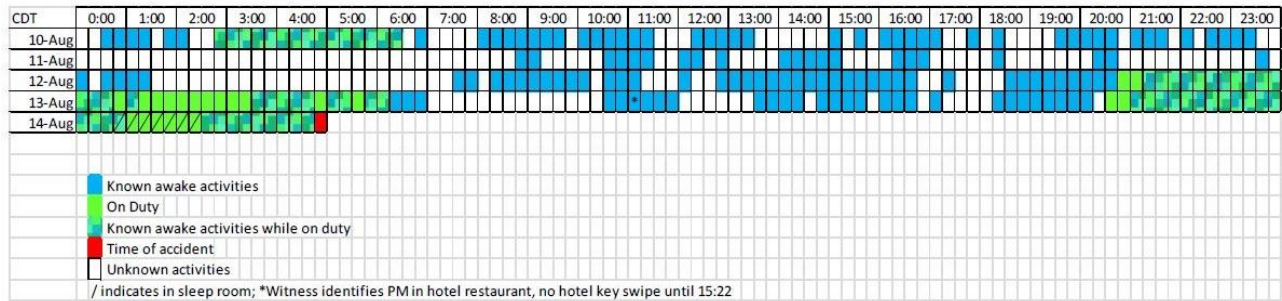
Chart 5

Chart 5²⁷ provides PM's graphical data of pre-accident (both known and PED) activities during the same period. Again, to the extent the PED analysis can reliably correlate PED activity to non-sleep activity, it appears the PM had an opportunity for extensive periods of un-interrupted rest during the 36-hour period prior to the KBHM accident. The PM is quoted, however, as saying in the CVR transcript that while she slept in KRFD, she was still tired. The feeling of sleep pressure she experienced appears to support the findings in the PED Factual Report that such loss of sleep resulted from personal activities during the 60+ hour layover in KSAT. While the PED report indicates that fatigue may have had an impact on the PM's performance, UPS believes that the behavioral markers throughout the flight were not of the type that would indicate to the Captain/PF that there was a fitness for duty concern with the FO/PM.

Proposed Finding: The FO/PM did not take full advantage of her sleep opportunities.

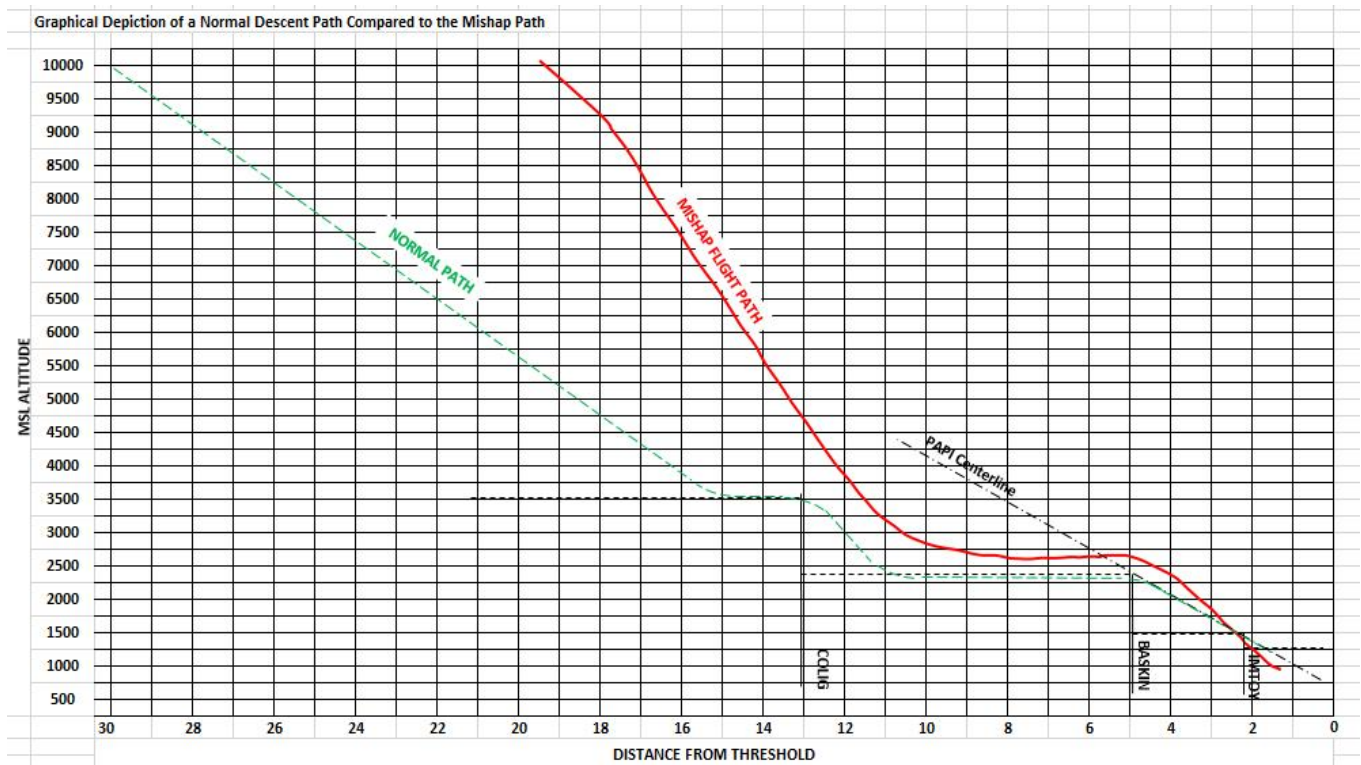
Chart 6

From CVR data obtained during the investigation, it appears the crew correctly determined that they were well above a normal descent path. (*Crew comments during the latter stages of the approach indicate this perception continued even after they passed through the normal approach path below 1000 feet AFE.*) The crew's correct analysis that they were high on the descent possibly became the primary focus for the PF as he concentrated on maneuvering the aircraft to meet the parameters for commencing the approach. The high workload generated by the late ATC descent required the PF to place his focus on energy management to the point of being unable to trap errors effectively. In short, the PF became task saturated at a critical phase of the flight.

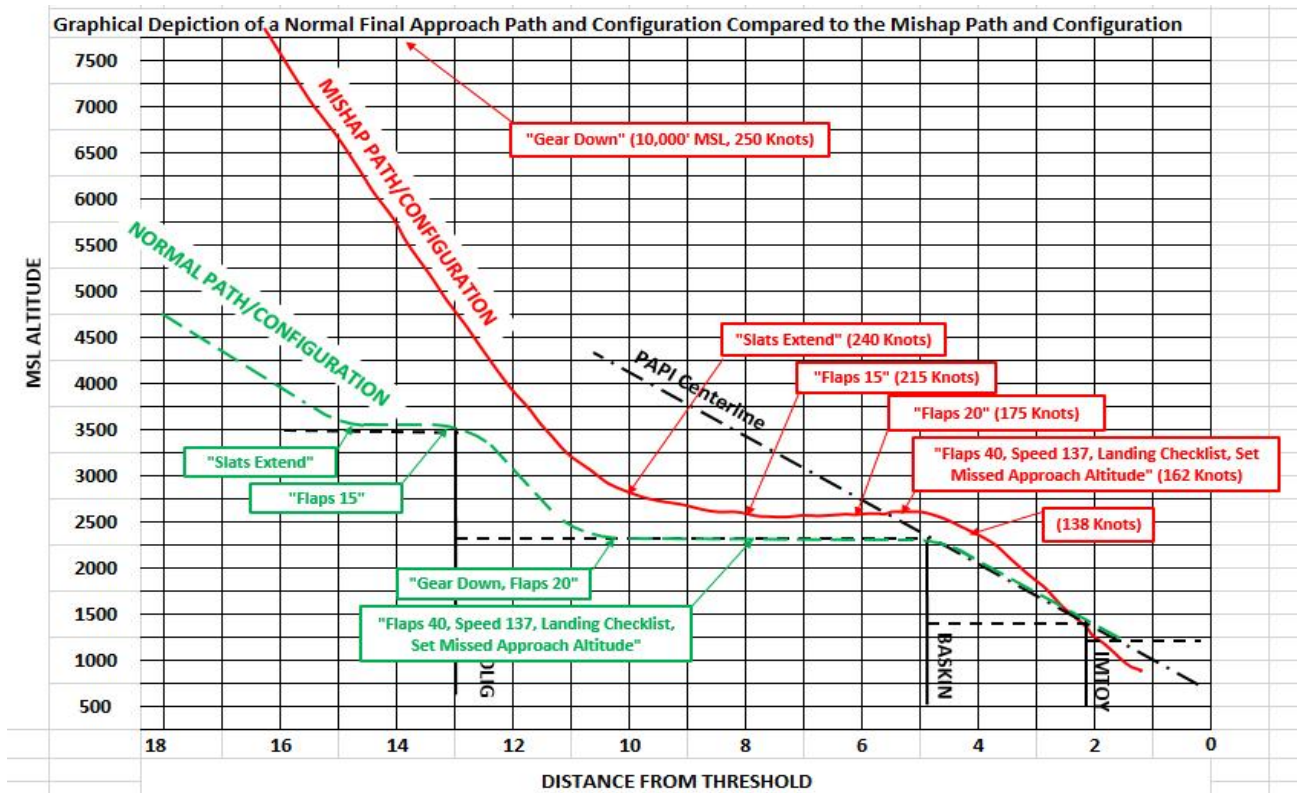
As the aircraft continued its descent on the approach, the PM verbally noted that COLIG, the initial approach fix (IAF), was approaching quickly and stated, "at least there is 8 miles between COLIG and BASKN (FAF)." This indicates that the PM was focused on the late descent and tight arrival and was mentally computing whether the flight could complete the descent in time to begin the approach. At this point the flight was well above a normal descent path. A normal path would have allowed the flight to descend, slow and configure correctly, arriving on altitude and airspeed in a position to safely commence the approach. Chart 7 is a graphical depiction of a normal final approach path and configuration compared to the mishap path and configuration.

At 11 miles from BASKN or 16 miles from the runway threshold, see Chart 7, the crew was cleared for the LOC18 and instructed to descend to 2,500 feet MSL. The PF was aggressively descending but due to their proximity to the field, the flight remained high and fast. The PF recognized that Final Approach Mode had not been activated and called for the PM to “activate final”. (This is required in addition to sequencing the FMS flight plan for VNAV path engagement and further demonstrated a level of situational awareness by the PF.)
