# INVESTIGATION PARTY SUBMISSION FOR NTSB FILE ERA18MA099 (N350LH)

Document No.: DAIPS-1 Rev. A

On March 11, 2018, an AS350B2 helicopter registered as N350LH and operated by Liberty Helicopters on behalf of NYONair and FlyNYON (jointly referred to hereinafter as “FlyNYON”) experienced a perceived engine failure and was forced to make an emergency landing into the East River in New York City. During the water landing, the helicopter rolled to the right, causing the aircraft to capsize.

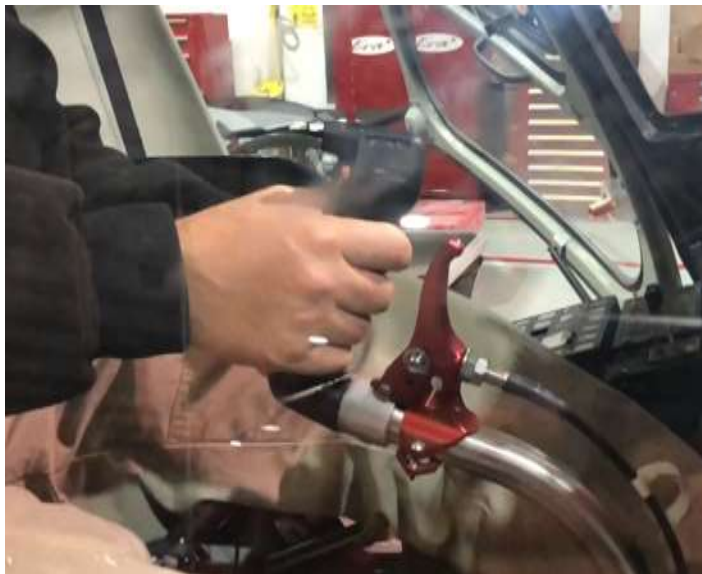
**Figure 1: Inflation Lever Installed on AS350 Helicopter**

The float inflation lever is designed to provide mechanical advantage for the operator in an ergonomic manner. The overall design is similar to that of a motorcycle or bicycle break lever, with rounded edges and an increased cross section toward the end of the lever. The design intent of the lever is to allow for a single hand operation, with the pilot using the base of the palm and thumb to control the cyclic while using the rest of the fingers to pull the lever to full travel. This design has been used successfully on multiple models, such as the Airbus Helicopters H130, H135, H145 and the Bell 206, 407, and 505.

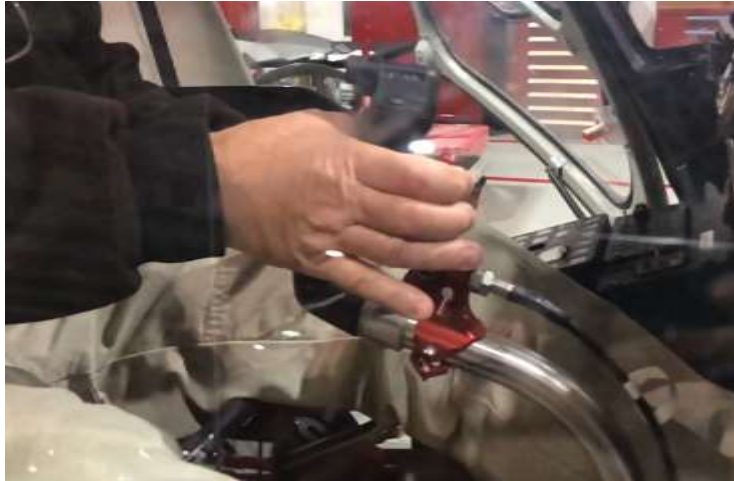
**Figure 2: Inflation Lever Being Pulled During Inflation**

When a pilot pulls the emergency float inflation lever, there are three basic ways for the pilot to determine that the floats have inflated: (1) he/she hears the loud “pop” sound that accompanies the activation of the reservoir (especially where, as here, the engine is not operating), (2) he/she feels the significant increased drag on the helicopter's operation, and (3) clearly sees that the front floats of each side of the floatation system have properly inflated. As mentioned in the pilot testimony, the pilot pulled the inflation lever during autorotation procedures and apparently believed that there was commencement of inflation. Therefore, it is concluded that he prematurely stopped pulling the lever aft and, instead, directed his attention to completion of emergency landing maneuvers.

It is clear that had the pilot continued to pull the inflation lever to its full travel, then both the LH and RH reservoir assemblies would have been activated, thereby releasing a balanced amount of gas to each side. It is probable that had he accomplished this, the pilot would have had the ability to counteract rolling moments during the water landing – especially had he followed the published procedures and entered the water with a forward speed of not more than 10 kts. While the water entry speed was much higher than the recommended maximum forward speed for float utilization (indeed, more than twice as fast), it is unclear whether the additional speed, combined with the additional drag area from fully inflated floats, would not have introduced other failures.

During the investigation, in conjunction with recommendations from the FAA and NTSB, Dart released a Service Bulletin (SB2018-03) that provided clarification on the proper function of the inflation lever. Specifically, the Service Bulletin instructs pilots that pulling the inflation lever to full travel is the recommended method for ensuring full float inflation.
