**Party Submission to the
National Transportation Safety Board**

**Investigation of the Airbus Helicopters A350B2 Accident
East River, NY, March 11, 2018**

ERA18MA099

**Presented by Jillian O'Brien,
Party Coordinator for
NYONair LLC and FlyNYON LLC**

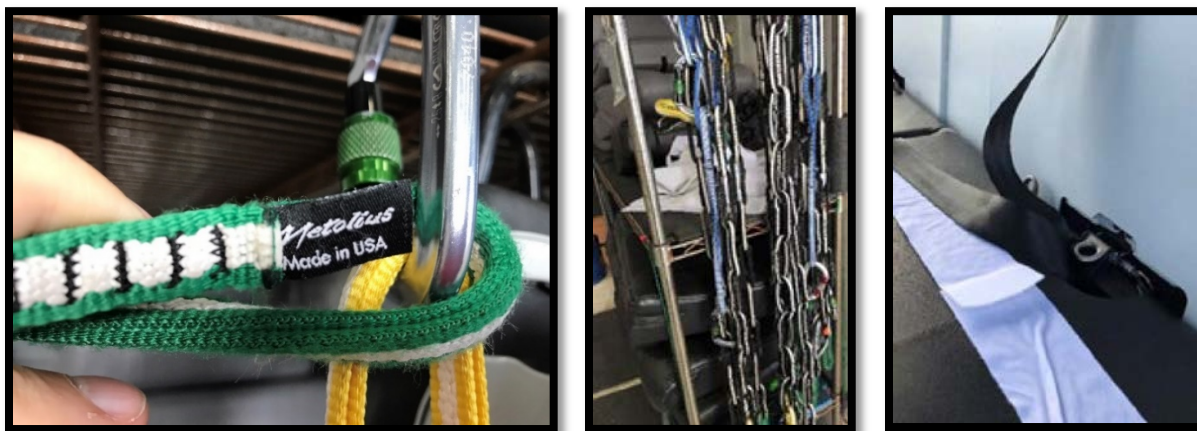
Figures 7-9: Liberty PMI’s photographs of the tethers and carabiners used by Liberty during doors-off operations

On October 31, 2017, Liberty’s FAA Principal Maintenance Inspector (“PMI”) observed Liberty’s operation of doors-off aerial photography flights during routine surveillance.²⁴ Liberty personnel explained the format of the flights and the use of harnesses, and the PMI observed the passenger loading process. He understood that passengers wore harnesses during the flight, that the harnesses were tethered to a hard point in the aircraft, and that cutaway knives were provided.²⁵ While on site that day, the PMI photographed the supplemental restraint/harness system equipment, including the tethers and locking carabiners shown below, and had internal discussions with Liberty’s POI about their use.

After “in depth” discussions, Liberty’s POI and PMI concluded that there was “nothing contrary to the regulations.”²⁶ They did not take any action to stop the use of the harness system on Liberty operated doors-off flights and did not conduct any further inspections.²⁷ As the POI explained, he did not feel compelled to go see the operation himself because he “was comfortable that the operation could be conducted safely.”²⁸

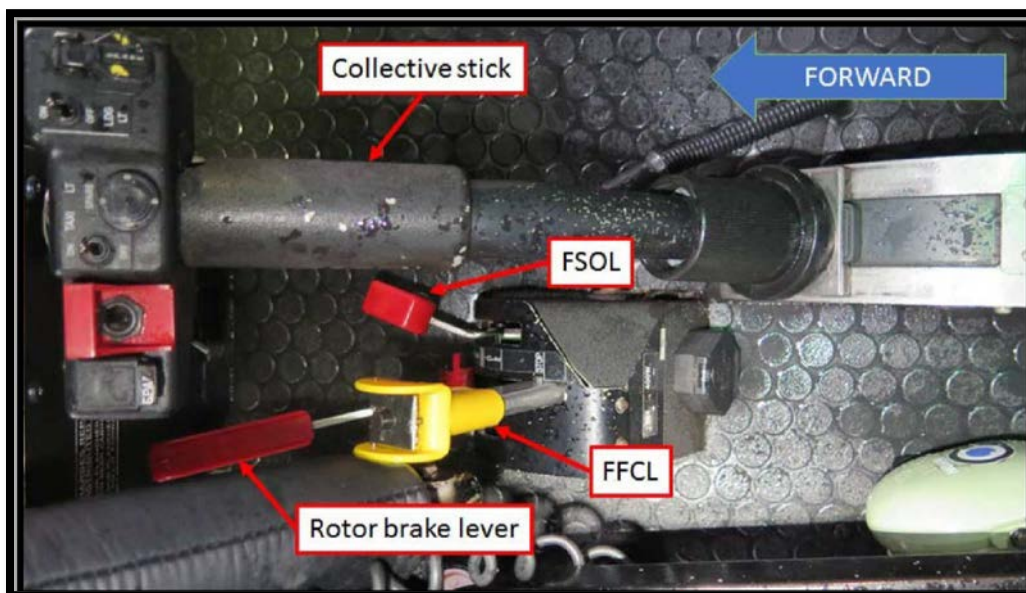
Figure 10: NTSB Airworthiness Group Factual Report diagram of engine controls and rotor brake lever

The fuel control quadrant of the Airbus AS350B2 helicopter model is located on the floor between the pilot and the front passenger's seat. It is comprised of the Fuel Flow Control Lever ("FFCL"), the FSOL and the rotor brake lever (*see* Figure 10). The FSOL provides a means to open and close a valve on the fuel line between the fuel tank and the engine. When the FSOL position is forward and down, the valve is open, permitting fuel to flow to the engine. When the FSOL position is aft and up, the valve is closed, cutting off fuel flow to the engine.

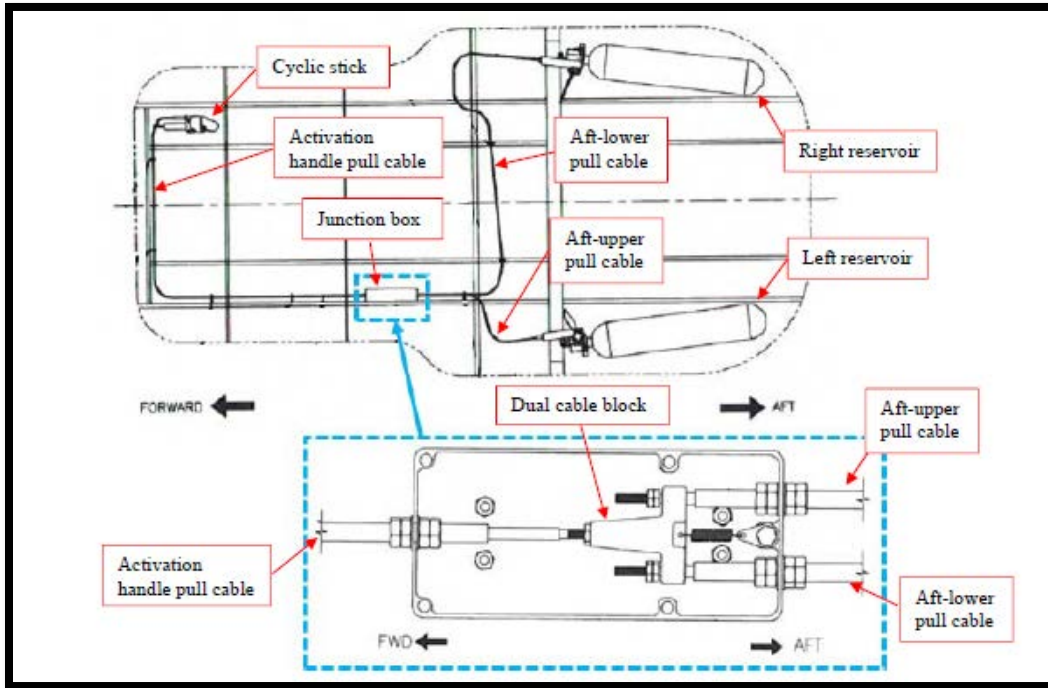
Figure 15: Illustration of emergency flotation system from Installation Instruction No. II350-6

Hoses connect the three left floats to the left manifold, the latter of which is supplied gas by the left reservoir assembly. Similarly, hoses connect the three right floats to the right manifold. A cross-feed hose, installed between the left and right manifolds, is intended to allow gas to traverse between the left and right sides. A single reservoir assembly, e.g. the right or left reservoir assembly, was intended to be able to inflate both the left and right side floats should one reservoir not operate correctly.

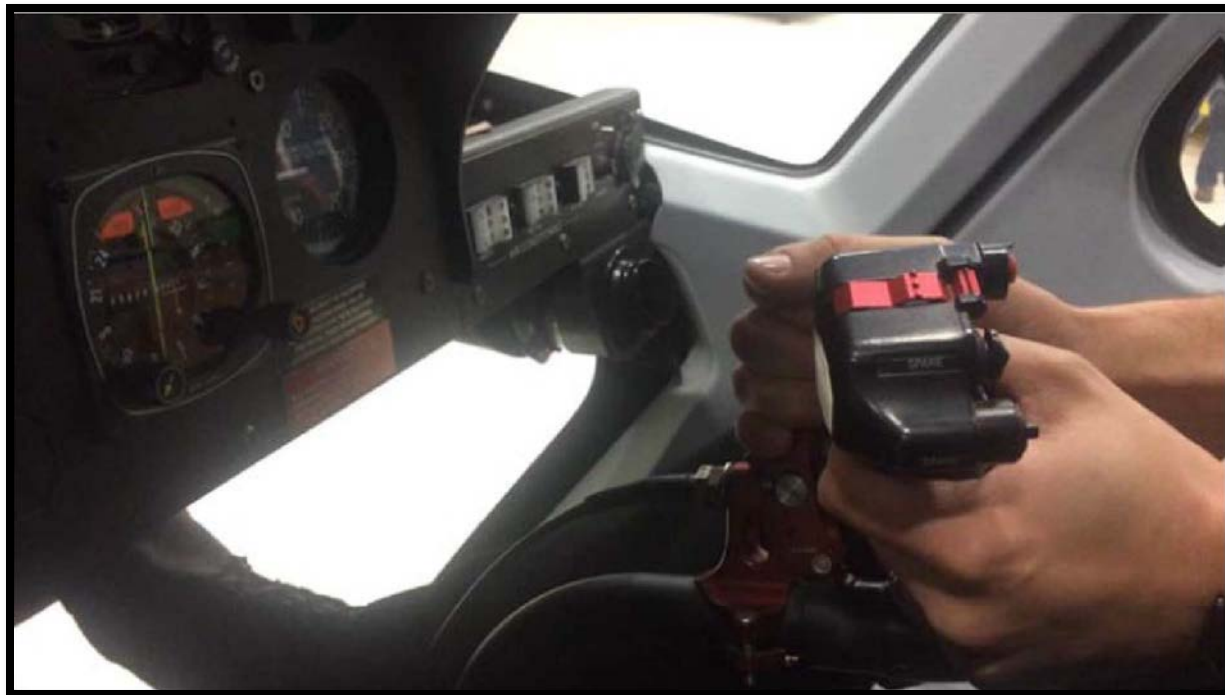
Figure 17: Screen capture from the December 14, 2016 emergency flotation system deployment

activate the system. (See Figure 17 below). Videos showing the deployment of the emergency flotation system during 36-month inspections on two other Liberty helicopters, on May 2, 2016 and March 1, 2017, also show the pilots using two hands to operate the system. Like the Accident Pilot, they used the left hand to brace the cyclic and the right to pull the activation handle.

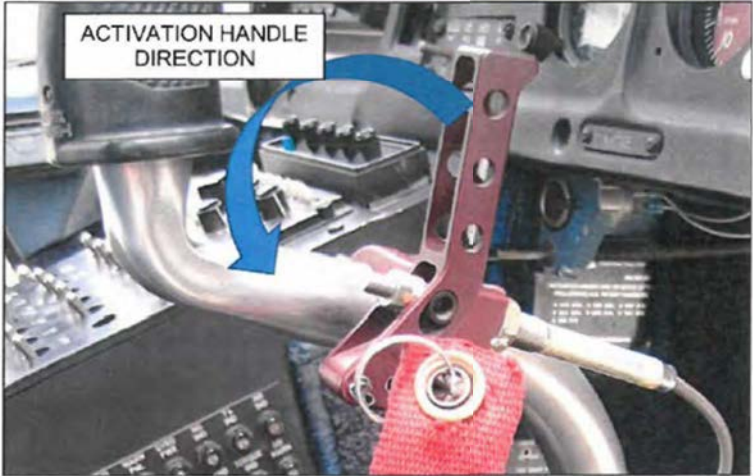
Figure 18: Mandatory Service Bulletin 2018-03

- "Float Activation Handle should be pulled fully aft, around the handle's pivot, towards the pilot until there is no travel left available. To prevent asymmetric inflation, the handle shall be activated to full travel even when initial float inflation is observed. Full activation of the floats will result in both sides appearing firm and fully rounded out in less than 5 seconds. If one side appears to be fluttering, further travel of the handle may be required."

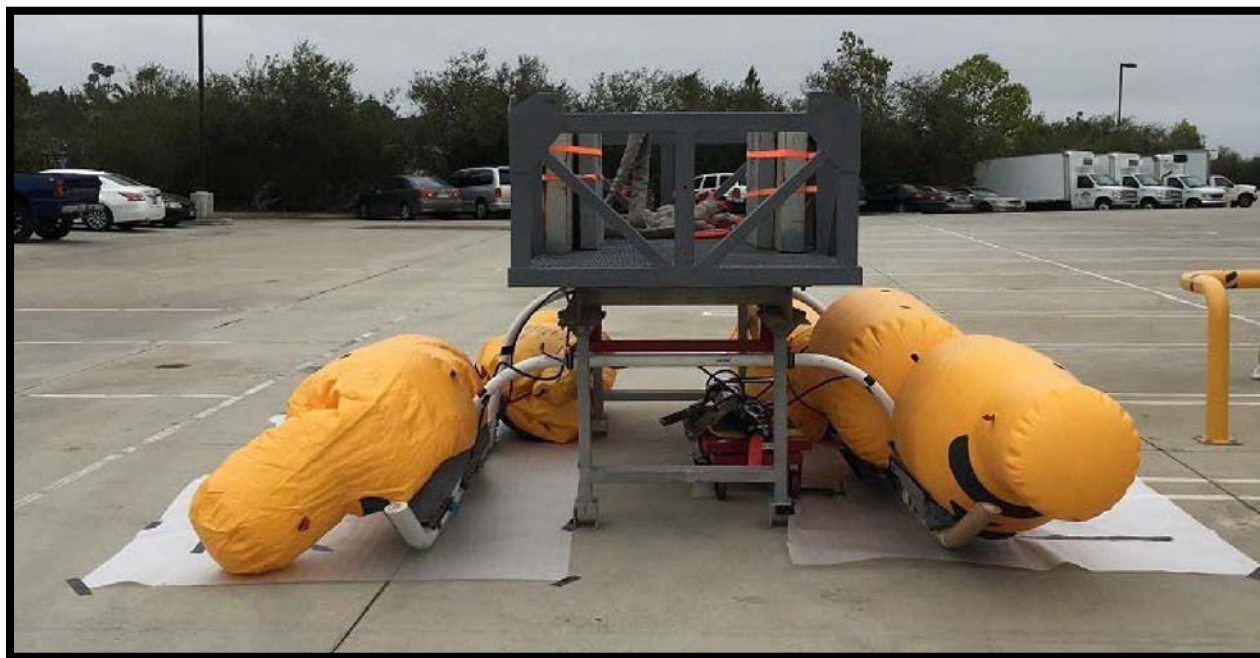
Figure 19: The inflated floats at the conclusion of the first inflation test

The inflation tests examined three configurations: the amended STC SR0047LA design, the original STC SR0047LA design, and an alternative design. For the first inflation test, the EFS Group tested a standard float installation with a cross-over hose as per the amended STC SR0047LA design. In this test, as in the Accident scenario, the cross-over hose failed to distribute

The clear takeaway from the EFS Group testing is that the deployment of a single cylinder, with or without the cross-over hose, will result in one side being inflated more than the other and will not provide sufficient stability to avoid a rollover. In this way, having a single cylinder deployment may be even worse than not having any emergency floatation devices installed on the aircraft in that asymmetric deployment, at the inflation levels achieved in the EFS tests, will result in an immediate rollover reducing the time available for egress. This is a critical design failure.
