Subject: Gulfstream Submission to NTSB Investigation ERA111A316

Gulfstream G200 SN 165 Incident Summary & Conclusions

Root Cause Analysis for G200 S/N 165

Collapsed Landing Gear, During Landing

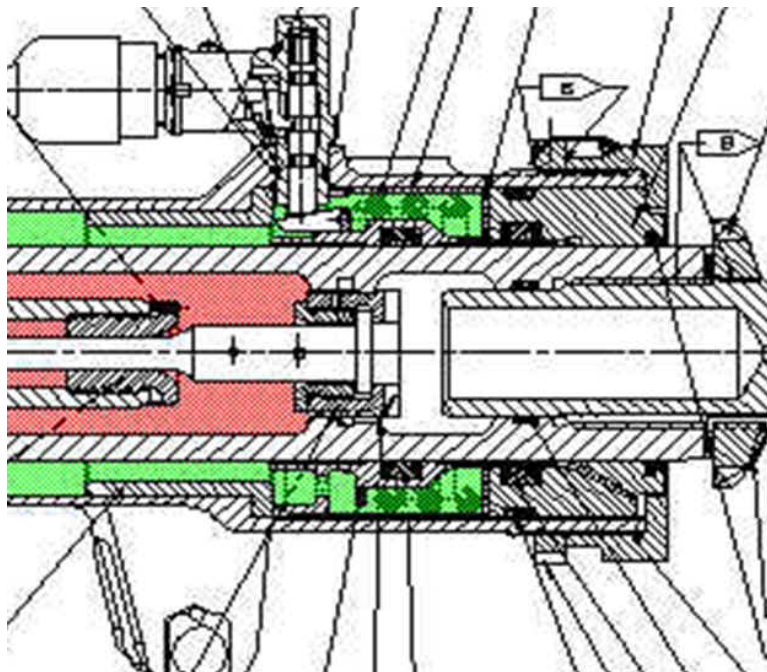
Figure 3 – MLGs Down lock Mechanism Cross Section

The down lock segment threshold ATP requirement for unlocking is ~240 psi (min) for no load condition, as a result, if the back pressure of the system is higher than the value above, down lock segment will remain triggered (unlocked) continually regardless of operation mode (normal or emergency).

During ATP which performed for the right MLG actuator of A/C 165 the measured down lock threshold was ~280psi (within requirements)

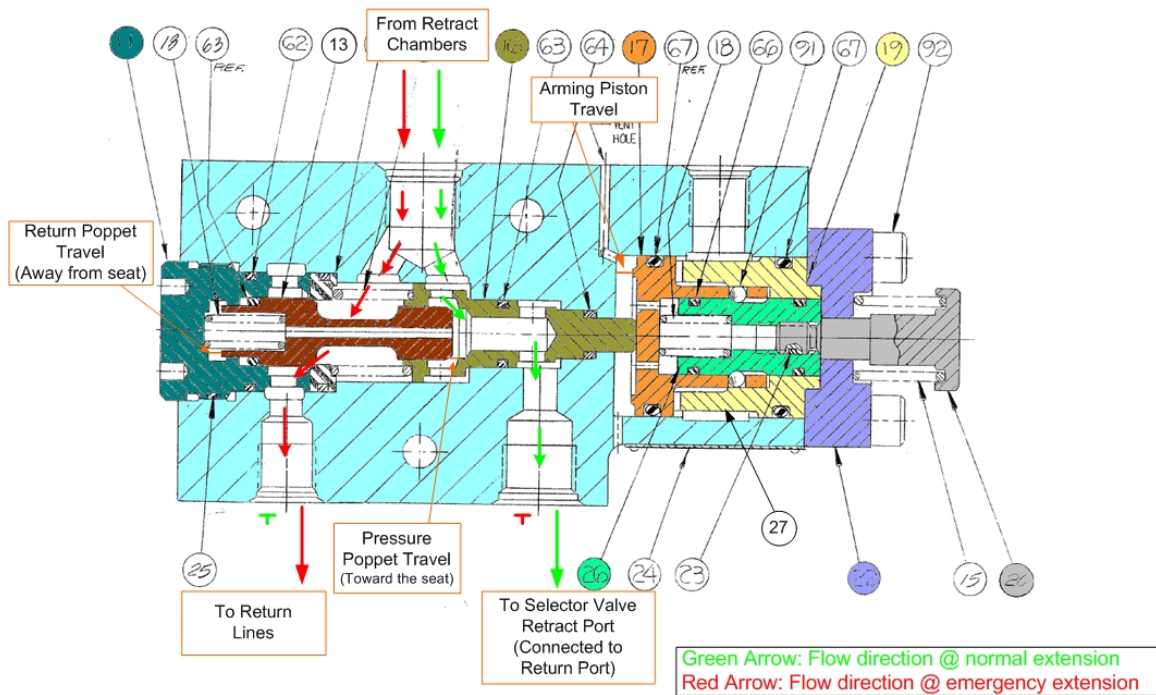
Figure 5-dump valve cross section

During gear extension P port is connected to return pressure through LGSV in order to evacuate the retract chambers fluid which enters at C port toward return system. At that phase all ports are connected to the return system and internal by-pass condition will not affect gear extension function.

In addition, if emergency dump valve had suffered from internal by-pass condition RHS was expected to abnormally operate after gear retraction (when P connected to high pressure).

The analysis above shows that there is no failure mode related to the emergency dump valve which can result abnormal behavior as occur during the event.

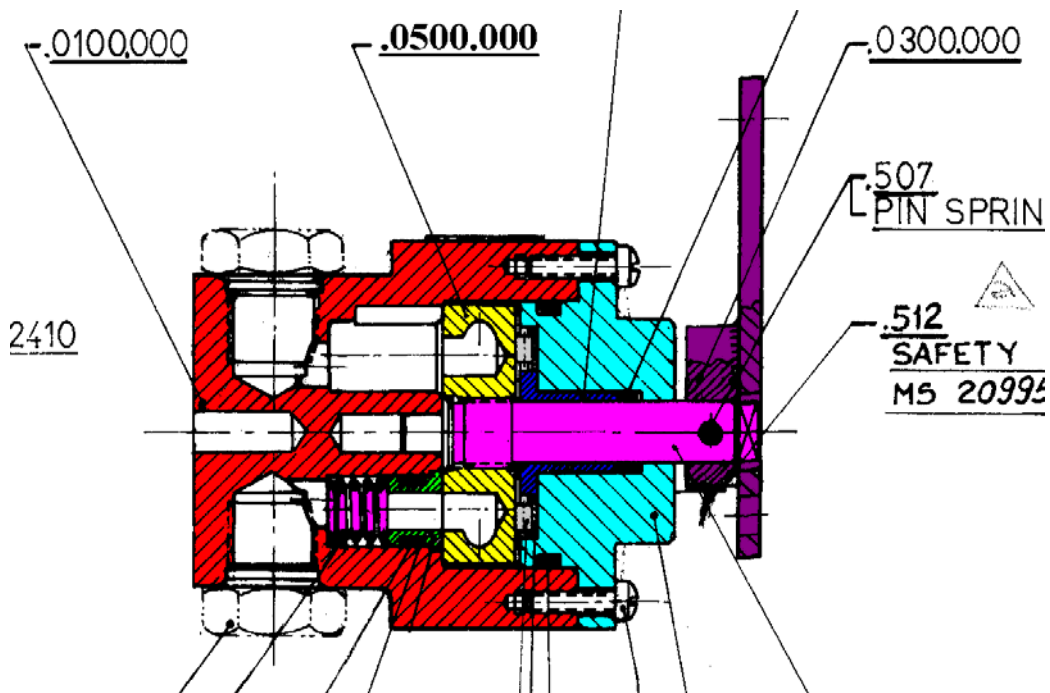
Figure 6-selector valve cross section

Full flow condition occur at 22.5° of LGSV lever angle, with 10 gpm by pass flow (which was the maximum test bench capabilities)

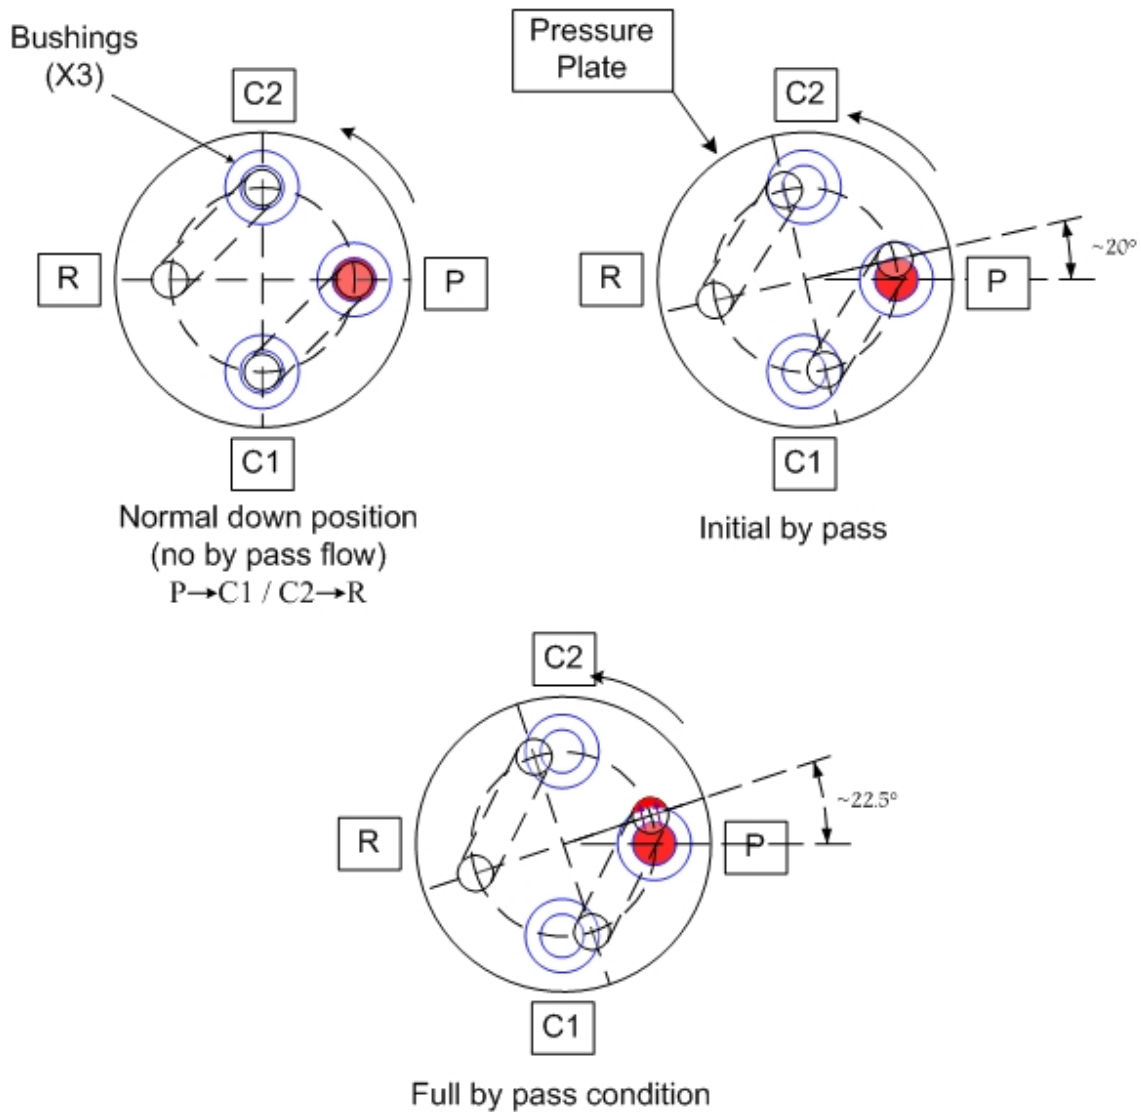
Figure 7- selector valve cavities kinematics (down position to full by pass flow)

At intermediate position (Figure 7) the LGSV can result a massive by pass flow (depend on selector valve position) followed by a system pressure drop, hydraulic fluid over heat (as reported) and a significantly higher back pressure.

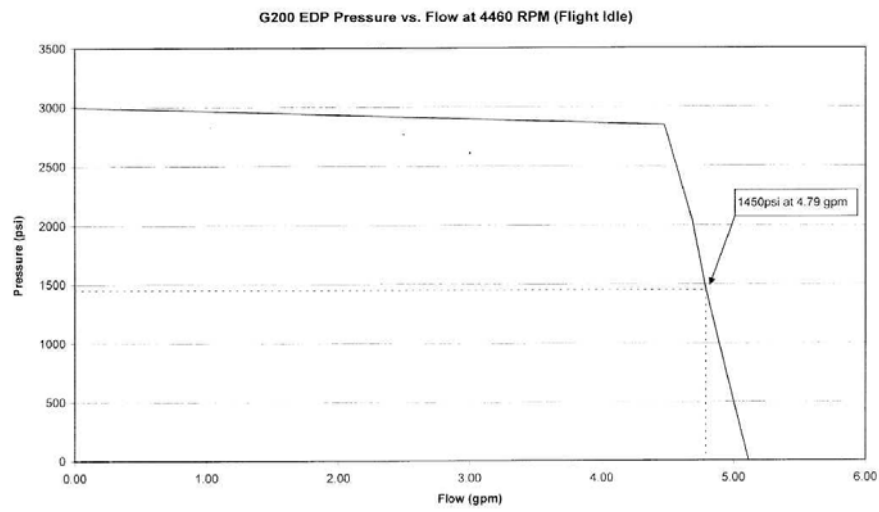
Figure 8-G20 EDP flow vs. pressure curve

Pump with flat cut off characteristics (such as the EDP) will suffer from a rapid discharge pressure drop upon reaching its maximum flow delivery capabilities. System pressure of ~1400-1500 psi indicates that the EDP was at the flat cut off curve after gears were selected down (before engine throttling to IDLE), in these initial conditions, after engine RPM was reduced to IDLE, the EDP would have likely to suffer from additional discharge pressure drop.

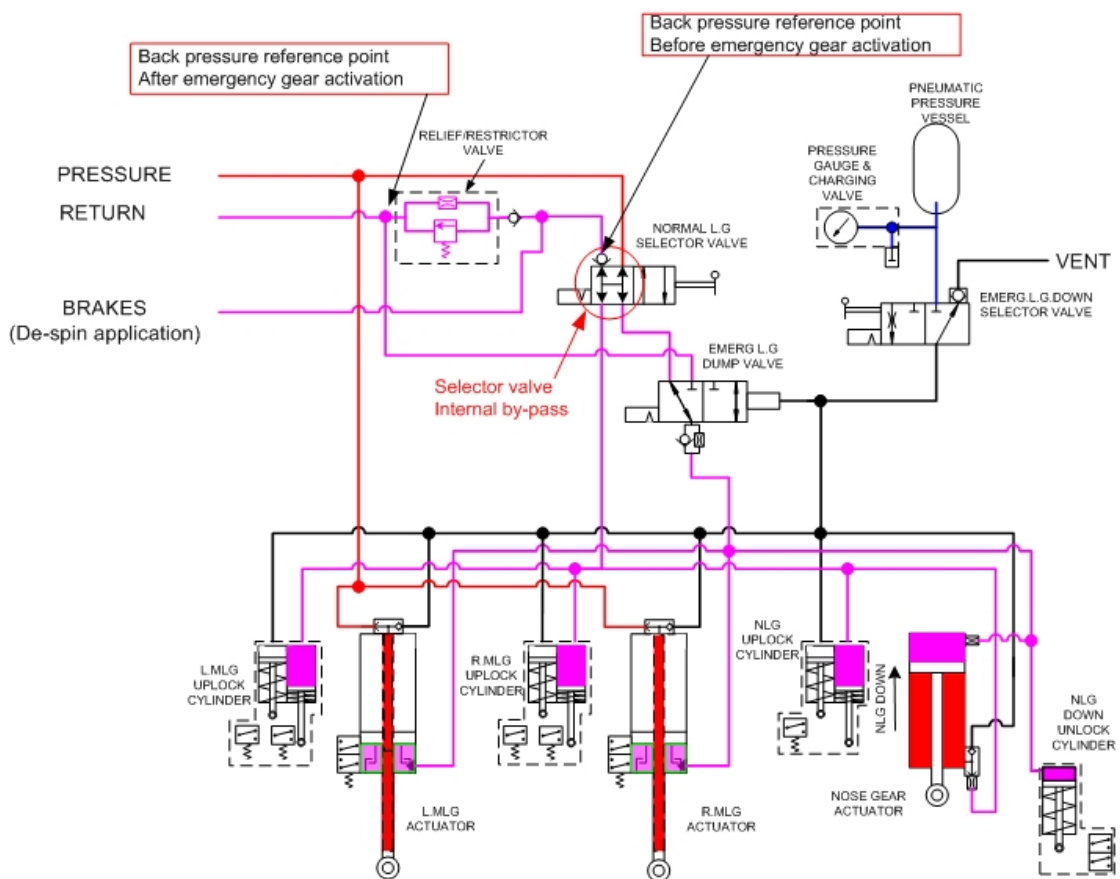
Figure 11 - L/G schematic with selector valve at intermediate position

1. Landing handle was not placed on fully down position and consequently the LGSV internally by passed fluid.
2. RHS pressure dropped to 1400-1500psi (see note below) and the internal by pass condition raised RHS back pressure to ~450psi (see note below), which prevented from the down locks to lock.

Two cases were considered for each flow condition, before and after emergency gear extension due to the change in the return cavities passages after dump valve triggering upon emergency extension actuation (dump valve triggers and connect the C port to R thus, changing return pressure path (see Figure 11 - .
