Party Submission

Landing Gear Collapse during Landing

Israeli Aircraft Industries Gulfstream 200

NTSB Investigation ERA11IA316

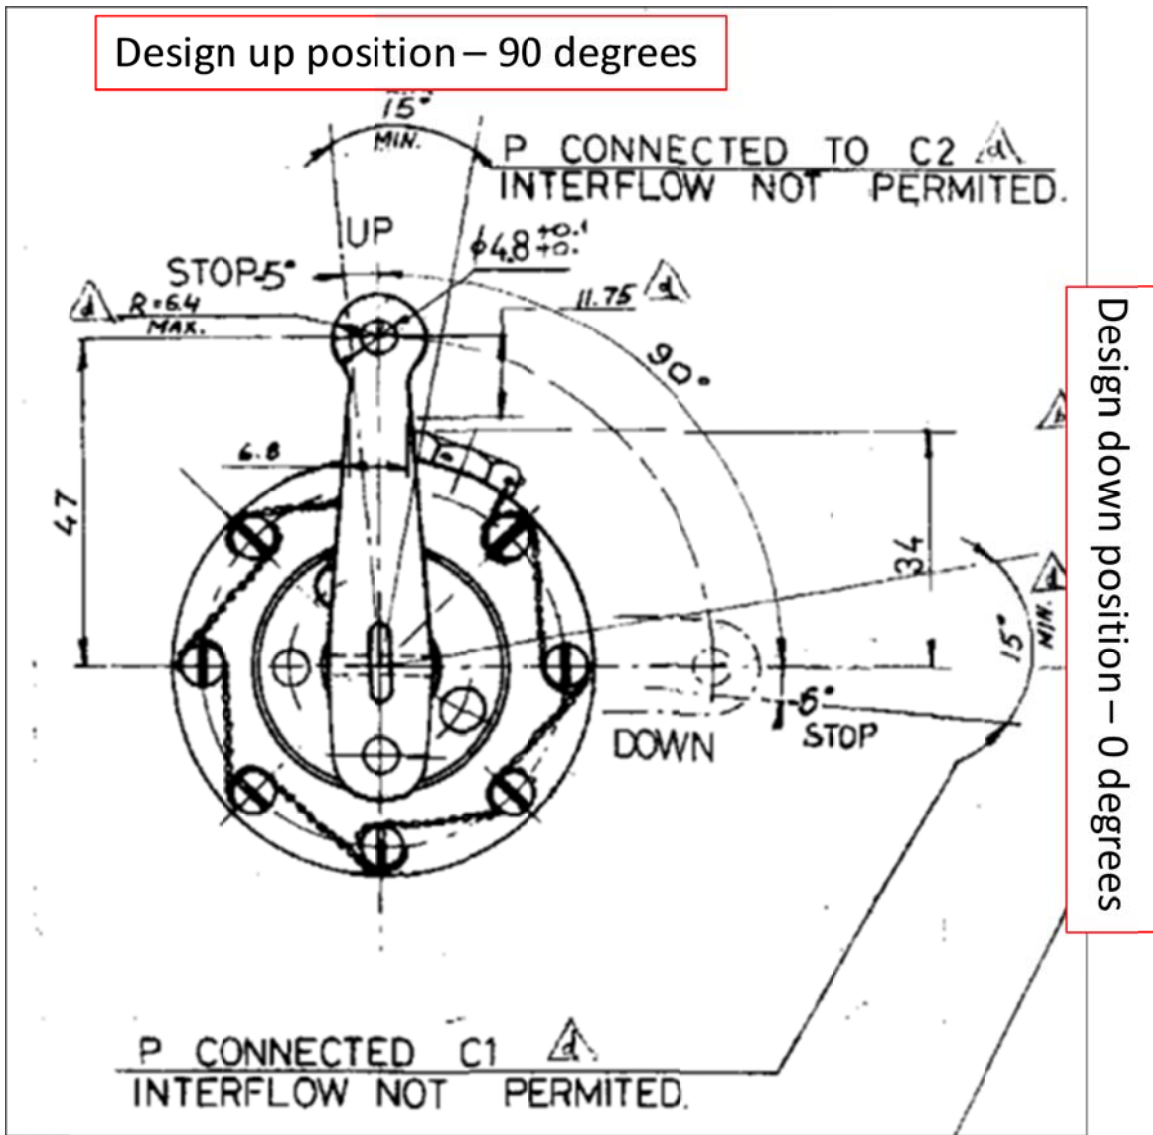
Figure 3 – Excerpt from landing gear selector valve drawing

As annotated in Figure 3, the down position can be assigned the 0 degree position and the up position is therefore the 90 degree position. The physical travel is limited by mechanical stops at the -5 degree position and at the +95 degree position.

The first item of emphasis is that detents are provided at the 0 and +90 degree position. These detents are a ball and spring design as indicated in the teardown report for the landing gear selector valve.

The second item of emphasis is the specification for interflow described in the drawing. Between the -5 and +10 position and also between the +80 and +95 degree positions, interflow is not permitted. In other words, when the valve is between the -5 and +10 degree position, flow is only permitted from the pressure port to the extend port and from the retract port to the return port. Other flow paths are not permitted. Likewise, when the valve is between the +80 and +95 degree positions, flow is only permitted from the pressure port to the retract port and from the extend port to the return port.

Within the range of +10 to +80 degrees, interflow is permitted, although its characteristics are unspecified. Typical flow modes would involve a proportion of the pressure present at the pressure port being applied to the other three ports (extend, retract and return). Resulting flow would be determined by the exact position of the valve and other system characteristics. Of particular interest is the flow from the pressure port to the return port under the interflow condition. This flow is termed “bypass flow”.

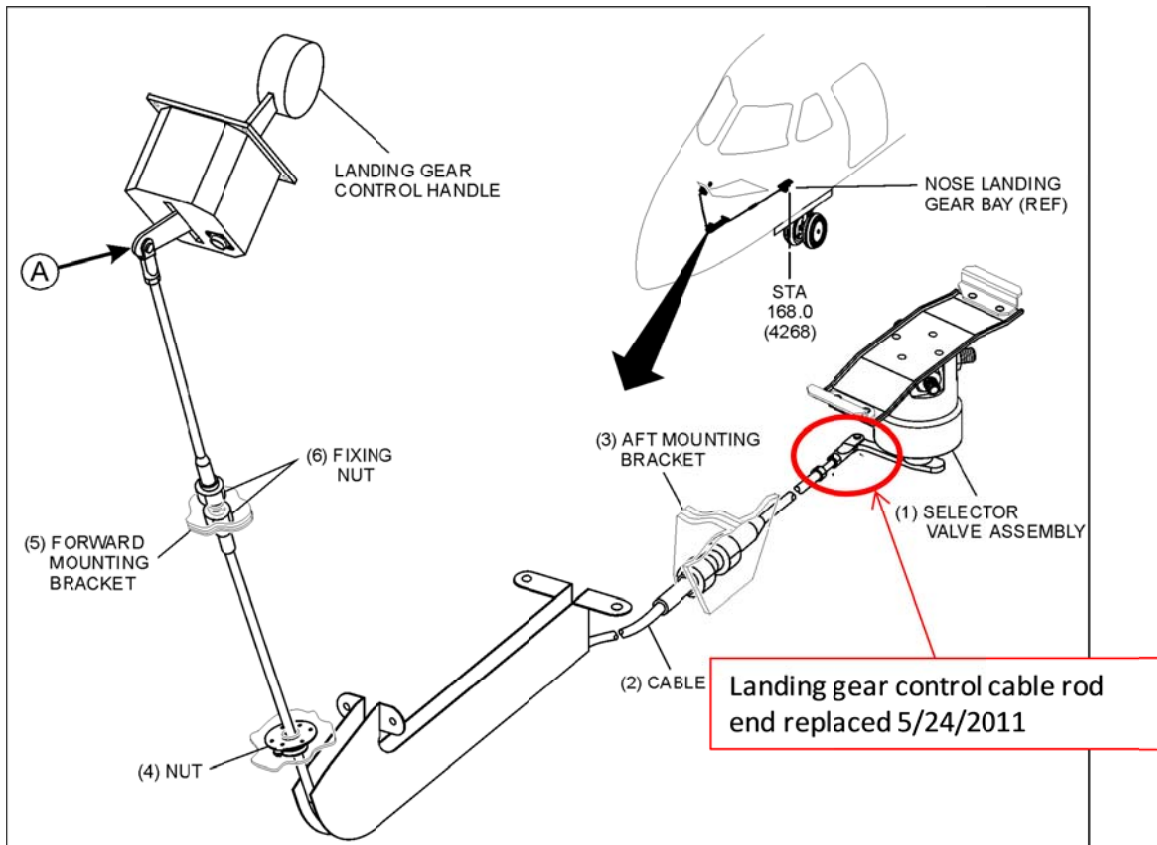
Squawk 8.17 and its sub items describe replacement of the landing gear control cable rod end adjacent to the landing gear selector valve. See Figure 4 – Landing gear control rod end replacement for location of the rod end. The action includes reference to maintenance manual task 32-30-10 which is titled Landing Gear Control Cable – Removal/Installation.

Subsequent to this maintenance, the work order indicates that the landing gear was cycled 20 times according to the procedures described in maintenance manual 32-30-00 B steps 14 and 15. These steps exercise the normal extension and retraction system. They do not exercise the emergency extension system or check the pressures necessary for unlocking, moving and locking the landing gear.

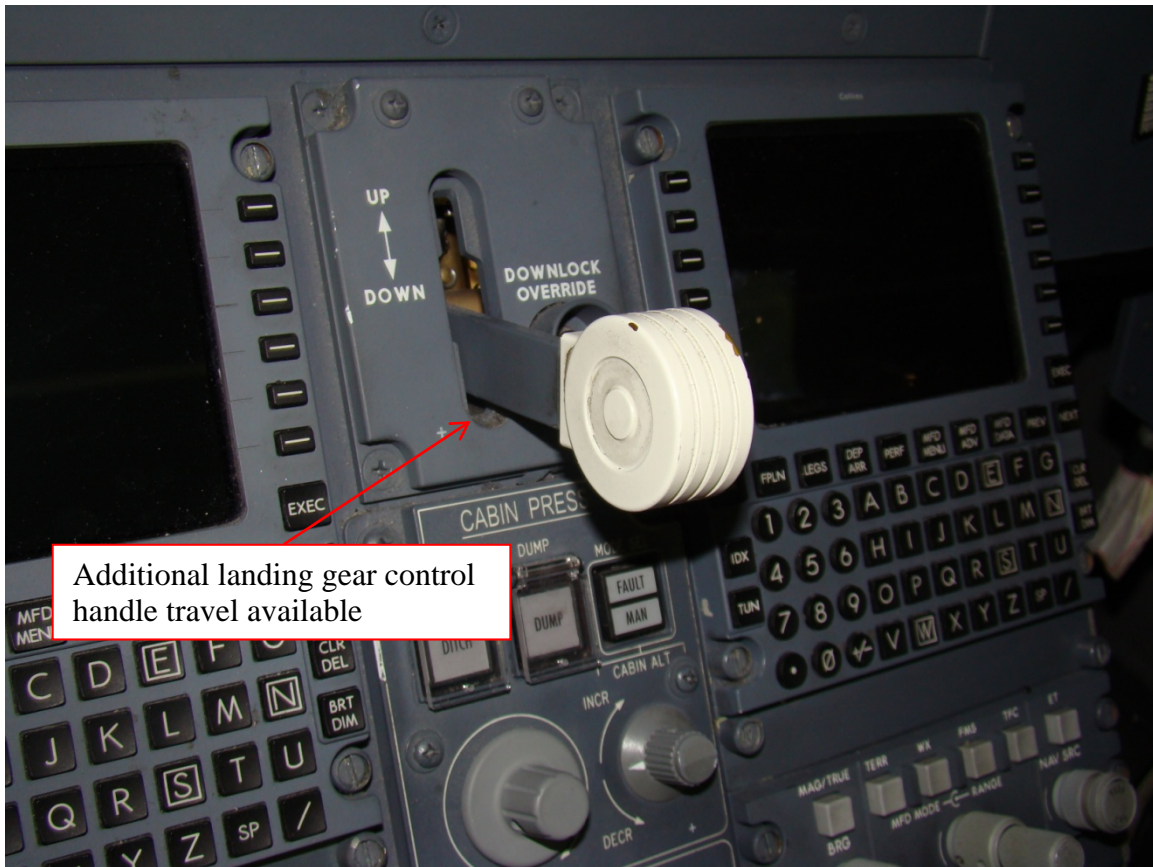
Figure 5 – Landing gear control handle position

The position of the landing gear control handle was photographed and is included in the docket. That photograph is reproduced in Figure 5- Landing gear control handle position. As the photo shows there is still room to move the handle further down as evidenced by the space between the bottom of the handle and the bottom of the handle slot.

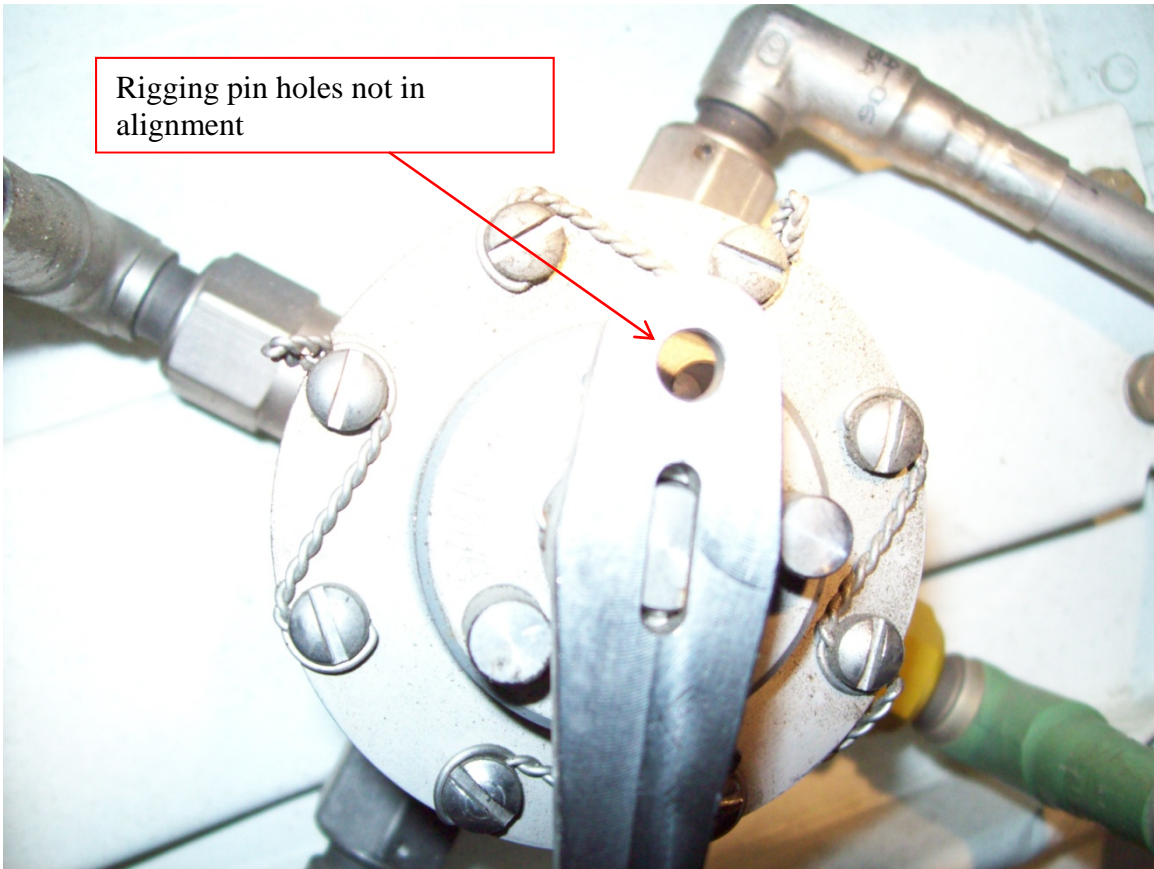
Figure 6 – Landing gear selector valve position – Photo 1

The position of the landing gear selector valve was also photographed and is included in the docket. That photograph is reproduced in Figure 6 - Landing gear selector valve position – Photo 1. Even though the camera was not square with the position of the valve it is clear that the rigging pin holes in the valve are not in alignment.

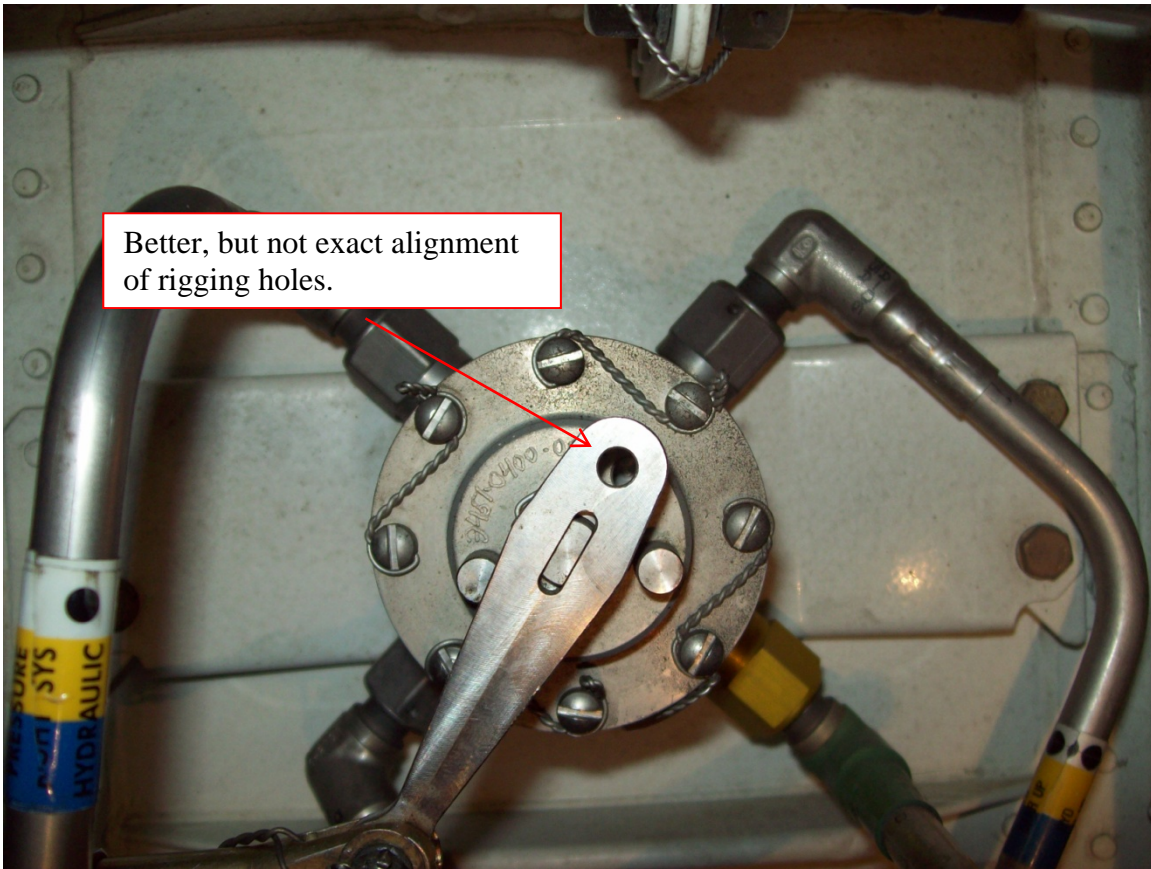
Figure 7 – Landing gear selector valve position – Photo 2

Subsequent to the pictures of the landing gear control handle and the landing gear selector valve being taken, the landing gear control handle was moved to the fullest extent of its downward travel. It was noted that the rigging pin holes were in better alignment, but still not in exact alignment. A second picture of the landing gear selector valve was taken and is included in the docket. It is reproduced in Figure 7 – Landing gear selector valve position – Photo 2.

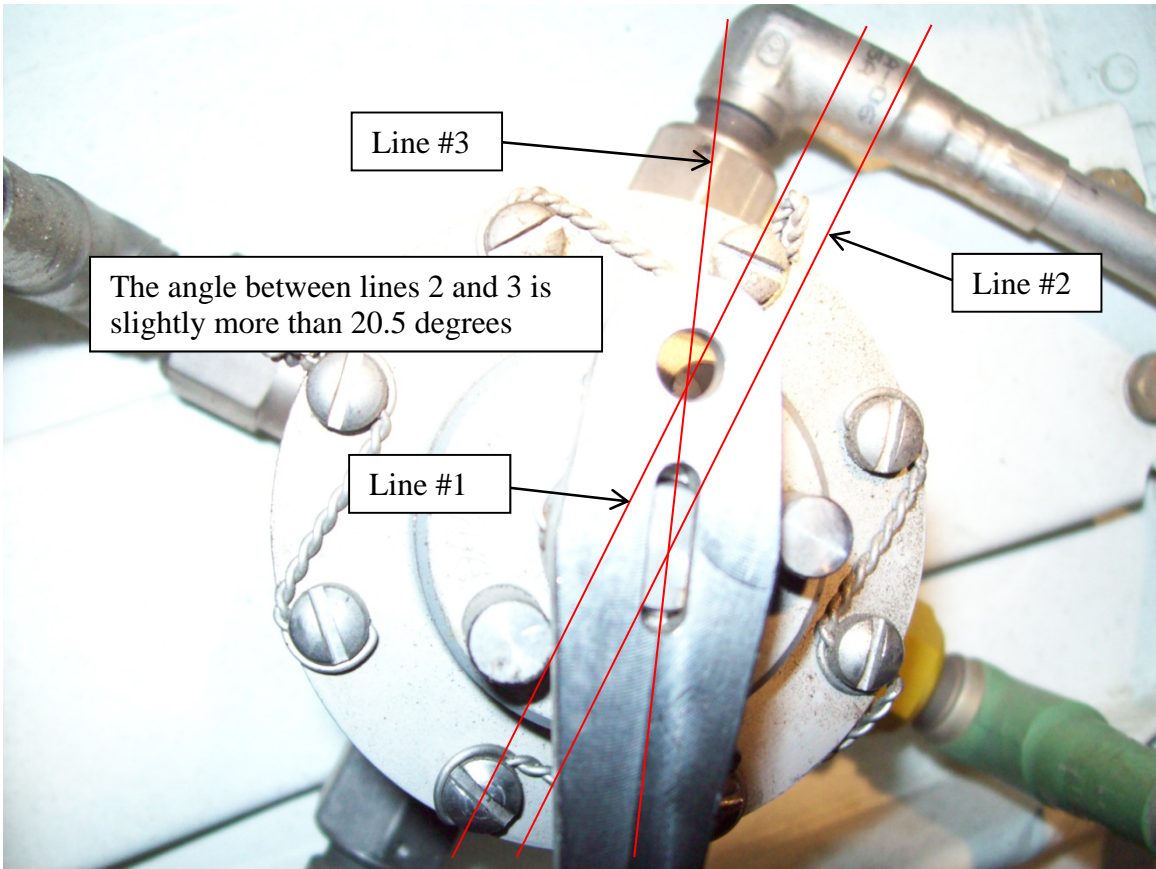
Figure 8 – Landing gear selector valve position – Photo 1 w/angles

Figure 6 is reproduced as Figure 8 – Landing gear selector valve position – Photo 1 w/ angles, with these lines added. Inspection of the angle between lines 2 and 3 indicates the valve is slightly more than 20.5 degrees from the 0 degree reference point for the down position. This is the angle of the landing gear selector valve actuating arm when the landing gear control handle was in the position shown in Figure 5 and prior to any movement of the landing gear control handle.

The position of the landing gear selector valve post incident and prior to any movement of the landing gear control handle was found to be slightly more than 20.5 degrees. According to the teardown report for the landing gear selector valve, interflow is initiated at an angle of 20 degrees and the valve will pass 3 gpm at 20.5 degrees. The report does not provide any pressure drop measurements associated with these flow rates.

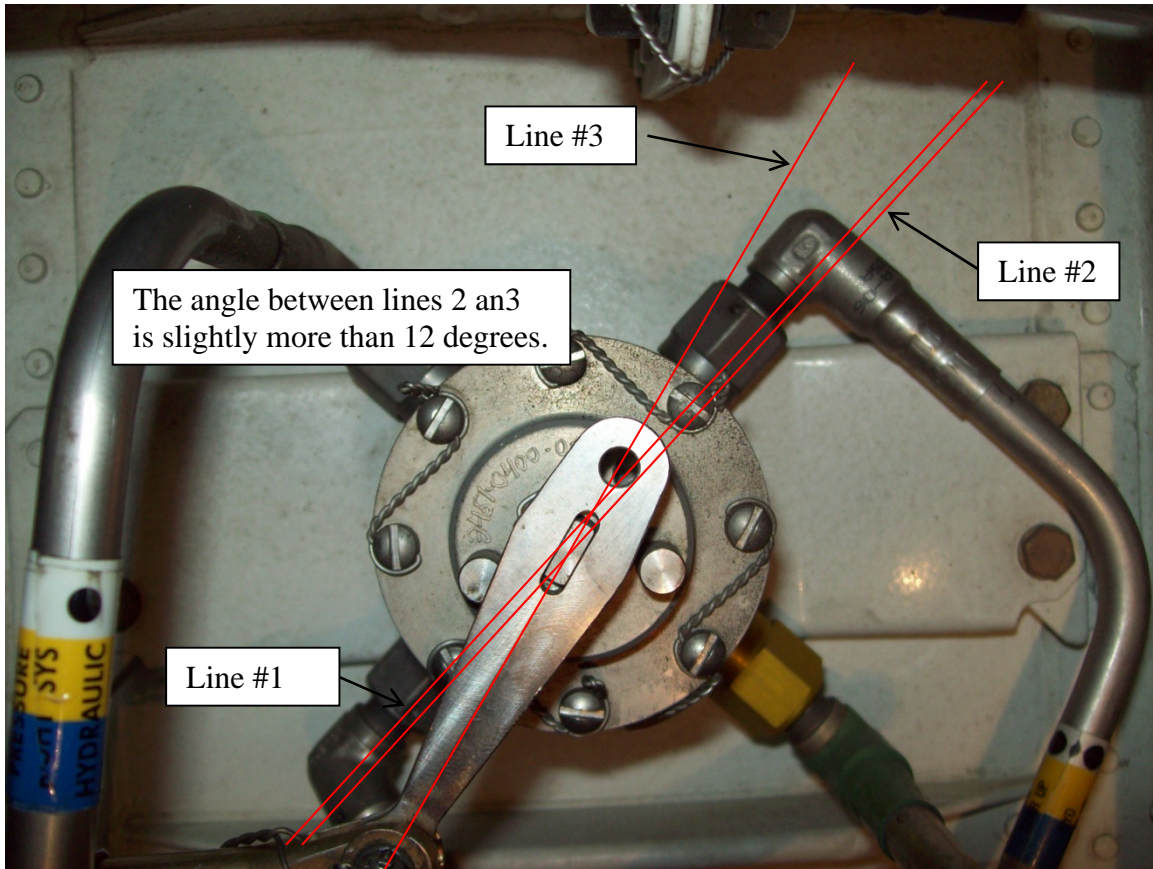
Figure 9 – Landing gear selector valve position – Photo 2 w/angles

Likewise, Figure 7 is reproduced as Figure 9 – Landing gear selector valve position – Photo 2 w/ angles, with these lines added. Inspection of the angle between lines 2 and 3 indicates the valve is slightly more than 12 degrees from the 0 degree reference point for the down position. This is the angle of the landing gear selector valve actuating arm when the landing gear control handle was at the full extent of the downward travel.

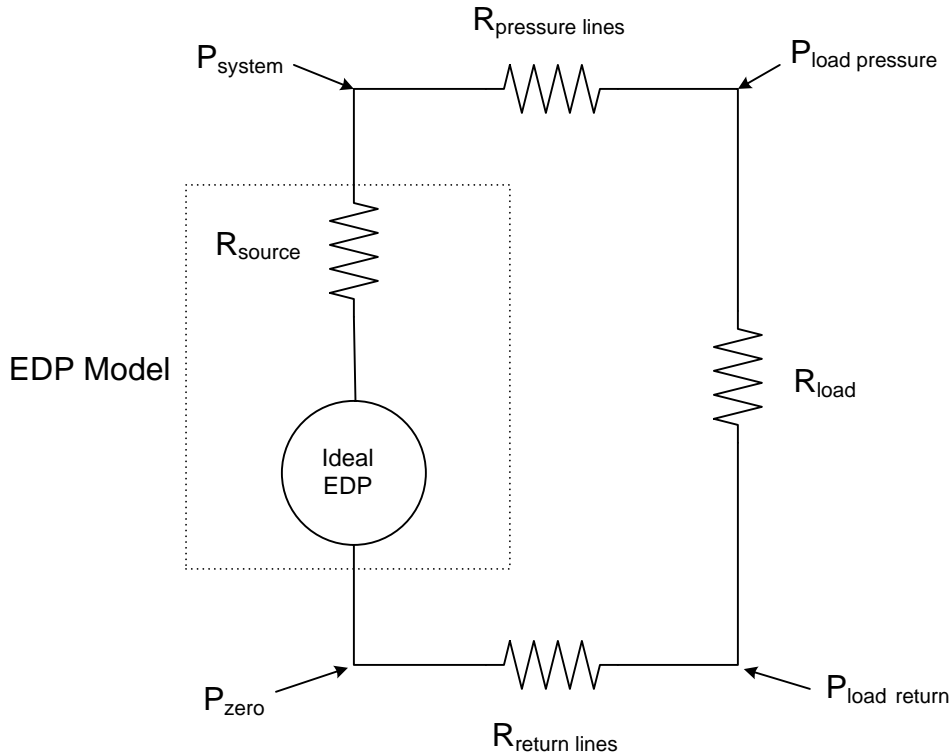
Figure 10 – Simplified hydraulic system schematic

Figure 10 – Simplified hydraulic system schematic, depicts a much simplified version of the hydraulic power system and landing gear extension/retract system.

Under quiescent hydraulic system operation, R_{load} presents a very high resistance to hydraulic flow. Typically it is only the internal leakage of the hydraulic components which is negligible. Under this condition, P_{system} and $P_{load\ pressure}$ are equal to the pressure of the ideal source (i.e. 3,000 psi), there is no pressure drop through the resistances $R_{pressure\ lines}$ and $R_{return\ lines}$, and $P_{load\ return}$ is equal to P_{zero} . As the sum of the pressure drops around the circuit must sum to zero, the entire system pressure is dropped across R_{load} .

When a hydraulic component is actuated, R_{load} is effectively decreased and fluid begins to flow. Each resistance now has an associated pressure drop across it. P_{system} is now less than the ideal source pressure and further pressure drops are present at $R_{pressure\ lines}$ and $R_{return\ lines}$. This causes $P_{load\ pressure}$ to be reduced and $P_{load\ return}$ to be increased. The pressure drop across R_{load} is less than P_{system} . Because of the fluid flow through the resistances, energy is dissipated and the fluid temperature increases. A short time later, the work of the system is complete and the system returns to its quiescent state.
