BROTHERHOOD OF LOCOMOTIVE ENGINEERS AND TRAINMEN

BEFORE THE NATIONAL TRANSPORTATION SAFETY BOARD

NTSB Accident Number: DCA17MR007

Proposed findings, probable cause, and safety recommendations, in connection with the derailment and subsequent fire of Union Pacific Railway unit ethanol train, UEGKOT 09, on March 10, 2017 in Graettinger, Iowa.

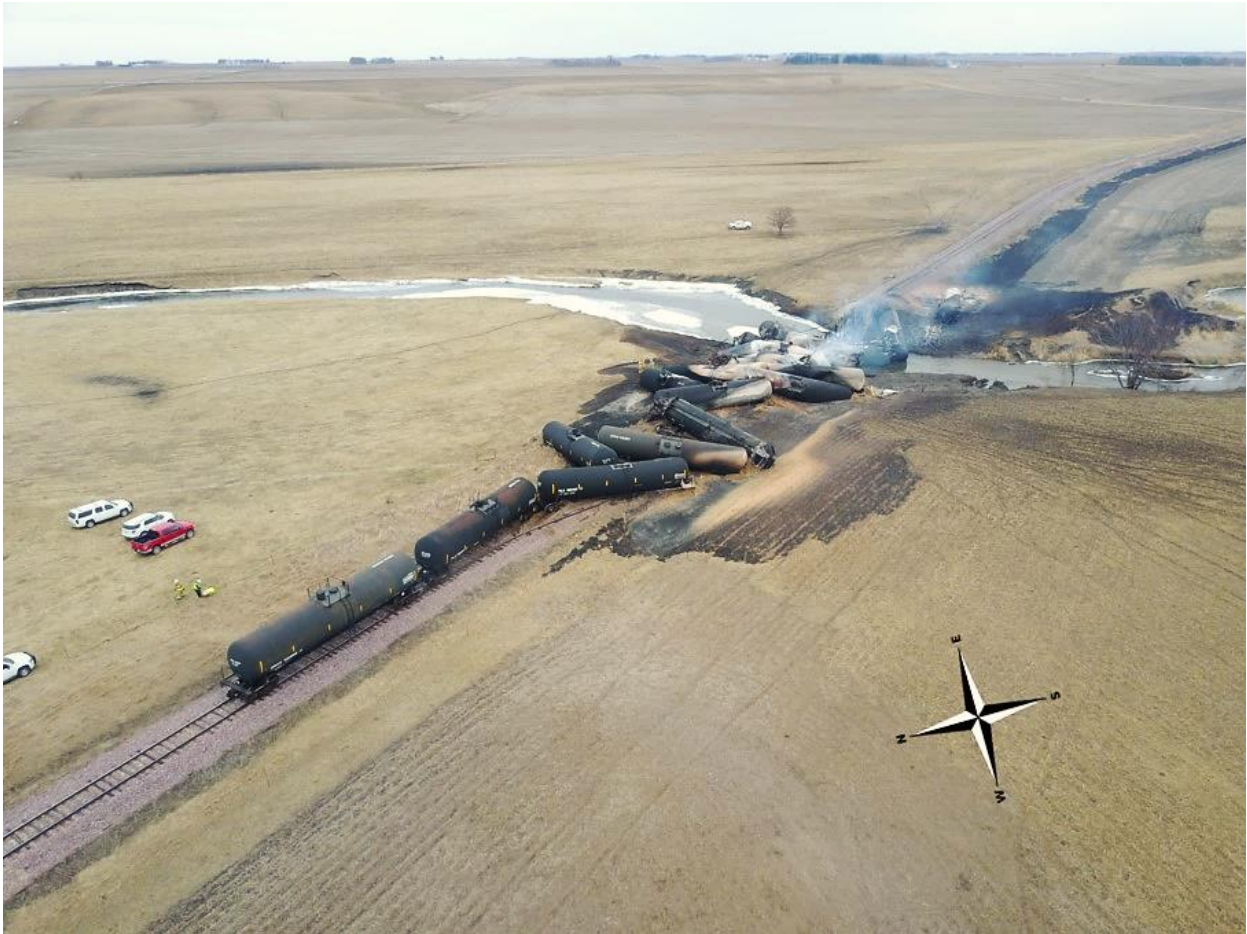
Figure 1

On Friday, March 10, 2017, at 12:50 a.m., Central Standard Time (“CST”),¹ eastbound Union Pacific Railroad (“UP”) unit ethanol train, UEGKOT 09, derailed as it travelled over the Jack Creek bridge which is a timber constructed railroad bridge, milepost (“MP”) 56.8 near Graettinger, Iowa.² Twenty (20) of the liquid ethanol tank cars derailed. Fourteen (14) tank cars released ethanol fueling a post-accident fire.

Figure 1: Overhead view of the accident (photo courtesy of the NTSB).
