Brotherhood of Locomotive Engineers and Trainmen

NTSB Accident Number: DCA-12-FR-007

Proposed findings, probable cause, and safety recommendations, in connection with the collision and derailment of freight trains Kansas City Southern (KCS) train No. QSHKC20 and Burlington Northern Santa Fe (BNSF) train No. EMHSEBM088 at a railroad diamond interlocking located near Arcadia, Kansas.

FINAL SUBMISSION

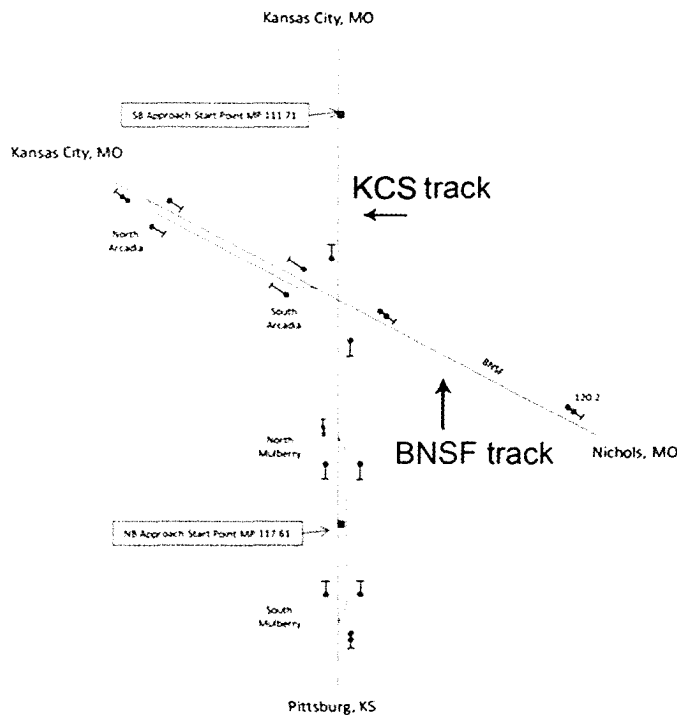
Figure 1: BNSF/KCS interlocking diamond of accident area below:

Track Geometry at the location of the derailment consists of a diamond crossing of fifty-eight degrees (58°). The diamond is maintained by KCS. Maximum Authorized Speed at that location varies slightly with a MAS of forty-five (45) MPH for BNSF trains, and a MAS of forty (40) MPH for KCS trains.
