Air Canada
Submission
to the
National Transportation Safety Board
in the Investigation of the
Overflight of a Taxiway at San Francisco International
Airport
on July 7, 2017
NTSB Investigation Number: DCA17IA148

Marcel Comeau
Manager Corporate Safety Investigation
Party Coordinator
Air Canada
May 31, 2018

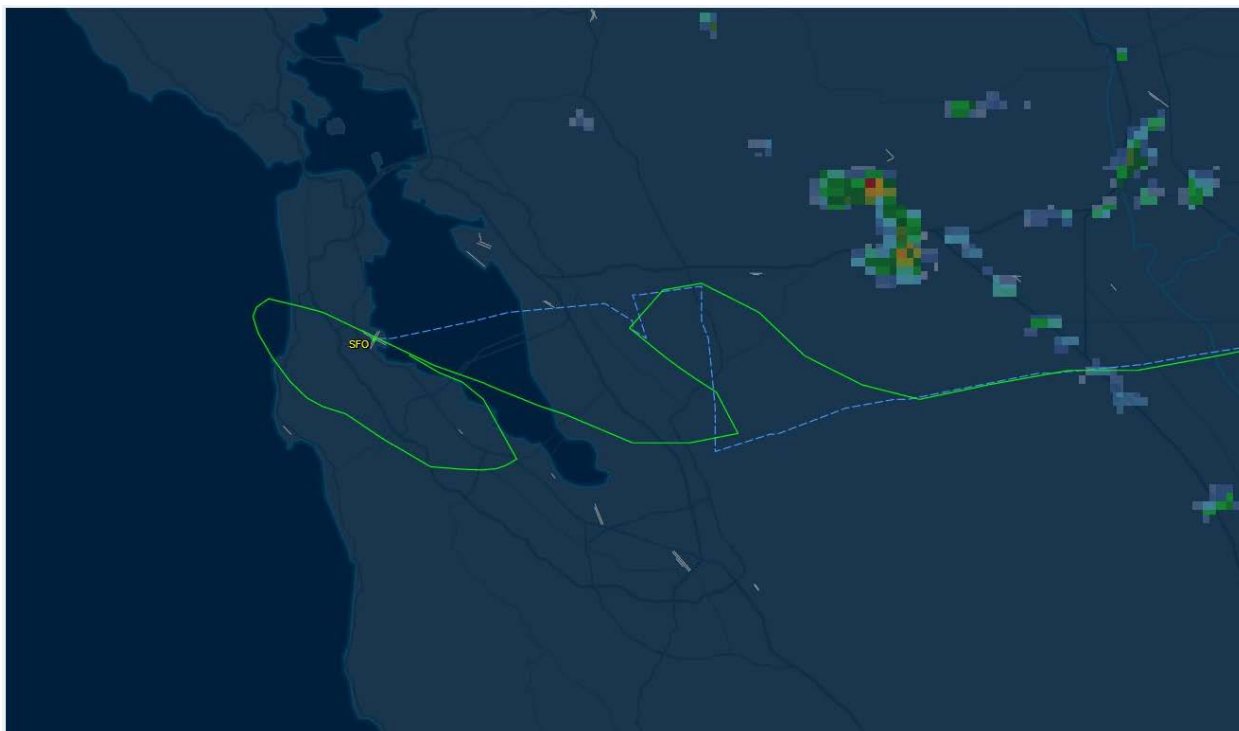
Figure 2: Actual (Green Line) ACA759 Track to KSFO

Once ACA759 contacted NORCAL, they were vectored off the arrival by the controller who informed them that it was for spacing (Figure 2). NORCAL also assigned them speed restrictions. Their airspeed was reduced to the point where they had to extend the flaps to the flaps 1 setting. The flight crew anticipated being placed back on the arrival; however, the controller continued to vector them instead. The controller then directed the flight to descend and subsequently cleared ACA759 for the FMS Bridge Visual to runway 28R. As advised by ATC, the crew then visually acquired the preceding aircraft, Delta flight 521, a B737.

When ACA759 contacted NORCAL, NORCAL vectored them off the arrival and assigned them speed restrictions. (See Figure 2). NORCAL informed ACA759 that they were vectored off the arrival for spacing. The flight crew had anticipated being placed back on the arrival; however, the controller continued to vector them instead. The controller then directed the flight to descend and subsequently cleared ACA759 for the FMS Bridge Visual to runway 28R. As advised by ATC, the crew then visually acquired the preceding aircraft, Delta flight 521, a B737.

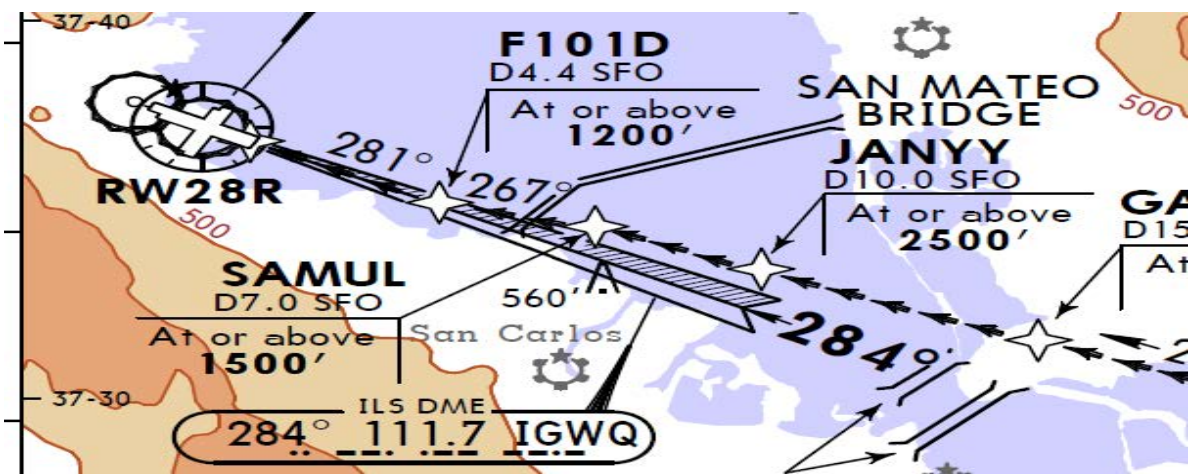
Figure 3: Approach Heading & Altitude

As the aircraft was on the approach at the "JANYY" waypoint, the Autopilot & Auto Thrust (AP/AT) were engaged in "DES & NAV" mode with flaps 2. The gear was then selected down between "JANNY & SAMUL." At "SAMUL" the aircraft was level at 1500' and the FMS ordered a turn towards 267° per the chart (Figure 3). As the aircraft started to turn towards 267° and around the San Mateo bridge, the autopilot was disengaged and Visual Approach SOP was followed (as directed by Jeppesen 19-3-1A); the aircraft heading reached 273°. The flight director was removed and full flap were selected at 5.2 nautical miles (nm) from SFO VOR. At the final approach fix, F101D, the aircraft heading was 281° with gear down, flaps full and AT engaged. At this point, the crew were visual and following the Visual Approach SOP (AOM 1.04.11.40). In fact, ACA759 was lined-up on the second set of lights to the right, which was Taxiway C. The distance between the centerline of Taxiway C and 28R is approximately 490 ft.

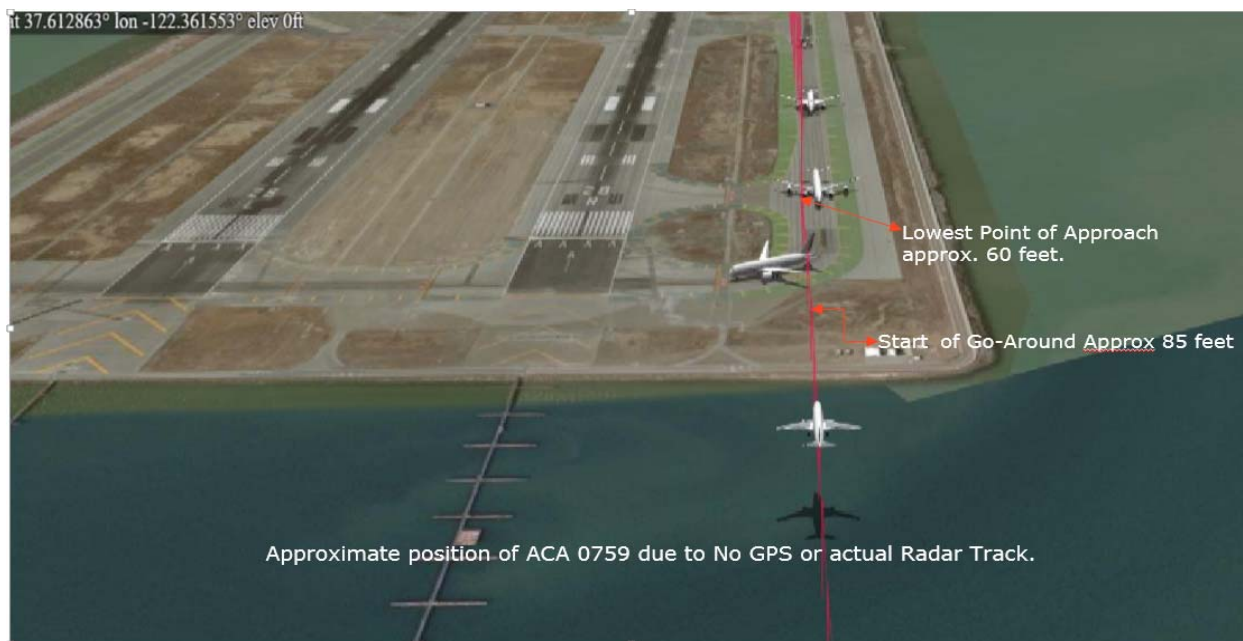
Figure 4: Approximate position of ACA759 during Go-Around.

initiation of the go-around occurred as the flight was crossing the Taxiway C seawall and at 85 feet AGL (Figure 4). The lowest altitude during the go-around was recorded as 60 feet AGL which occurred approximately two seconds after initiation of the go-around. Given the ground track, ACA759 overflew some of the aircraft on the taxiway during the go-around maneuver. The crew of ACA759 believed that they were between 300-400 feet Mean Sea Level (MSL) when they initiated the go-around.

The PF initiated the go-around with an initial pitch command of 19.5° with a resultant 1.6g vertical acceleration, as the aircraft is climbing at 2100 feet per minute and passing the second aircraft (PAL 115) on the taxiway. At 2356:09,⁶ three seconds after ACA759 had initiated the go-around, ATC directed ACA759 to go-around. ACA759 carried out the missed approach procedure cleared by ATC. On the downwind leg of the missed approach, the crew tuned in the ILS for runway 28R and landed without any complication.

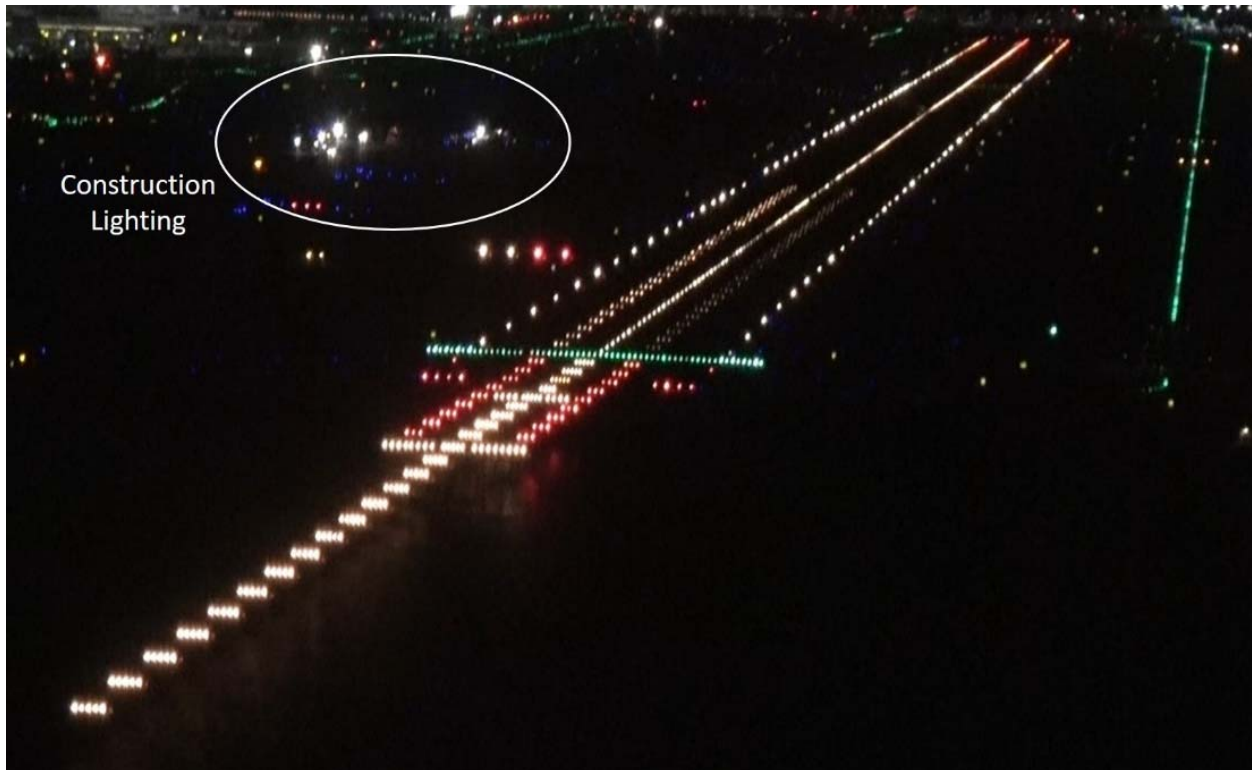
Figure 5: Construction Zone on runway 28L

Figure 5 depicts the construction lighting, consistent with lighting at KSFO on the night of the go-around event. The only evidence discovered during the investigation regarding any lighting assessment indicated a routine lighting inspection was performed on July 8, 2017, and no discrepancies were noted in the remarks column of the inspection form. There is no evidence that either the airport or FAA performed any analysis of the impact on arriving air crews' ability to discern the runway environment due to the combination of construction lighting, lighting outages, and existing lighting.

As noted above, Figure 5 depicts the construction, runway, and taxiway lighting, consistent with lighting at SFO on the night of the go-around event. The only evidence regarding any assessment of lighting is an entry indicating a routine lighting inspection was performed on July 8, 2017, and no discrepancies were noted in the remarks column of the inspection form.⁸

The investigation disclosed no evidence that SFO conducted any study or evaluation of the adequacy of the construction lighting and other existing lighting for assisting pilots to identify the runway environment during the nighttime construction periods. There is no evidence of assessment of the construction lights, no test flights by SFO to verify whether brightness or wash-out would be factors for flight crews, and no consideration of employing devices such as sequenced strobes to assist crews with alignment. The NOTAM for SFO containing three pages of text was the only informational element offered to flight crews.⁹

The crew of Delta flight 521, which landed on runway 28R about 4 minutes prior to the incident, confirmed during an interview conducted by the NTSB that they were also confused by the lighting during the approach. The flight crew of Delta 521 reported that the "construction lights were so bright we could not determine the location of the inboard runway, 28L." Visually acquiring the runway, both crewmembers reported questioning if they were lined up for runway 28R; however, after crosschecking with their LNAV they were able to determine they were lined-up for runway 28R. They received additional confirmation about 300 feet AGL when the Captain visually acquired the painted "28R" on the paved surface of the runway. The Captain of that flight further reported that the aircraft on Taxiway C were stopped and had their taxi lights off, which "helped to create this misconception that Taxiway C was RWY 28R."¹⁰ Air Canada has offered a recommendation related to Airfield Lighting.

- 5.3.1. To the FAA, conduct a study analyzing runway closure lighting, taking night visual approach procedures into consideration, and evaluate alternatives to enhance runway environment identification at night.
- 5.3.2. To the FAA, based on the study above, implement appropriate measures to enhance runway environment identification at night.
- 5.3.3. To the FAA, reiterate prior NTSB Safety Recommendations A-11-012 and A-11-013 regarding the studying and implementing of ASDE-X/ASSC which would provide alerts to air traffic controllers.

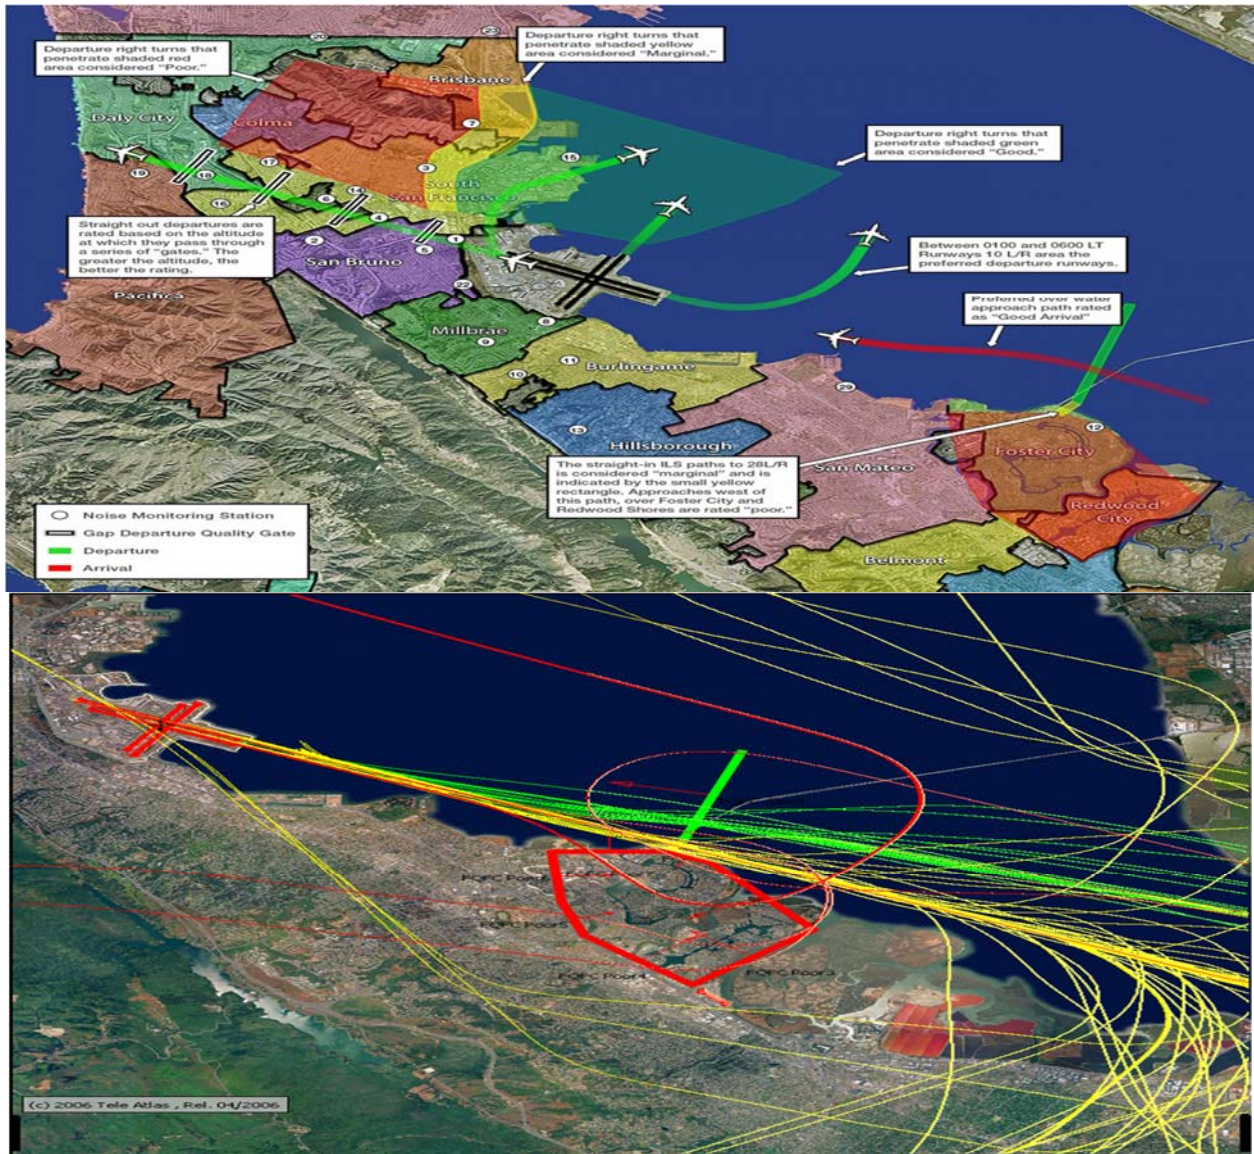
Figure 6: Foster City Arrival Quality Rating

The FMS Bridge Visual approach is an approach designed to come in at an angle/offset to runway 28R, and at the beginning of the approach it is in line with Taxiway C (see Attachment 8.1). This procedure keeps the aircraft away from the approach to 28L and, for noise abatement, away from Foster City (Figure 6). Once runway 28L was closed for construction, there were no requirements to fly the non-precision approach FMS Bridge Visual except for the Fly Quiet Program at SFO, and as such, a precision ILS approach could have been issued. The FAA ATC, after the ACA759 event, commenced vectoring arriving aircraft to SFO ILS 28R approach until the construction was completed.

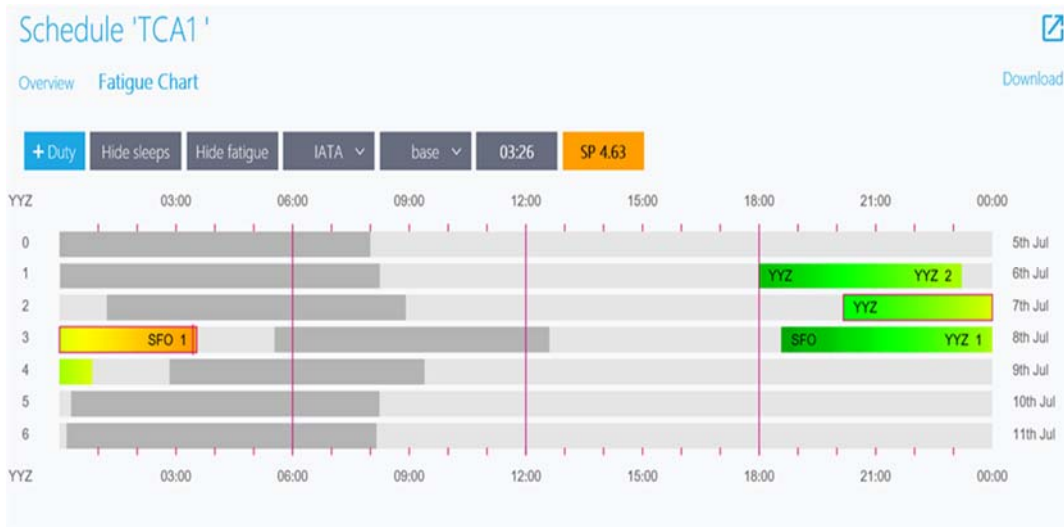
Figure 10: SAFE analysis of CA pairing.

A SAFE analysis of the crews pairing (Figure 10 & Figure 11) was carried out, and the conclusion from the fatigue manager for the FO operating the same pairing twice in a row did have a minor increase in fatigue on the second flight; however, the analysis indicates the increase in the fatigue score is because ACA759 on July 7 was delayed, thus the flight operated further into the WOCL. For the CA, the Safe analysis shows that the previous pairing the Captain operated should have had no appreciable

negative effect on the fatigue score of ACA759. The increase in fatigue score is most likely related to more exposure to the WOCL than the planned pairing due to the late arrival.

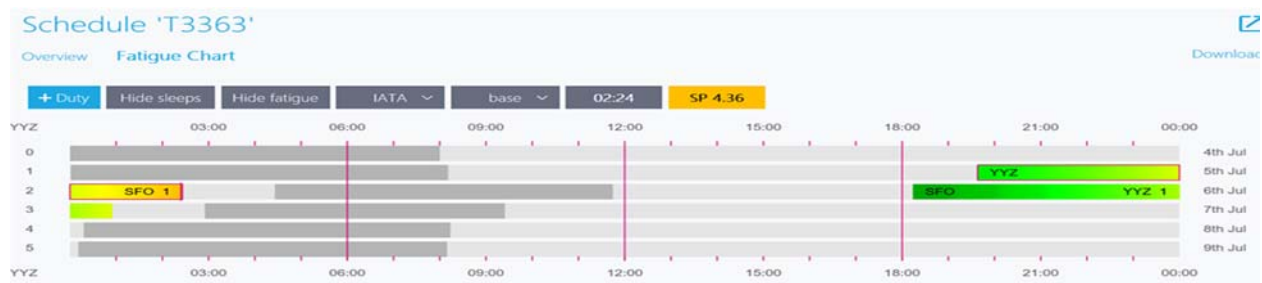
Figure 12: SAFE Analysis of pairing

A review of the pairing T3363 (ACA759/0750) (Figure 12) using the SAFE tool received a score of 4.36 on Samn-Perili scale. The rating for the Samn-Perili scale are:

Based on the above analysis, pairing T3363 has been created to mitigate as much risk to fatigue as possible.

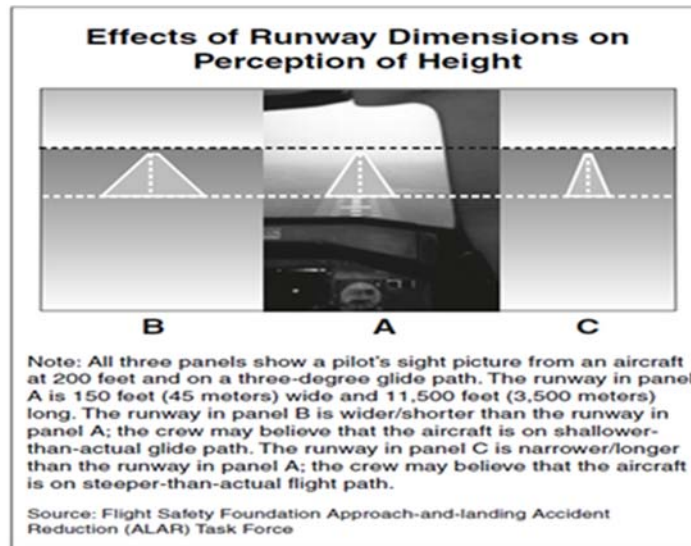
Figure 13: Effect of Runway dimension²²

Visual misperceptions will occur due to perceptual limitations.²¹ This is partly due to transferring the 3-dimensional objective world into a 2-dimensional retina image, and back into a 3-dimensional mental formation; and partly due to the imposition of cognitive influences such as assumptions, inferences and pre-conceived ideas. This latter “interference” can be summed-up by the phrase we see what we expect to see. Such optical illusions are numerous and include the misperception of aircraft height above touchdown caused by our inability to differentiate between the length of a runway and its slope. The crew of ACA759 believed that they were 300-400 feet MSL when they initiated the go-around; they reported this to the Duty Pilot the next day. Once they passed the FAF, their concentration was mainly to the outside environment and less on the cockpit displays, as the crew relied on visual cues for the perception of height. A normal sight picture for a runway is 200 feet and your mental models are based on that sight picture because they were lined-up on a taxiway with a width of 100 feet, or less, the perception would be that they were higher than they actually were (Figure 13).
