**USAir 1016 SUBMISSION
TABLE OF CONTENTS**

I. EXECUTIVE SUMMARY

At approximately 18:42 local time (22:42 UTC) on July 2, 1994, a DC-9-31 operating as USAir flight 1016 crashed while executing a go-around from the ILS approach to 18R at Charlotte-Douglas Airport (CLT) in Charlotte, North Carolina. At the time of the accident, the aircraft was embedded in an extremely heavy localized rainshower.

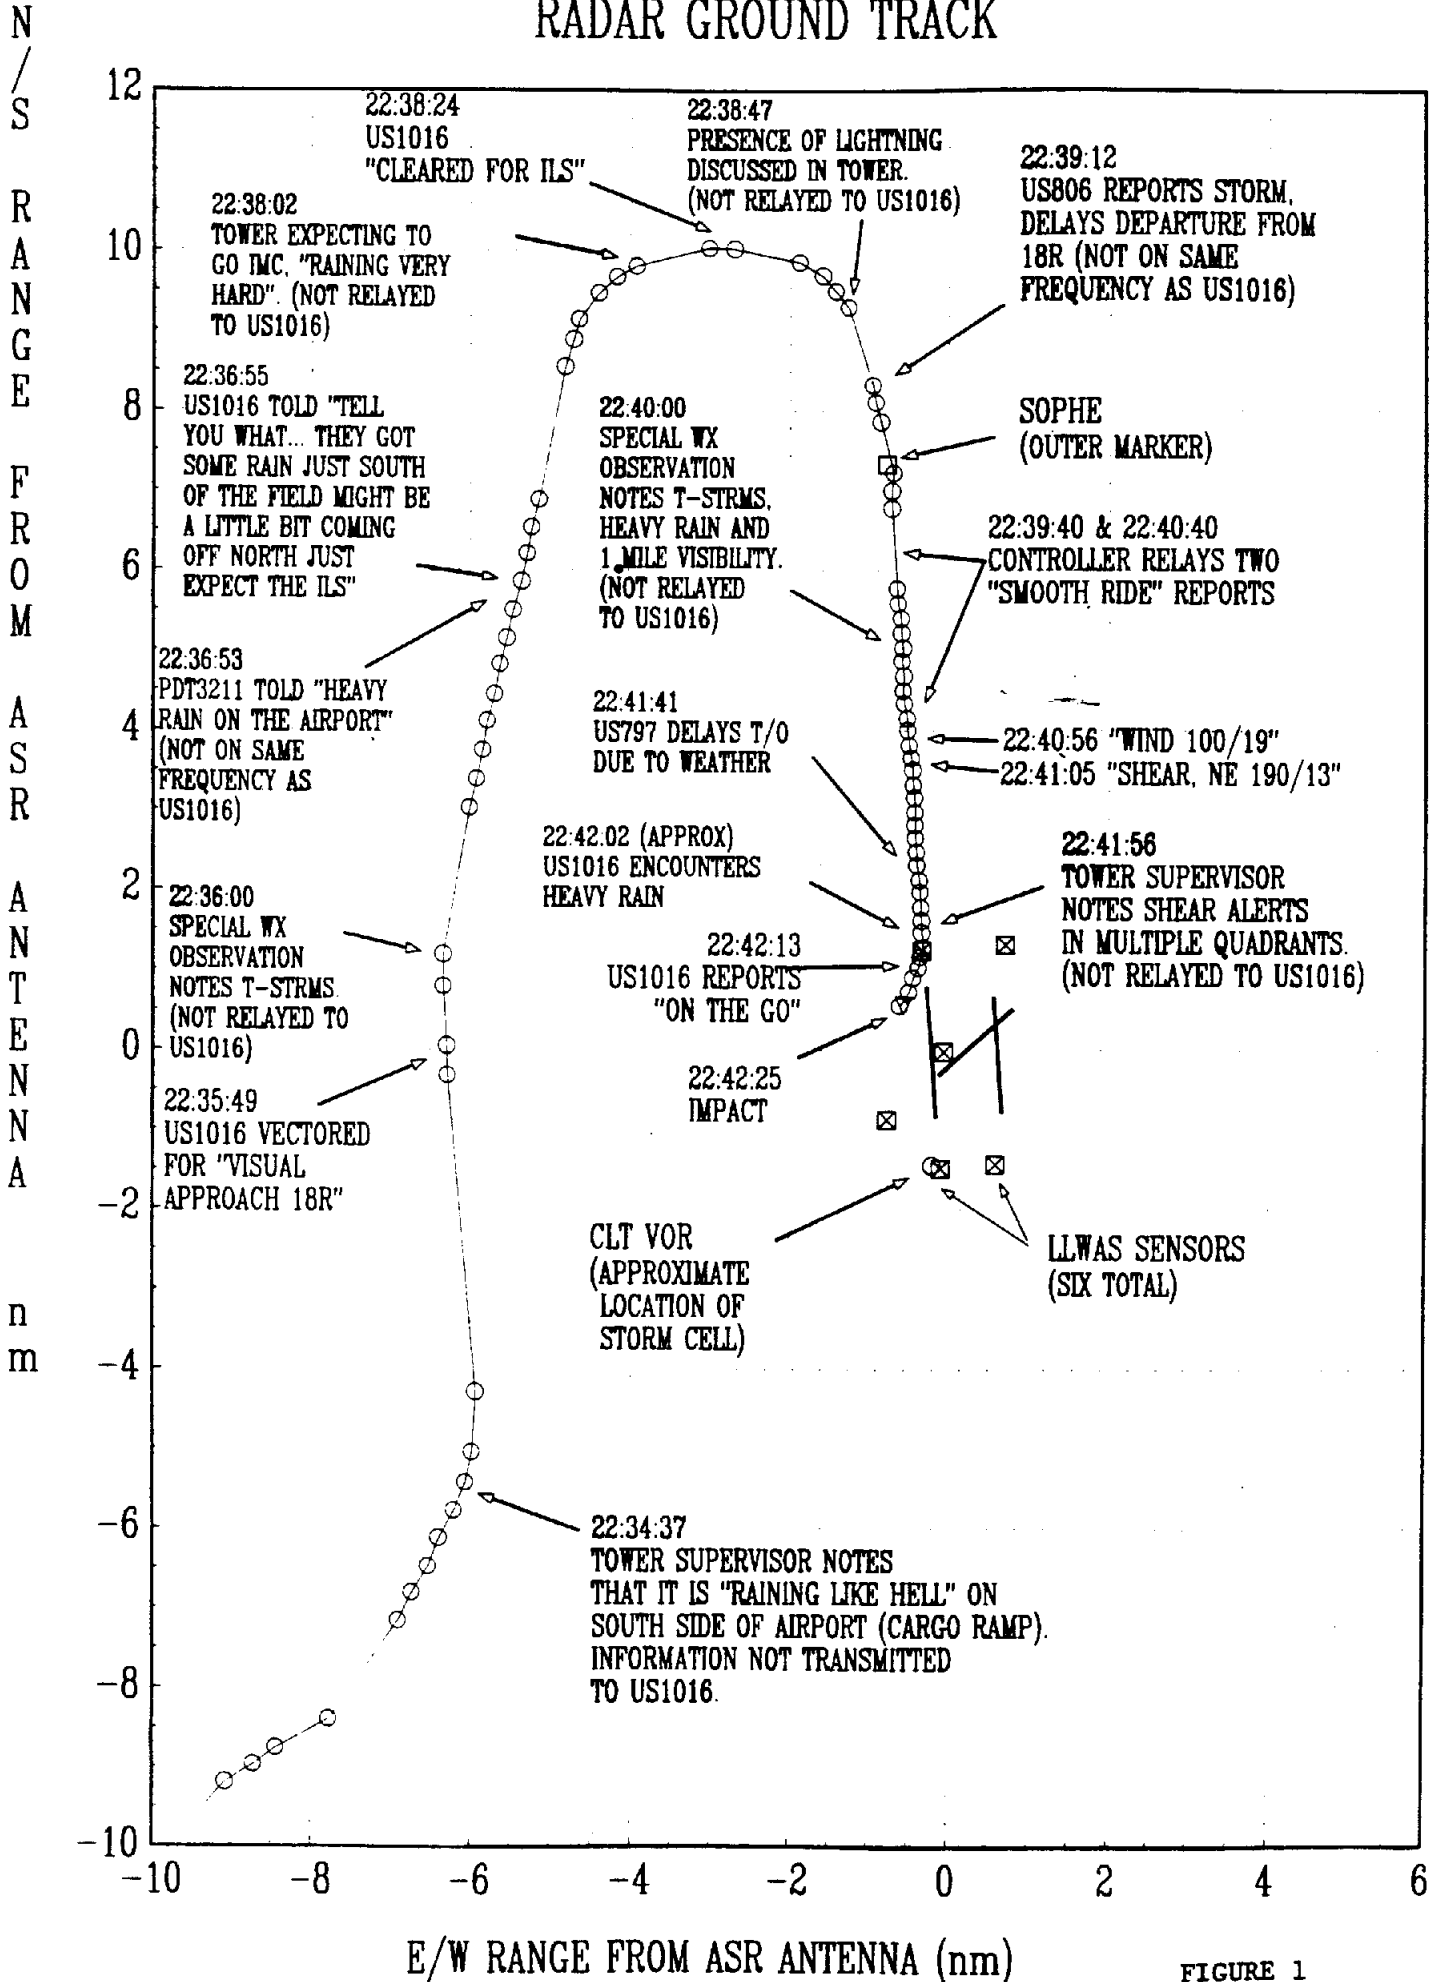
FIGURE 1

The crew had departed CLT at approximately 2050 Universal Coordinated Time (all times herein are UTC unless otherwise noted) and arrived without incident in CAE at approximately 2130. The flight departed CAE on schedule at 2210 as US1016 for the return leg to CLT, and it was during this approach into CLT that the accident occurred. Figure 1 presents an overview of the approach events.

USAir 1016 RADAR GROUND TRACK

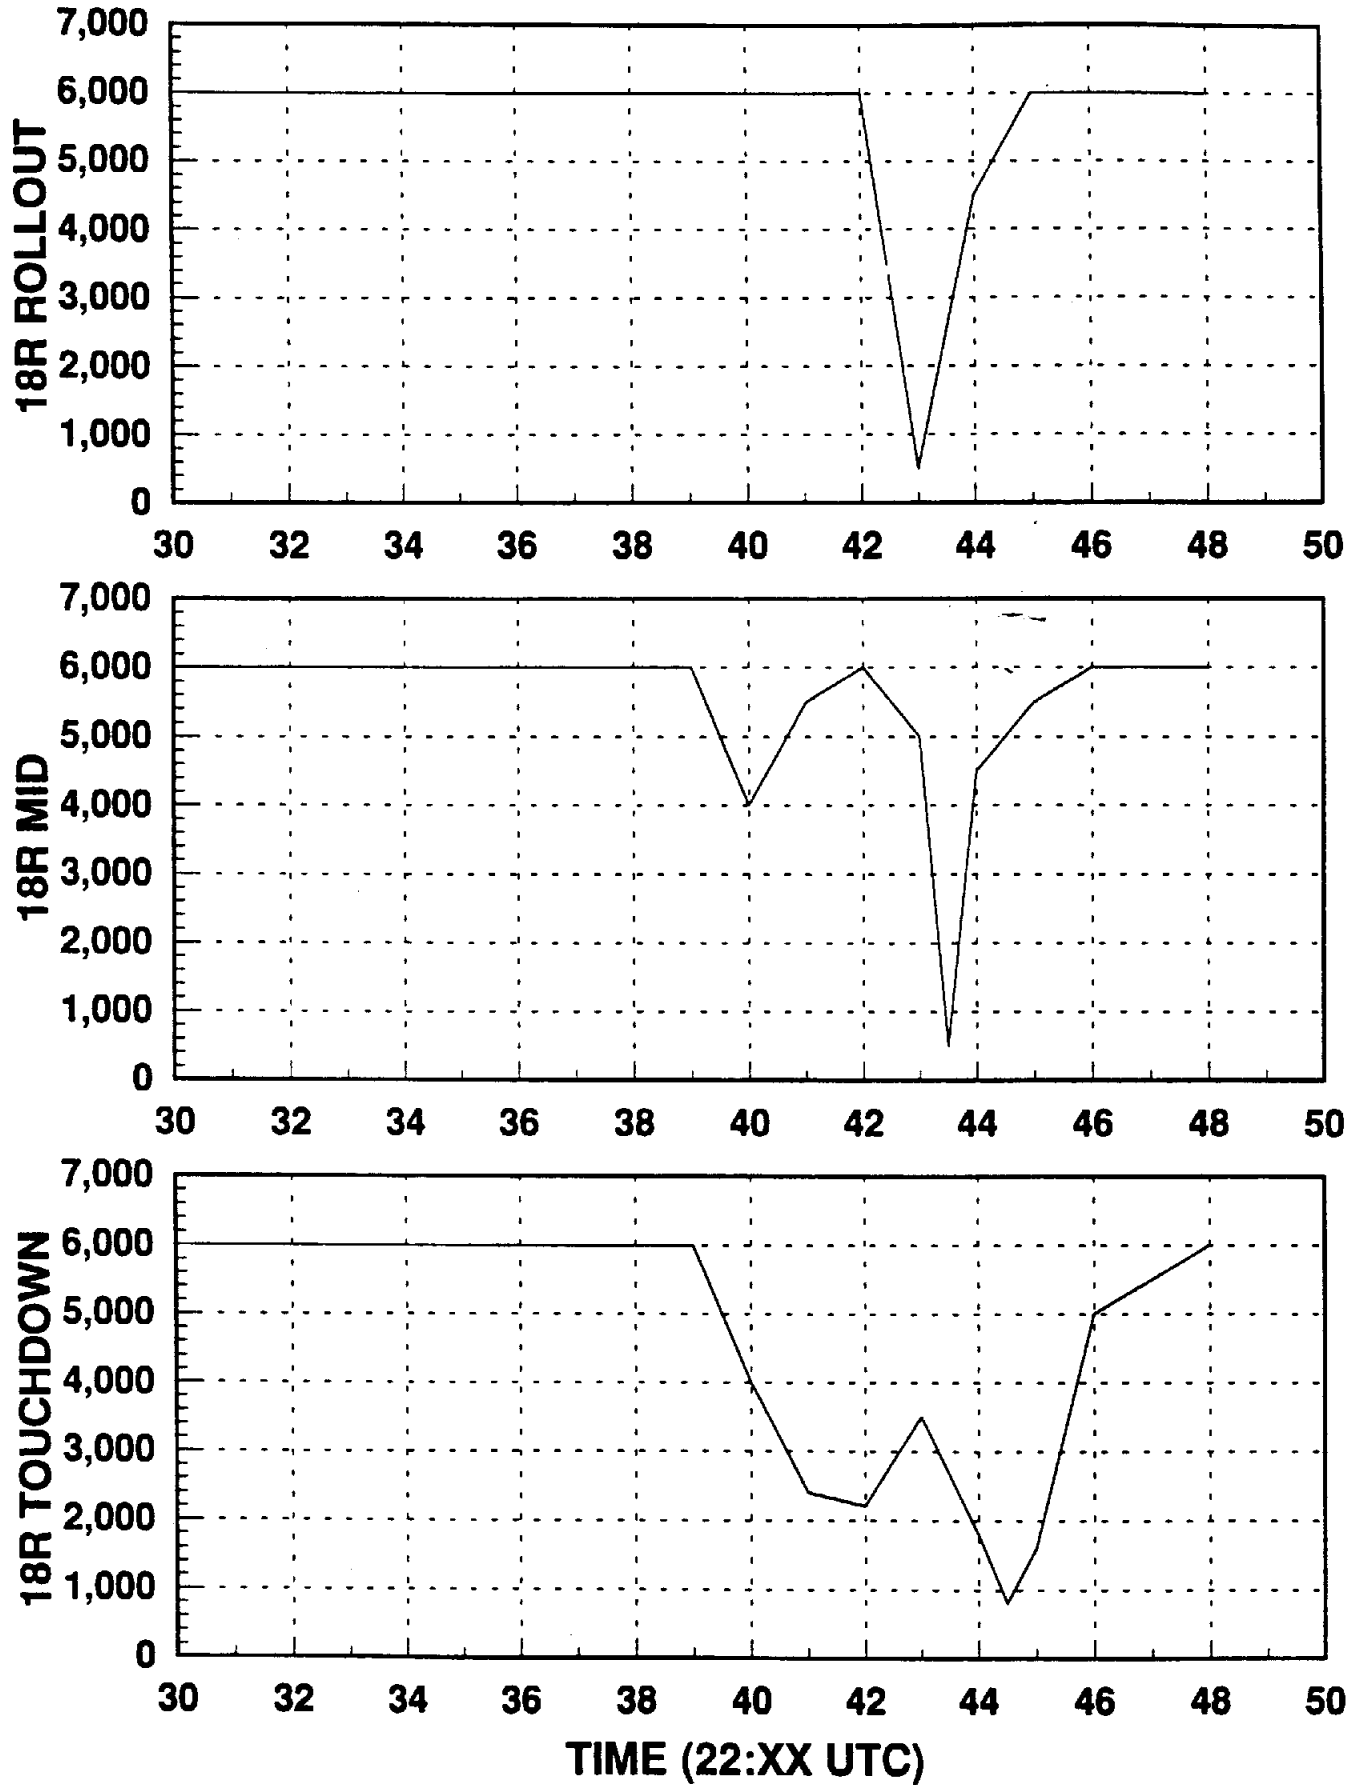
FIGURE 2

CLT RUNWAY VISUAL RANGE

JULY 2, 1994

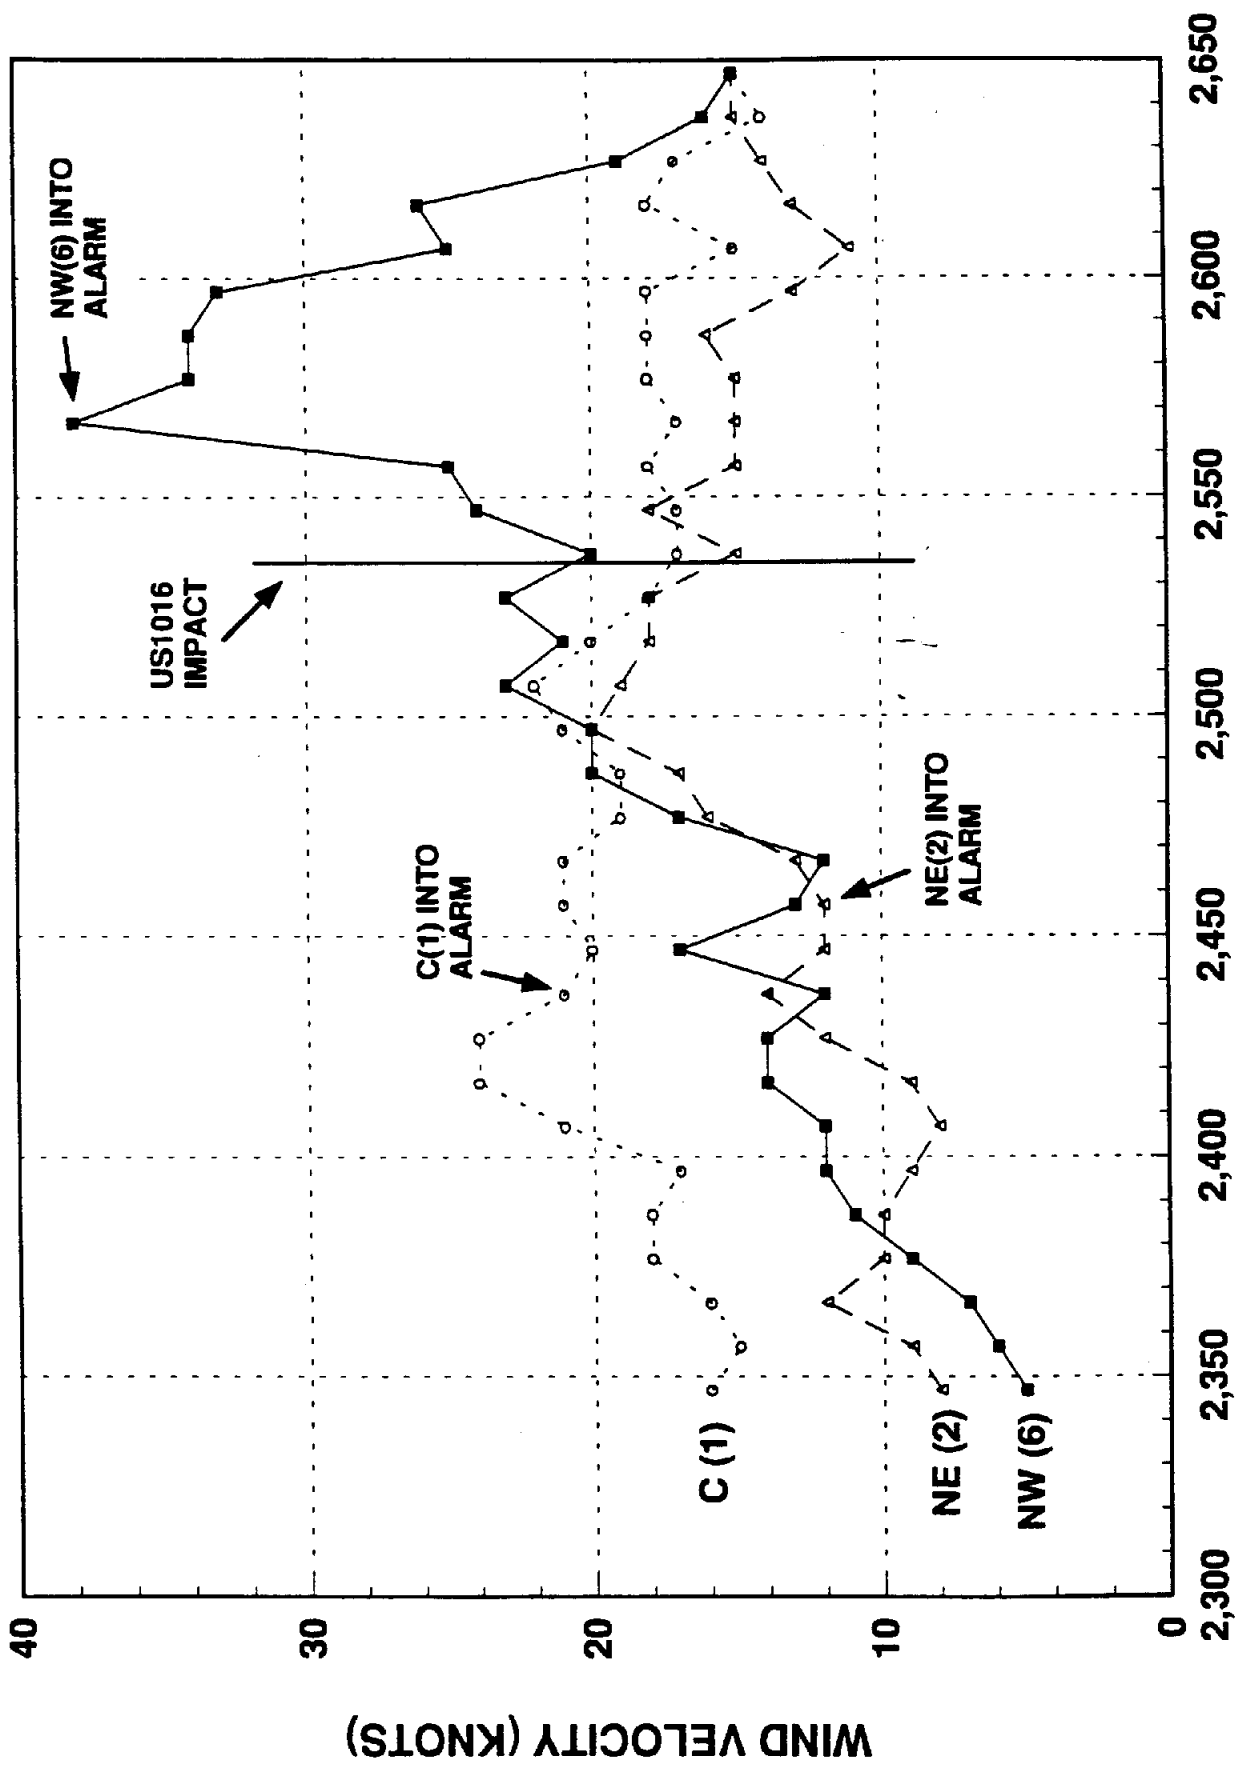
US Air 1016
CLT LLWAS WIND VELOCITY

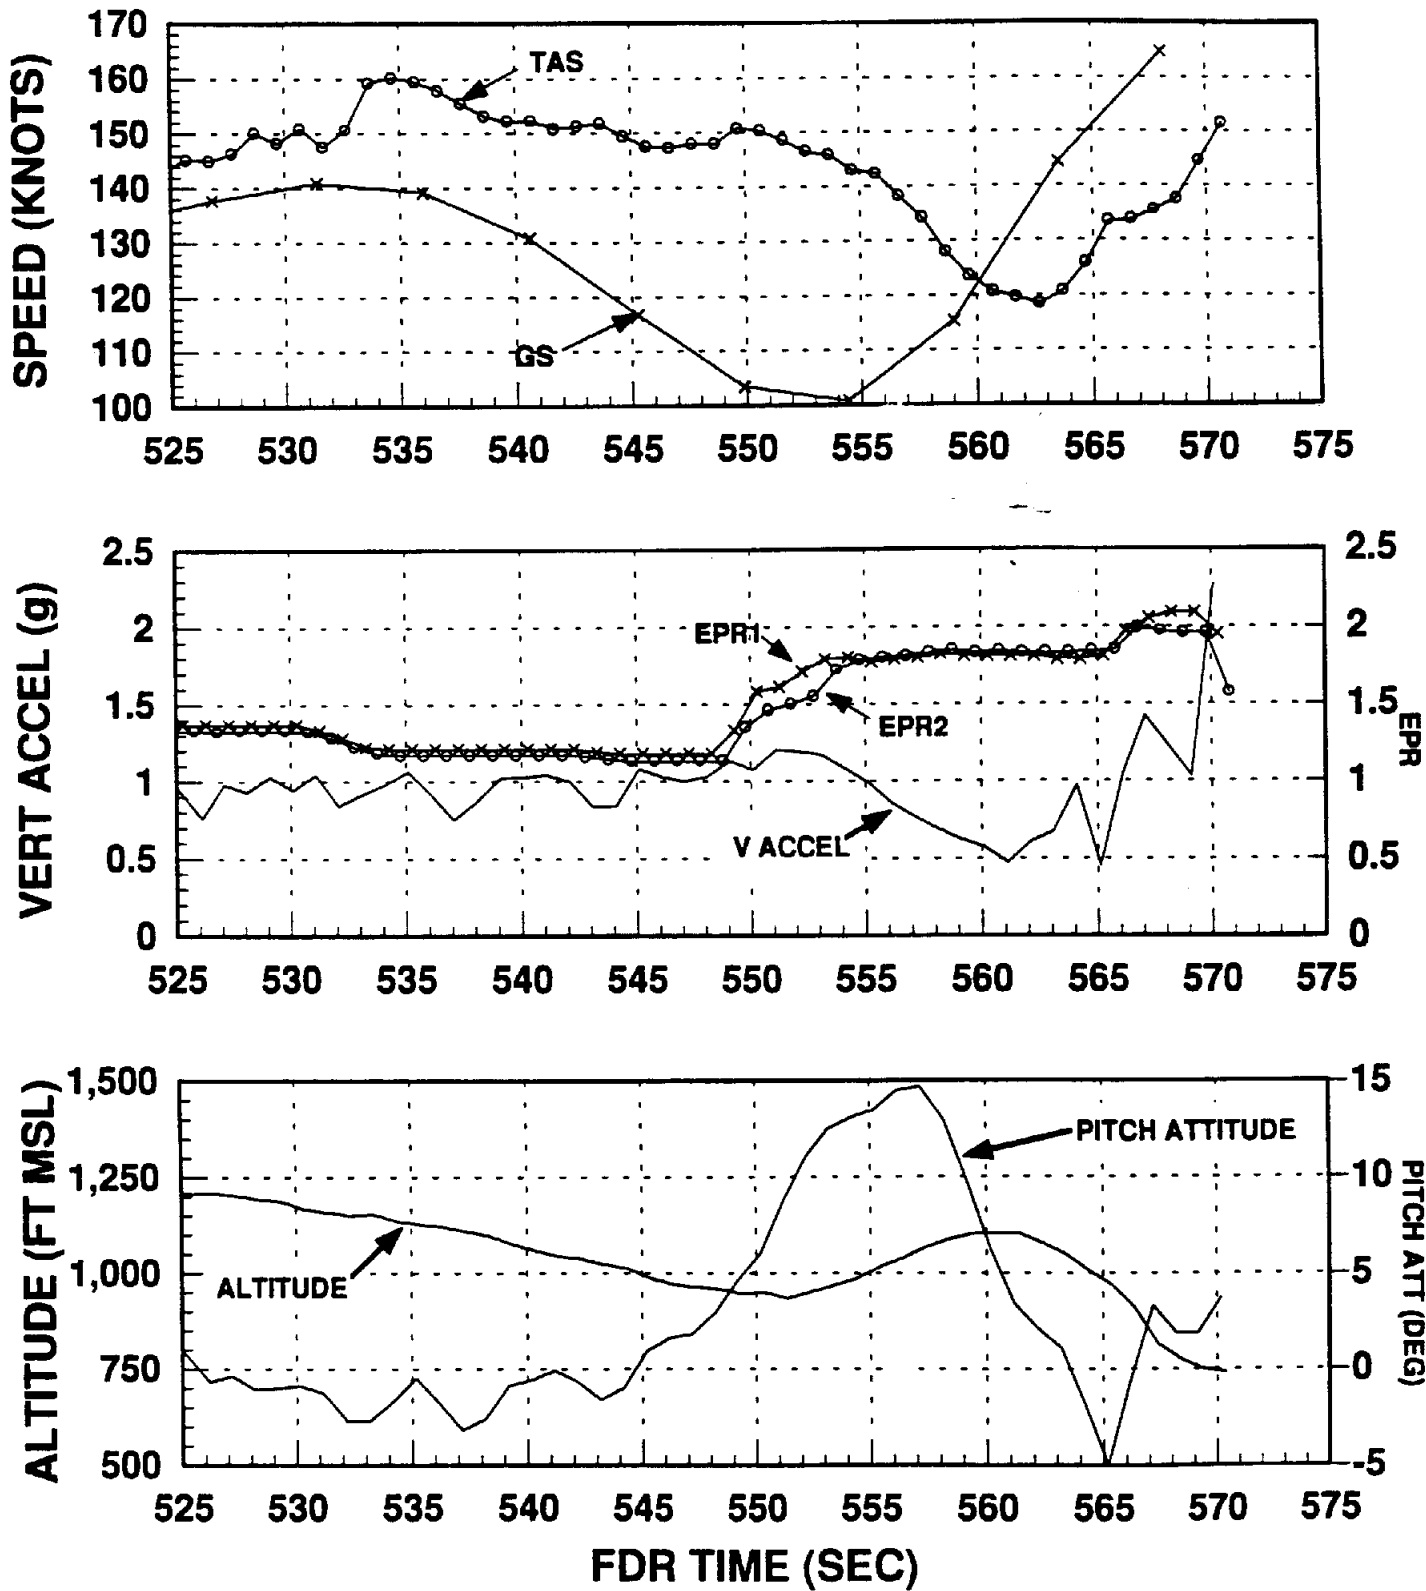
FIGURE 5

USAir 1016 FDR & BEACON DATA

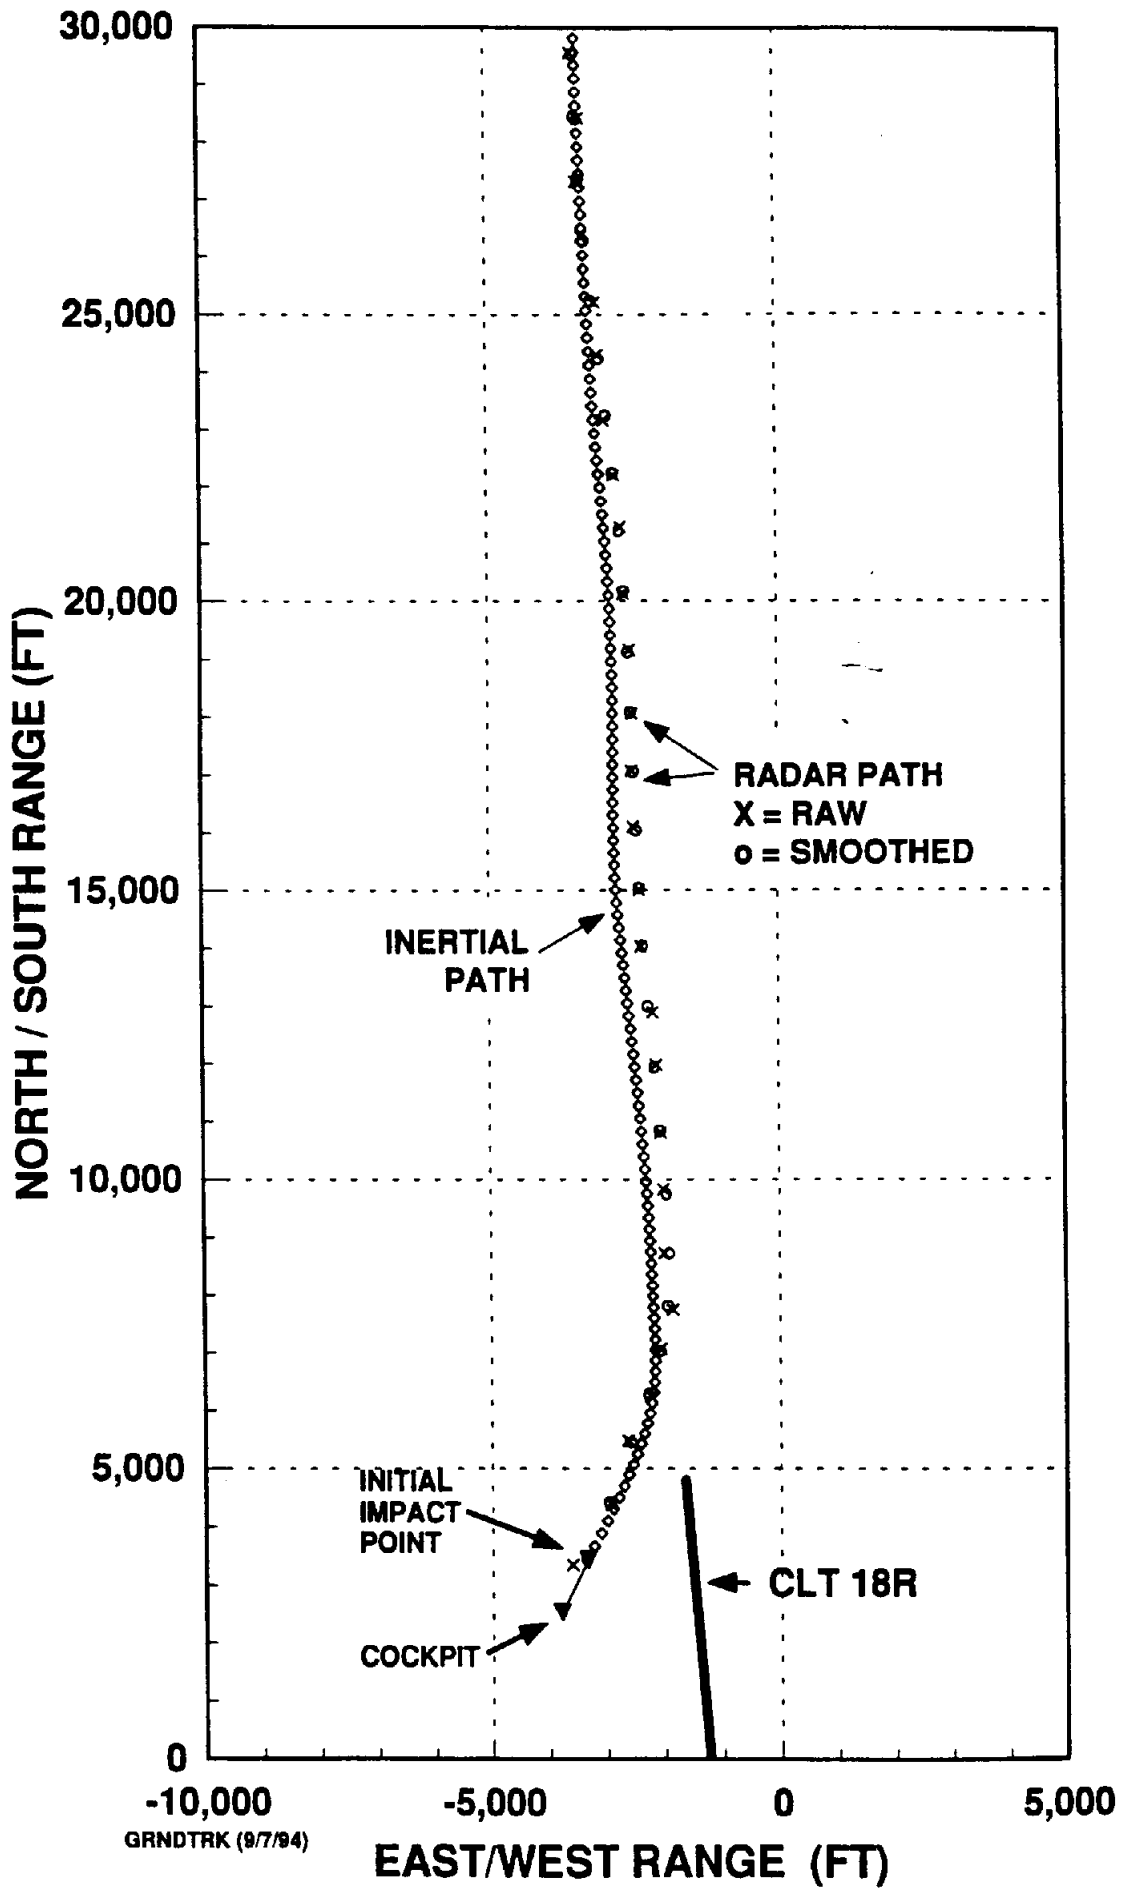
FIGURE 6

These results clearly show that US1016 encountered a severe microburst approximately 400 feet above ground level (AGL), and that the full effect of this microburst does not manifest itself until approximately fifteen seconds later, when the aircraft is only 200 feet AGL. Impact occurred after the aircraft had penetrated the core of the microburst, while it was still in the decreasing performance (increasing tailwind component) region of the microburst.

USAir 1016 GROUND TRACK COMPARISON

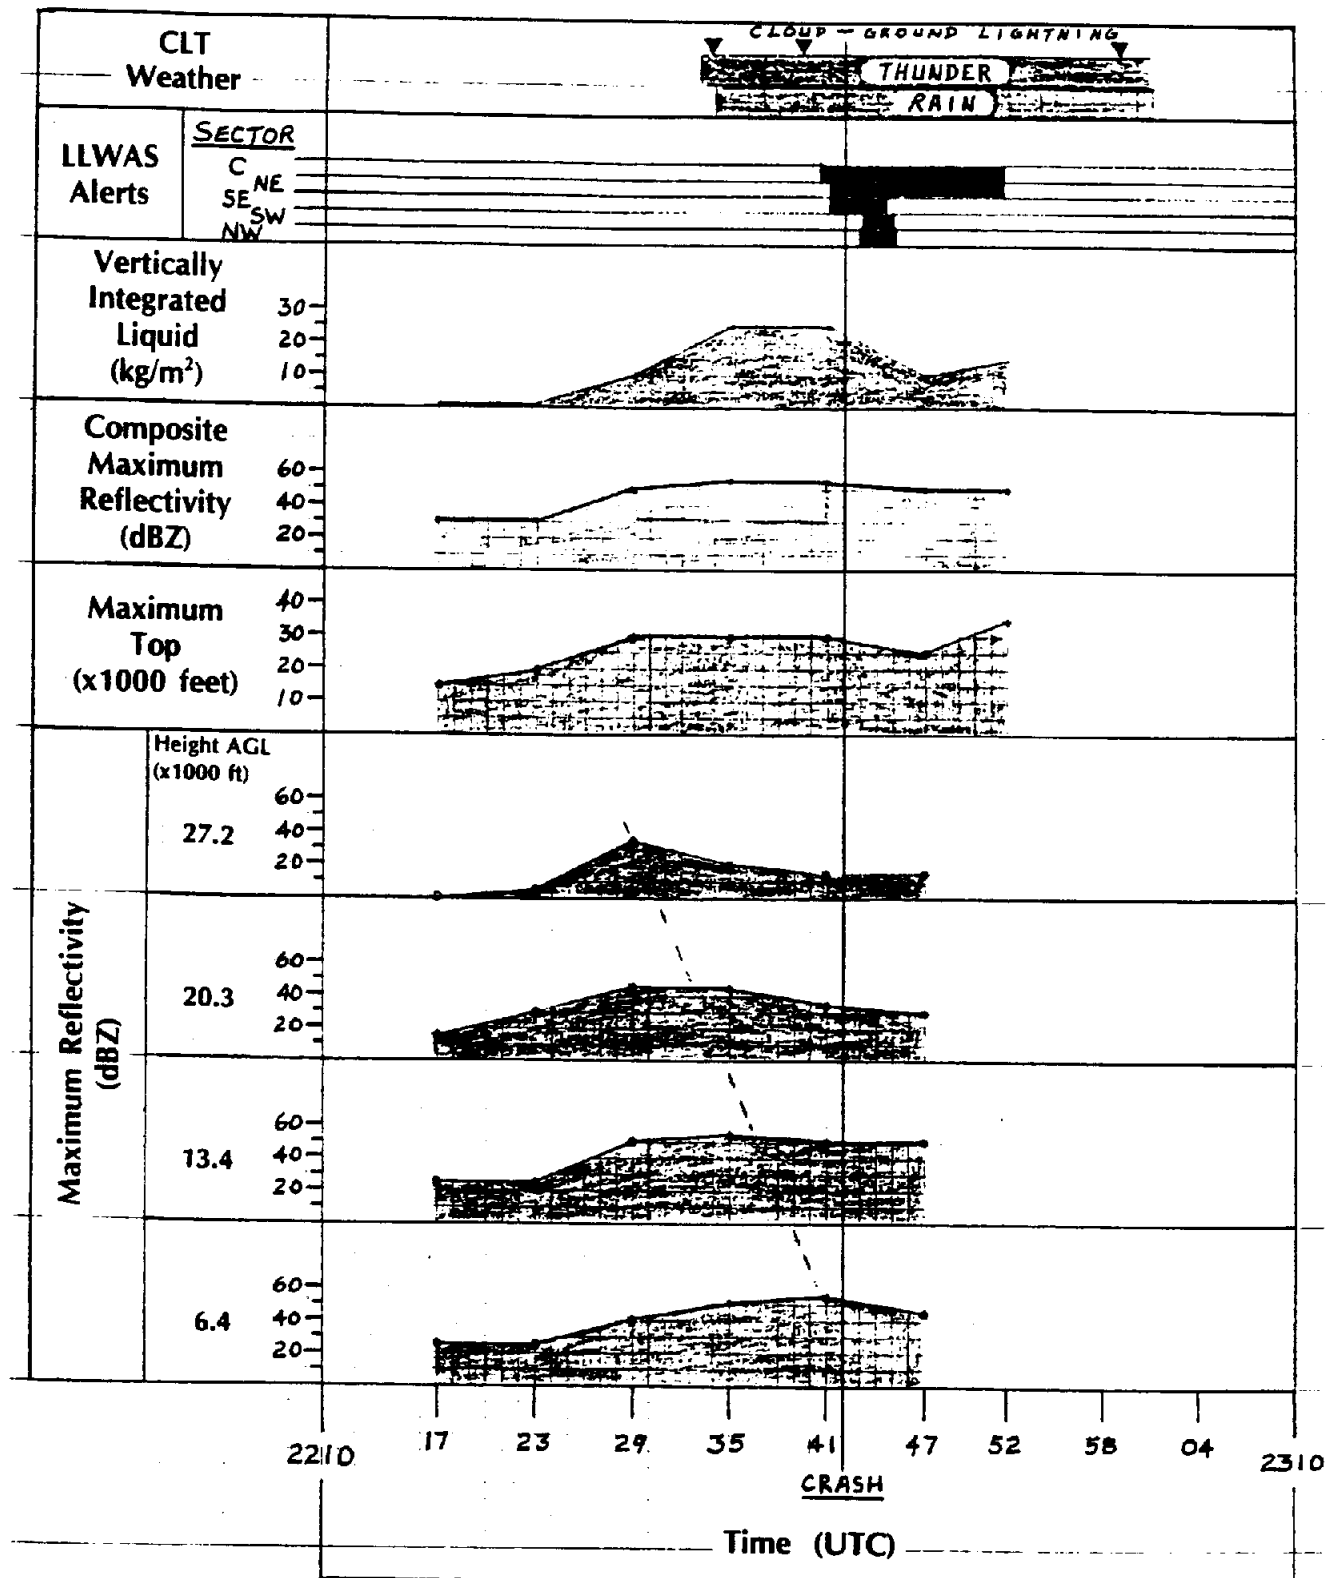
Figure 4. Time sequences of: Charlotte (CLT) weather (top graph); LLWAS II sector alerts (2nd graph); liquid water in CLT storm by radar (3rd graph); composite maximum radar reflectivity in CLT storm (4th graph); maximum radar echo heights in CLT storm (5th graph); and downward progression of maximum radar reflectivity [falling head] in CLT storm (bottom 4 graphs).

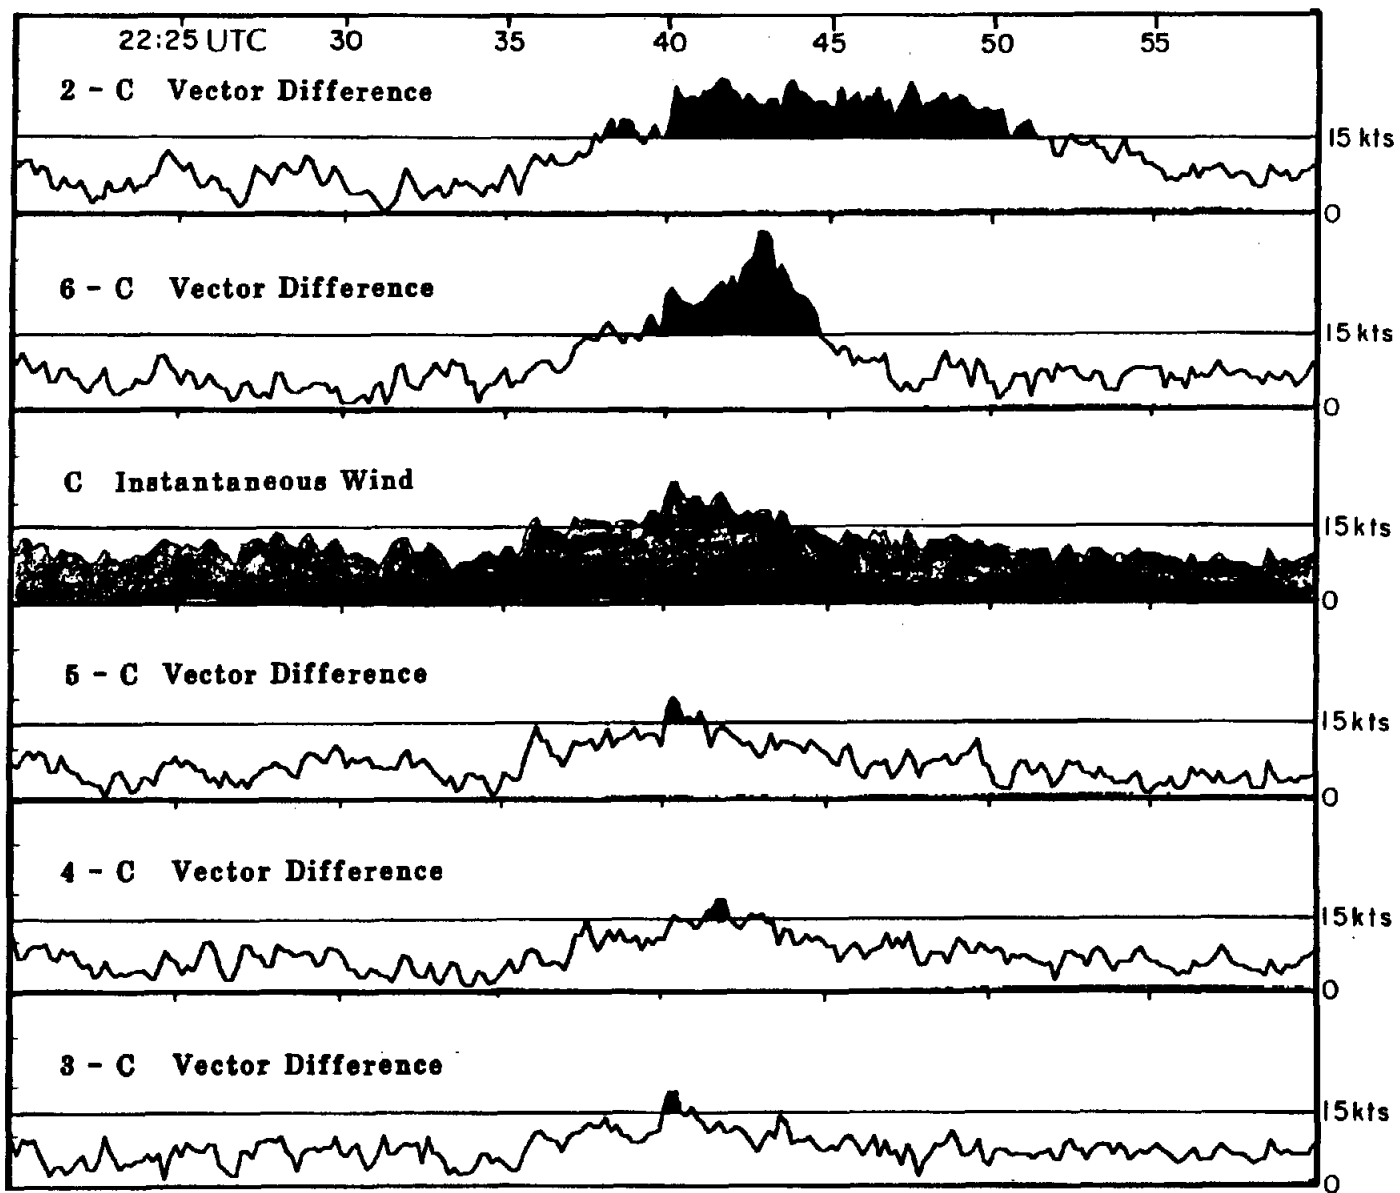
Figure 17. Vector Differences (knots) of each sensor (from Centerfield) 2220 UTC to 2300 UTC July 2, 1994 at Charlotte
