**Submission to the  
NATIONAL TRANSPORTATION SAFETY BOARD**

**Investigation of Scaled Composites, LLC's SpaceShipTwo, N339SS  
Rocket-Powered Flight Test  
Koehn Dry Lake, California, October 31, 2014**

**Virgin Galactic, LLC**

**The Spaceship Company, LLC**

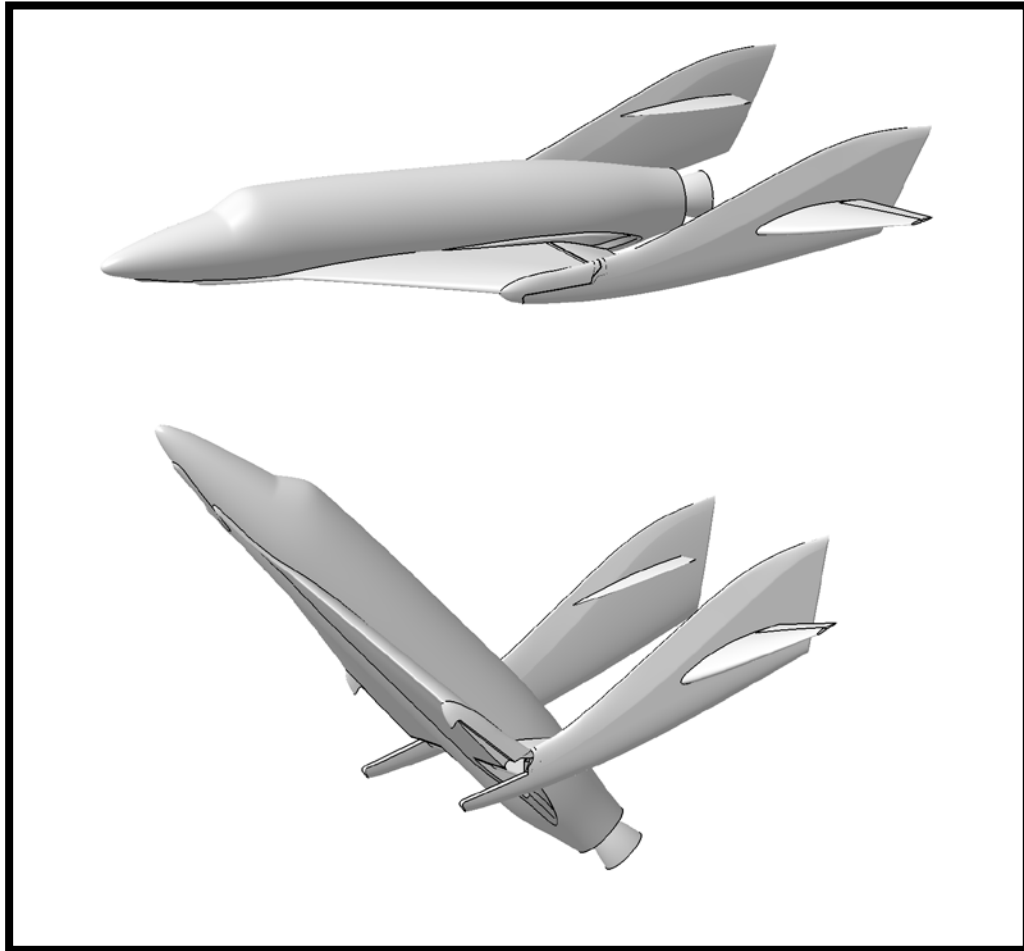
**Figure 5: SpaceShipTwo Unfeathered and Feather Up Configuration.**

The feather locks must first be unlocked by the copilot before the feather actuation handles can easily be pulled, deploying the feathers. To unlock the feather locks, the pilot moves the lock handles located on the center console downward to their mechanical stop. To lock the feathers, the pilot returns the handles to the up stop. The feather lock handles did not incorporate an automatic mechanical inhibit and it was therefore possible for the aircrew to lock or unlock the system during any phase of flight.

As part of Virgin Galactic and TSC's comprehensive Systems Safety Review (SSR) process, it was recommended, and the VG/TSC Change Control Board (CCB) authorized development of an electro-mechanical inhibit device to prevent inadvertent pilot actuation of the feather locks in either scenario. The device utilizes an electronic solenoid to inhibit movement of the feather locks during critical phases of flight. The concept is similar to landing gear switch inhibits which are commonplace throughout the aerospace world. It is also very similar to the inhibit on all cars with an automatic transmission that prevents moving the transmission out of Park without the driver's foot on the brake pedal.

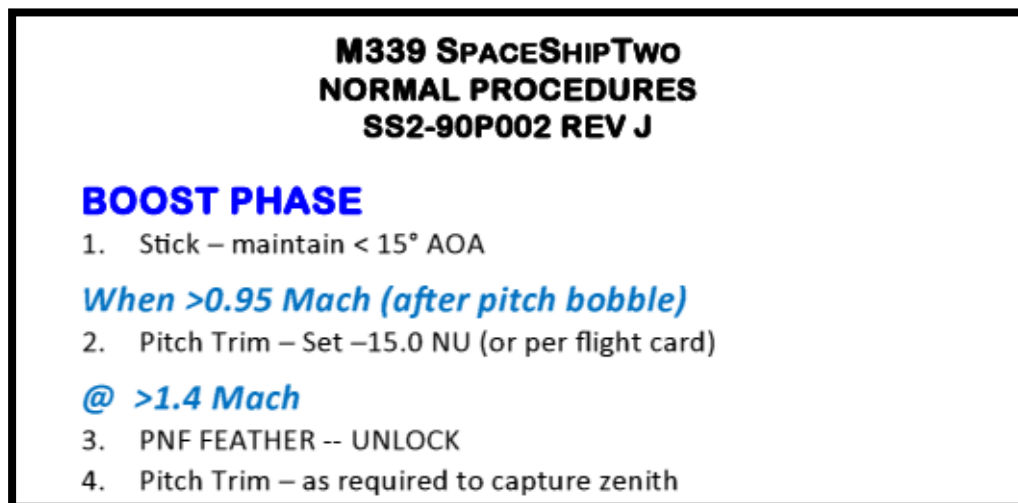
**Figure 6 – Boost Phase Normal Procedures**

After release and rocket motor ignition, the vehicle would accelerate toward the transonic phase of flight (approximately 0.80-1.20 Mach). Upon reaching 1.40 Mach during the rocket-powered boost portion of the flight the Normal Procedures Manual required the copilot (referred to as the Pilot Not Flying or PNF) to unlock SpaceShipTwo's feather as shown in Figure 6 below.

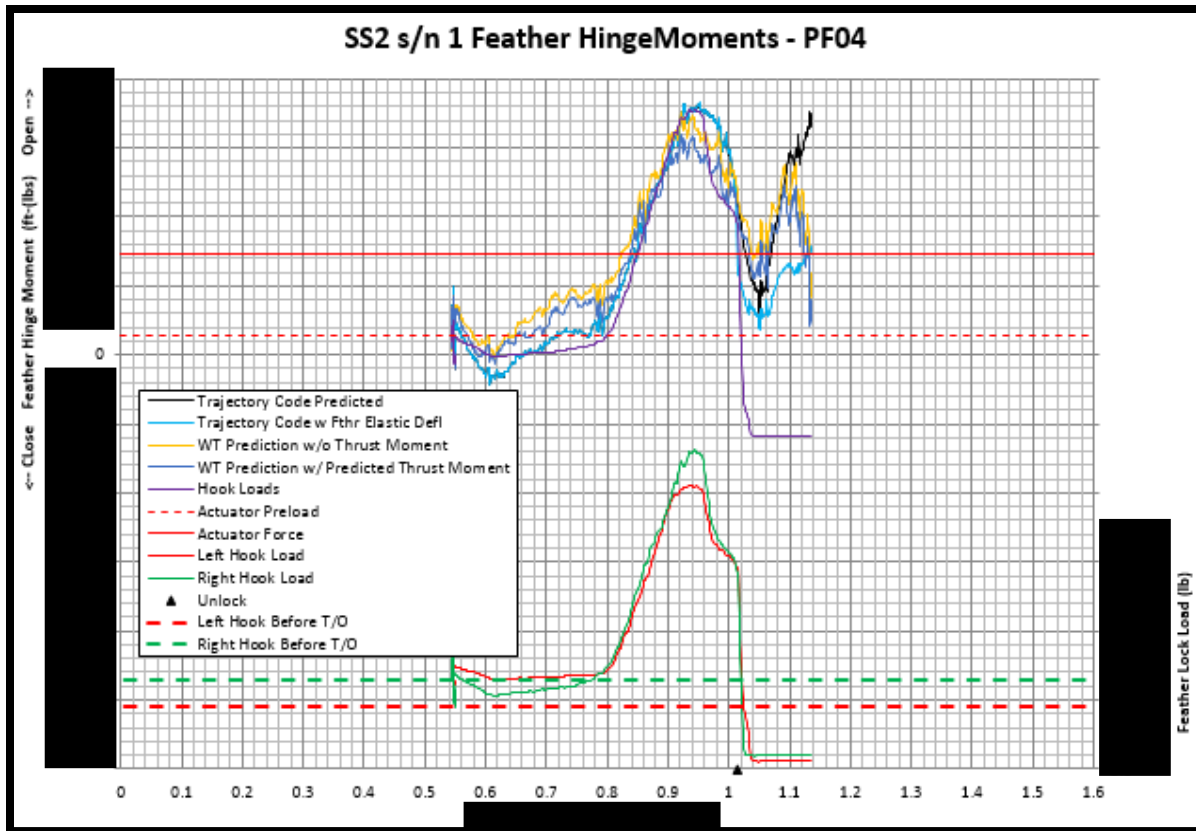
**Figure 9 – Feather Forces versus Mach Number**

### **2.1.3 Unlocking the Feather Locks at 0.92 Mach Caused the Tails to Extend into the Feather Position**

Telemetric data reviewed by investigators demonstrates that, once unlocked, upward aerodynamic forces on the tail of the aircraft overcame the actuator pre-load and caused the tails of SpaceShipTwo to extend into the feather position.

During the feather extension sequence, a maximum pressure in the retract side (down) of the feather actuators of approximately 710 psig in the left actuator and 759 psig in the right actuator was recorded. The pressure readings for the extend side (up) pressure for both actuators was slightly less than 0 psig during the feather extension. These data confirm that aerodynamic forces on the tail were acting to extend the feather. Starting at 10:07:32.44, data for the feather position was considered unreliable by investigators. (Systems Fact. Rpt., page 14.)

These telemetric data are consistent with high upward load forces on the tail. Scaled Composites' former Chief Aerodynamicist stated that this was the flight regime where aerodynamic upload forces would cause the tails to feather, if unlocked. Referring to Figure 9, above approximately 0.80 Mach (if the feather locks are not engaged) aerodynamic forces overcome the actuator pre-load and the feather loses approximately 90% of its structural stiffness in countering an upward load on the tail. Above approximately 0.84 Mach with the feather locks unlocked, aerodynamic forces are of sufficient magnitude to extend the feather without any other action.
