**From:** Brian J Weber [REDACTED]  
**Sent:** Friday, June 14, 2013 10:19 AM  
**To:** Fox Todd  
**Cc:** Jacky Tom; Certification  
**Subject:** RE: CEN13FA196 -- Passenger Statement/Interview Summary (Ref: 940201301192)  
**Attachments:** DSC\_0005.jpg; DSC\_0006.jpg

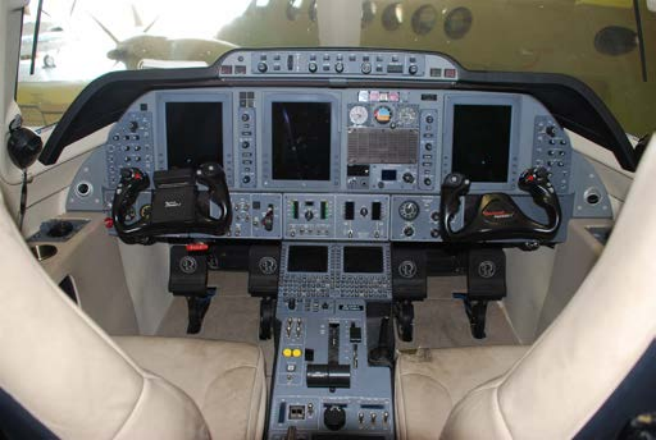
As we discussed, I attached two high-resolution photos of an exemplar airplane from our test fleet to assist with any follow-up questions for Evans. One photo is of the entire instrument panel taken from the flight deck partition. The other photo was taken from the seat that Evans described as the one that he occupied, adjacent to the emergency exit.
