Personal Account of King Air N786SR Flight 05/16/2011

Heather Seemann

05/16/2011

Flight #102

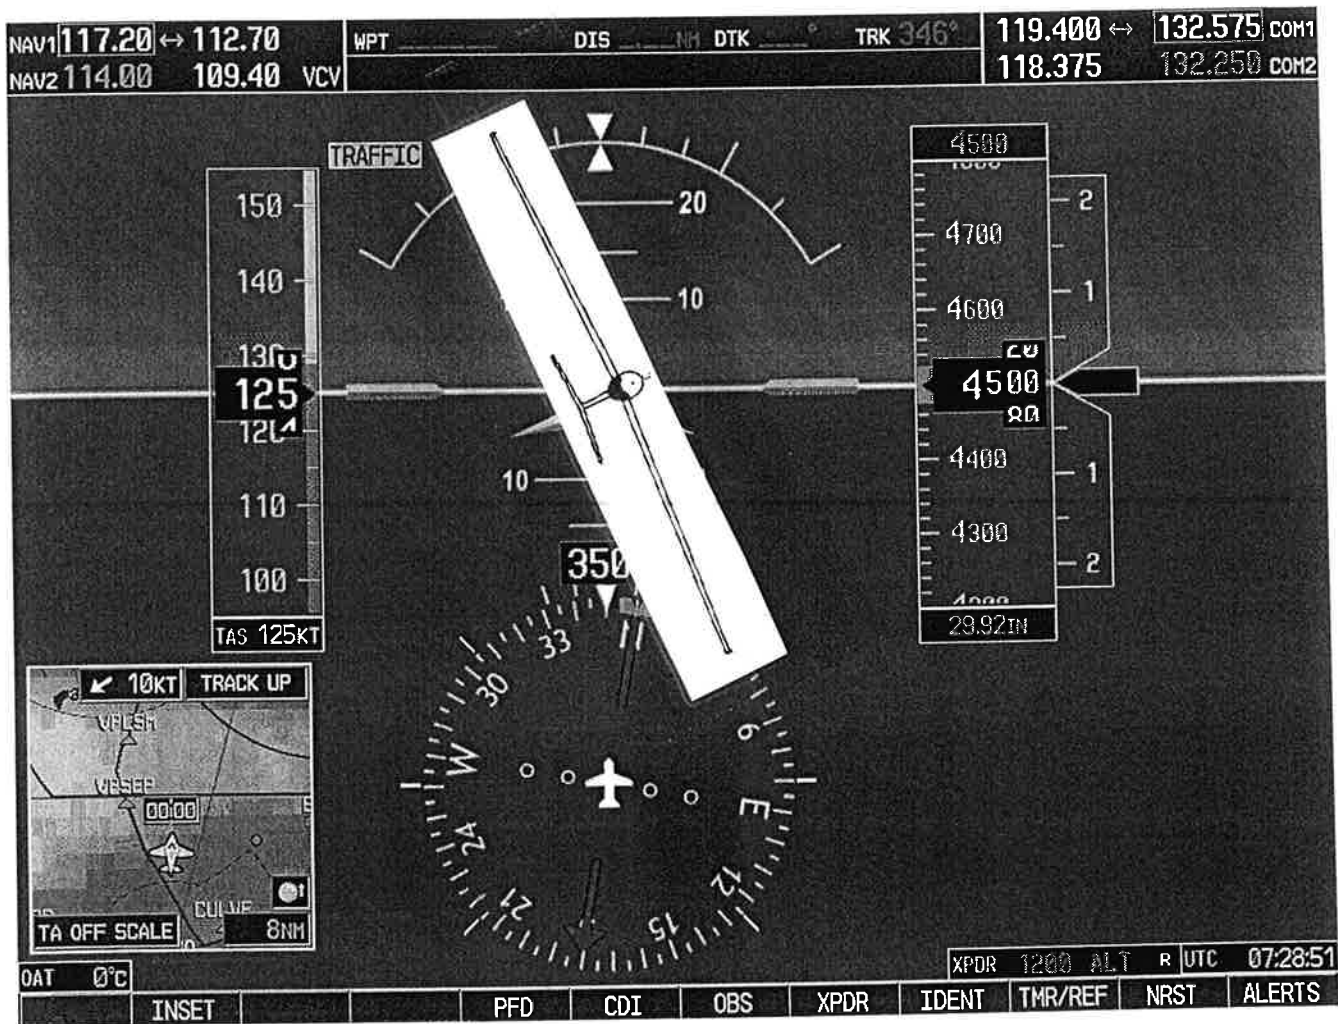
First Roll, Left

Steep roll to the left. (Refer to attached sheet with attitude indicator example, "First Roll, Left".) Remained at this attitude briefly. Returned to a neutral position. Rolled to the right (not as steep as first roll to the left). (Refer to attached sheet with attitude indicator example, "Second Roll, Right".) Returned to a neutral position. Rolled to the left. (Refer to attached sheet with attitude indicator example, "Third Roll, Left"). Returned to a neutral position. Rolled to the right. (Refer to attached sheet with attitude indicator example, "Fourth Roll, Right"). During each roll, I think that there may have been a corresponding yaw motion in the same direction as the roll (i.e. roll to the left with yaw to the left; roll to the right with yaw to the right). I cannot verify the yaw motion from observation of the attitude indicator – it was solely a physical sensation.

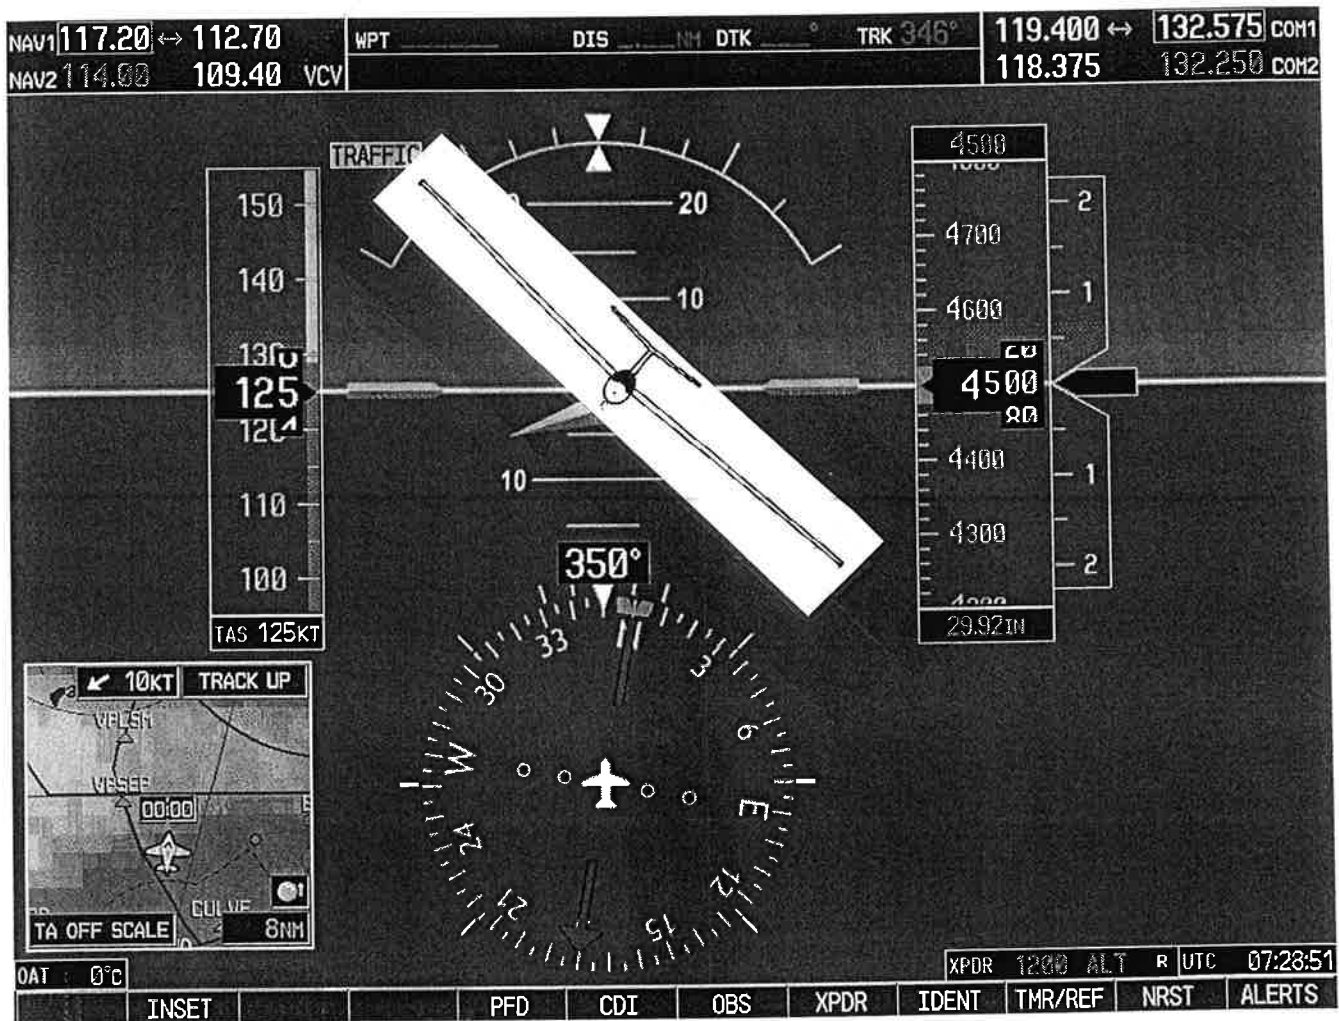
Fourth Roll, Right

After returning to a nearly neutral position after the fourth roll (right), I felt the nose pull up while observing the right yoke move backward (toward aft of A/C). A/C rolled to the left and I looked out the port-side window. A/C had broken through ceiling, tundra visible (snow covered with grass breaking surface). Left wing was pointed toward ground, angle greater than 45 degrees but less than 90 degrees. Unknown speed and altitude – upon observation of tundra out window, became very distracted and did not focus on attitude indicator again. Estimated A/C speed 100 kt with altitude of 100-200 ft AGL. Attempted to inform Cassie of proximity of A/C to ground and advise her to brace for imminent impact but was only able to say, "Um, Um, Cassie, Um." Cassie responded, "Yeah, I know. I see it."
