NATIONAL TRANSPORTATION SAFETY BOARD
Vehicle Recorder Division
Washington, DC 20594

On-Board Image Factual Report

Location: Red Oak, Iowa
Date: April 17, 2011, 0700 Central Daylight Time (CDT)
Operator: Burlington Northern-Santa Fe Railroad
NTSB Number: DCA11FR002

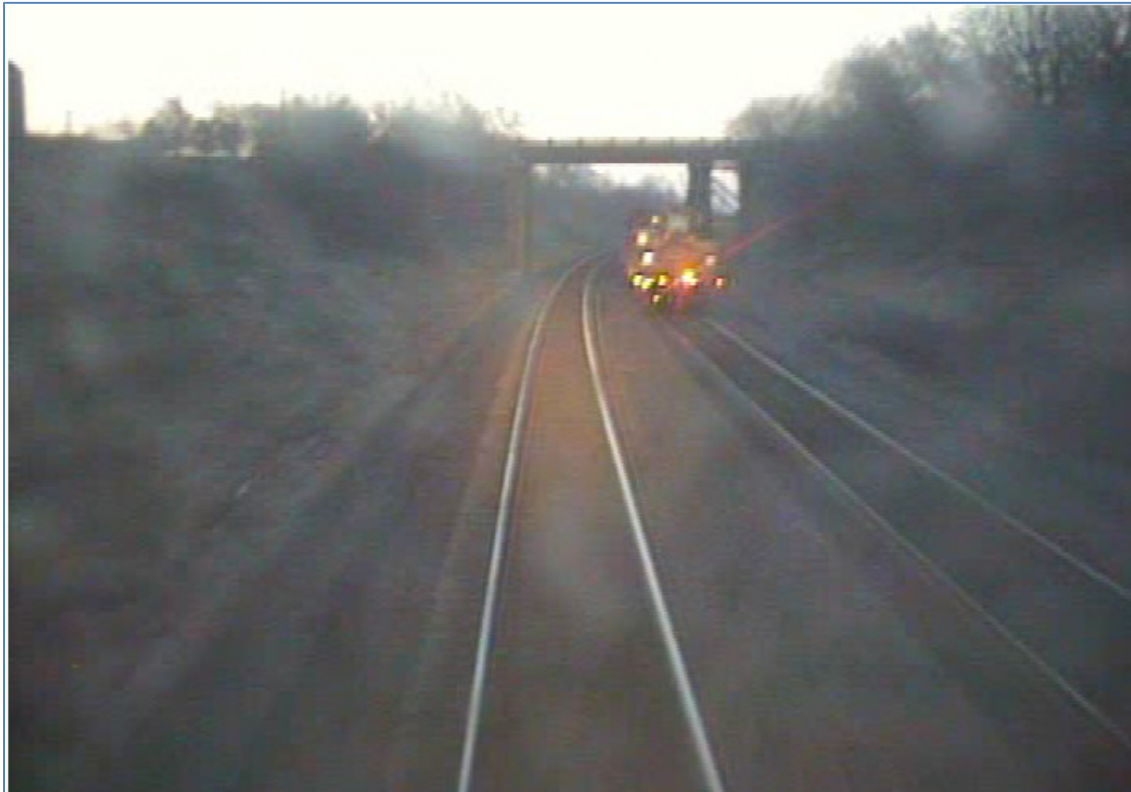
Figure 1. End of train device.

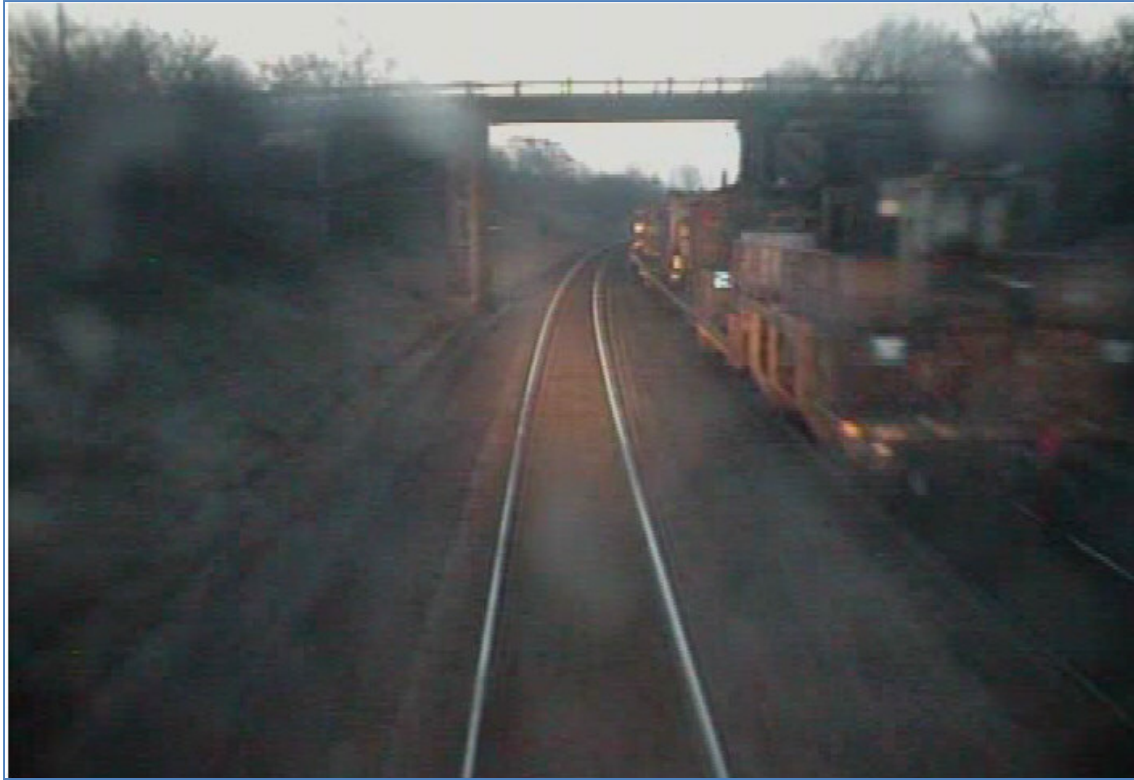
Figure 2. HGZX150 equipment.

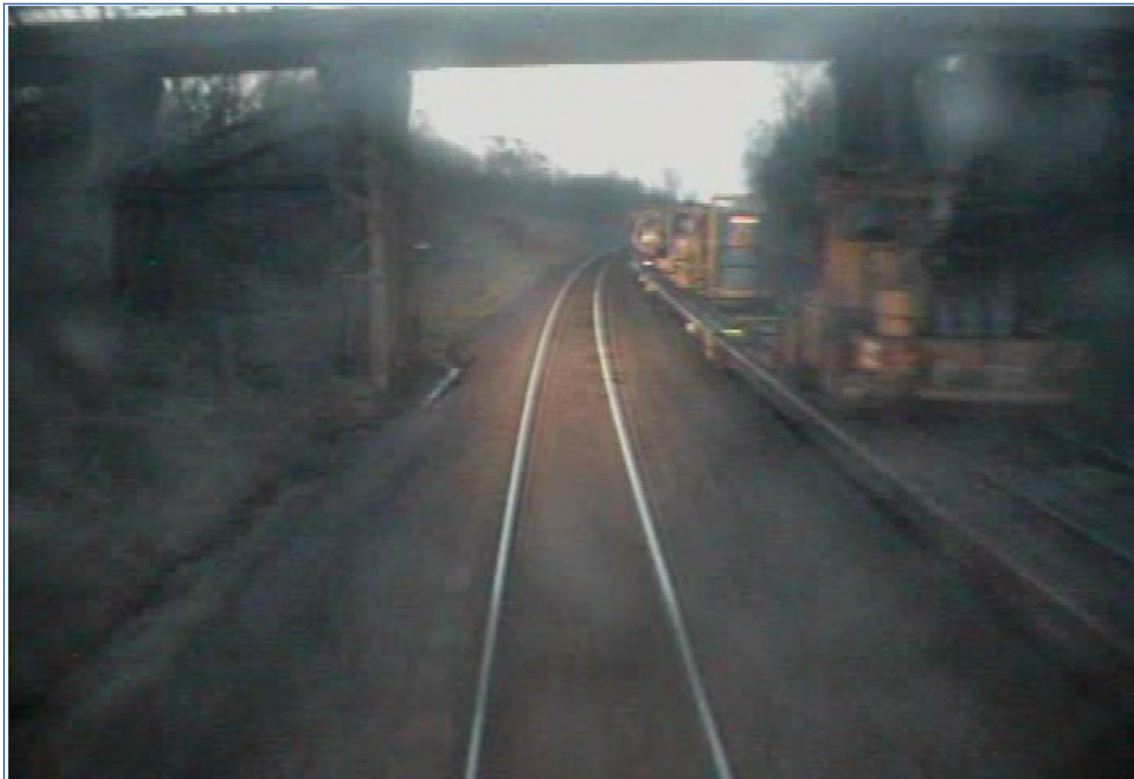
Figure 3. Scorpion equipment.

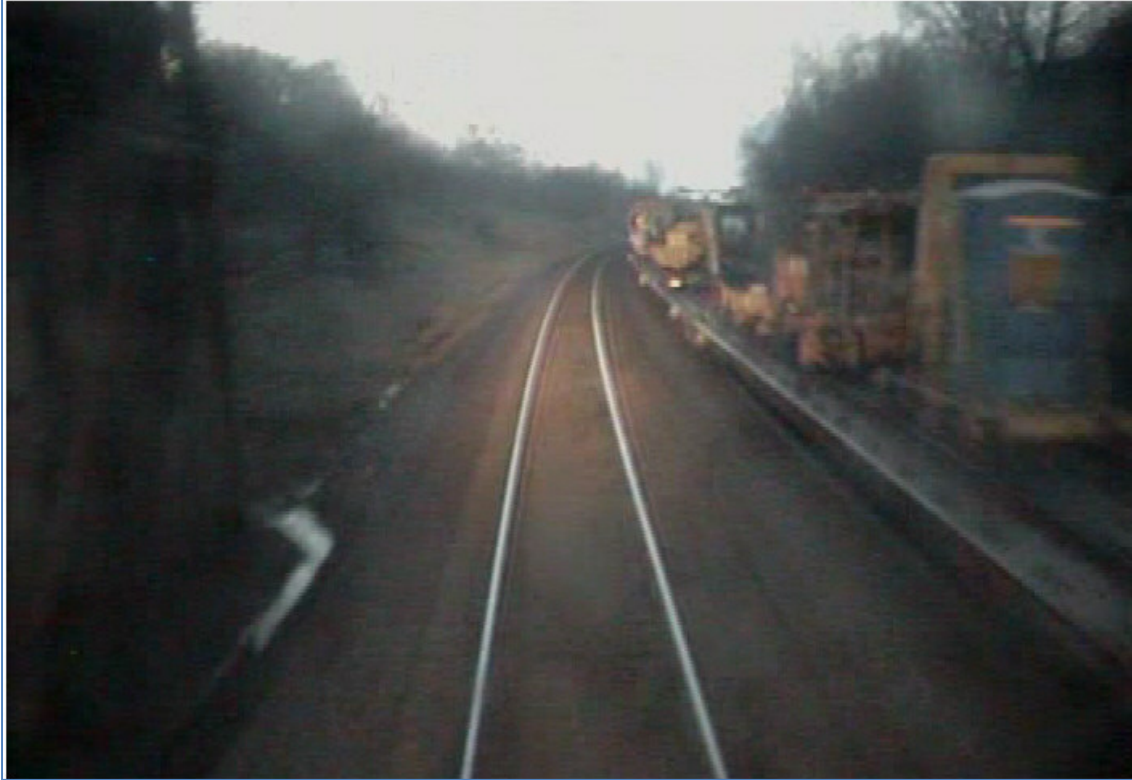
Figure 4. Line 32 payload.

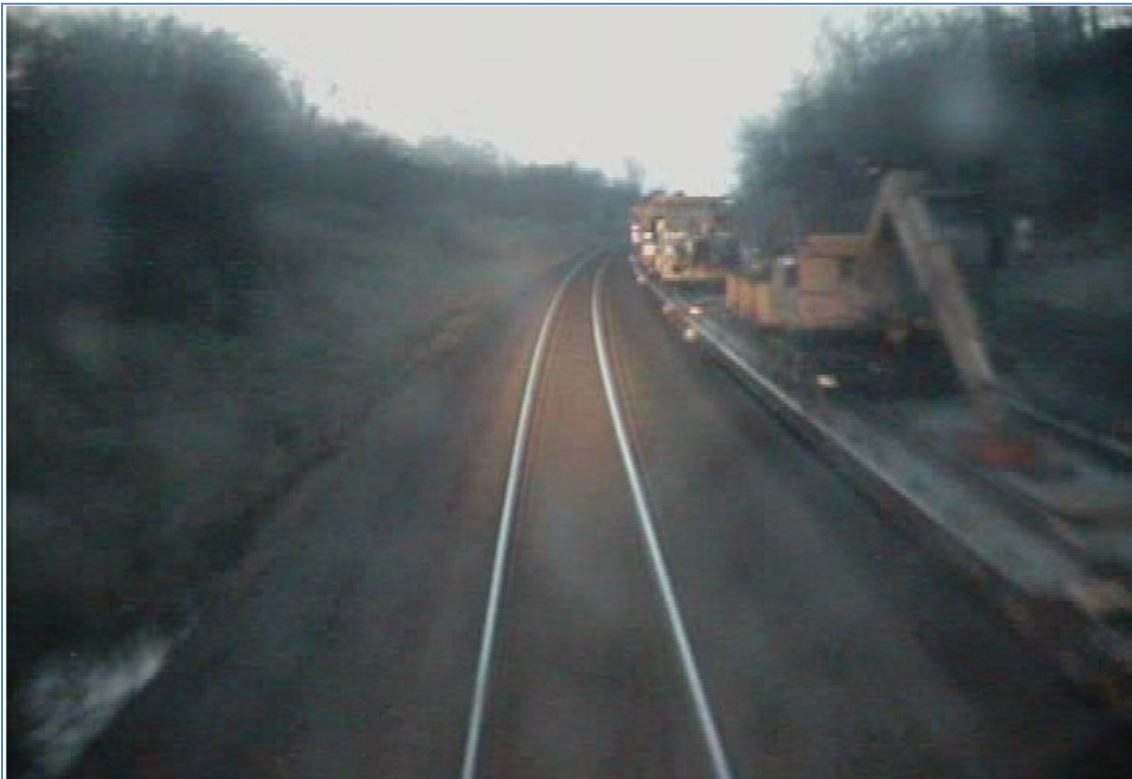
Figure 5. Line 31 payload.

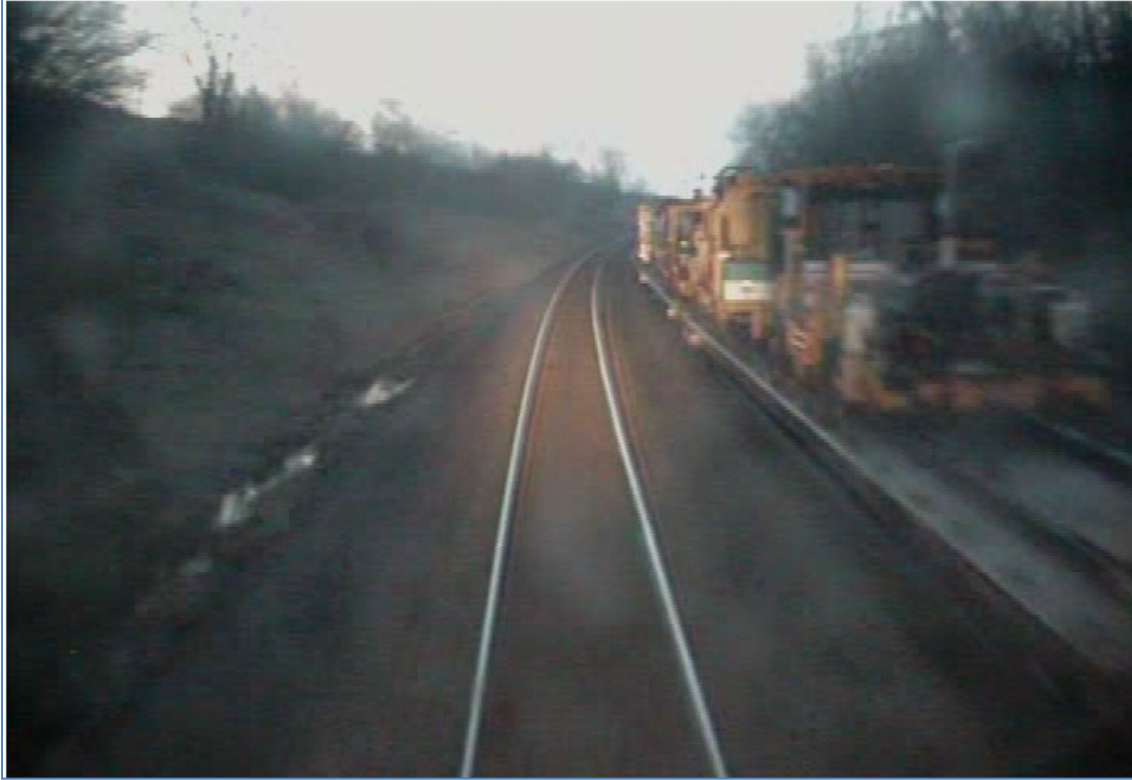
Figure 6. Line 30 payload.

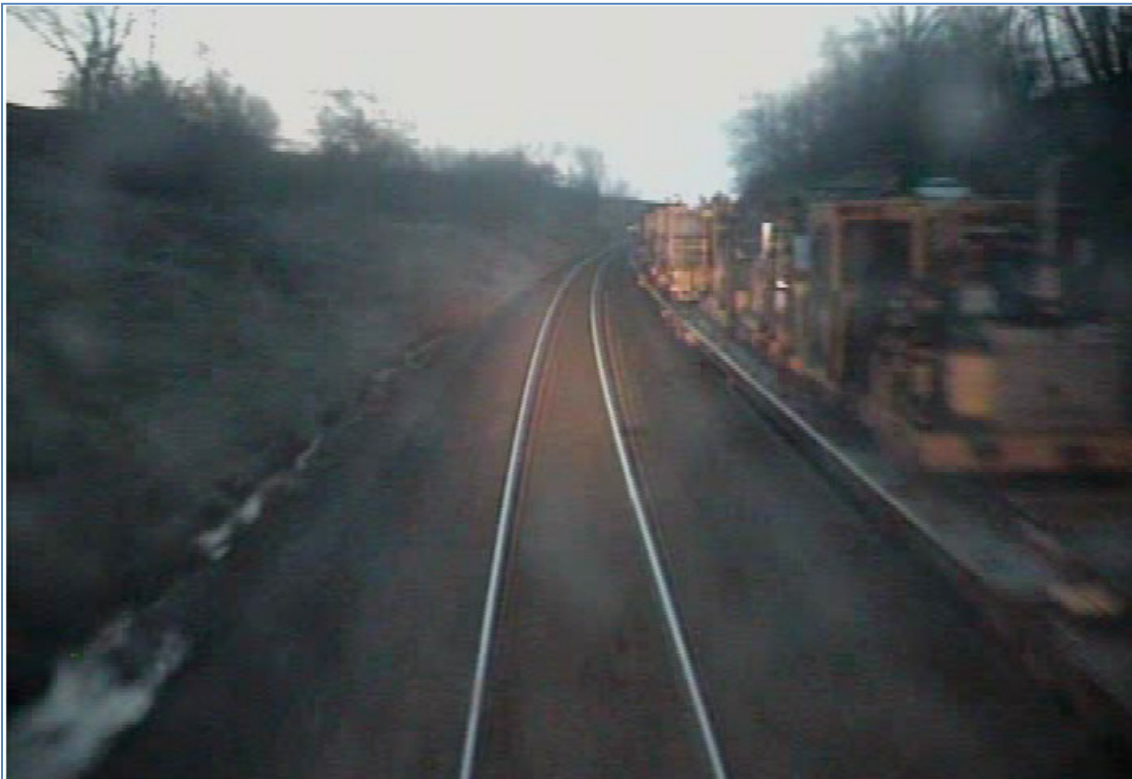
Figure 7. Line 29 payload.

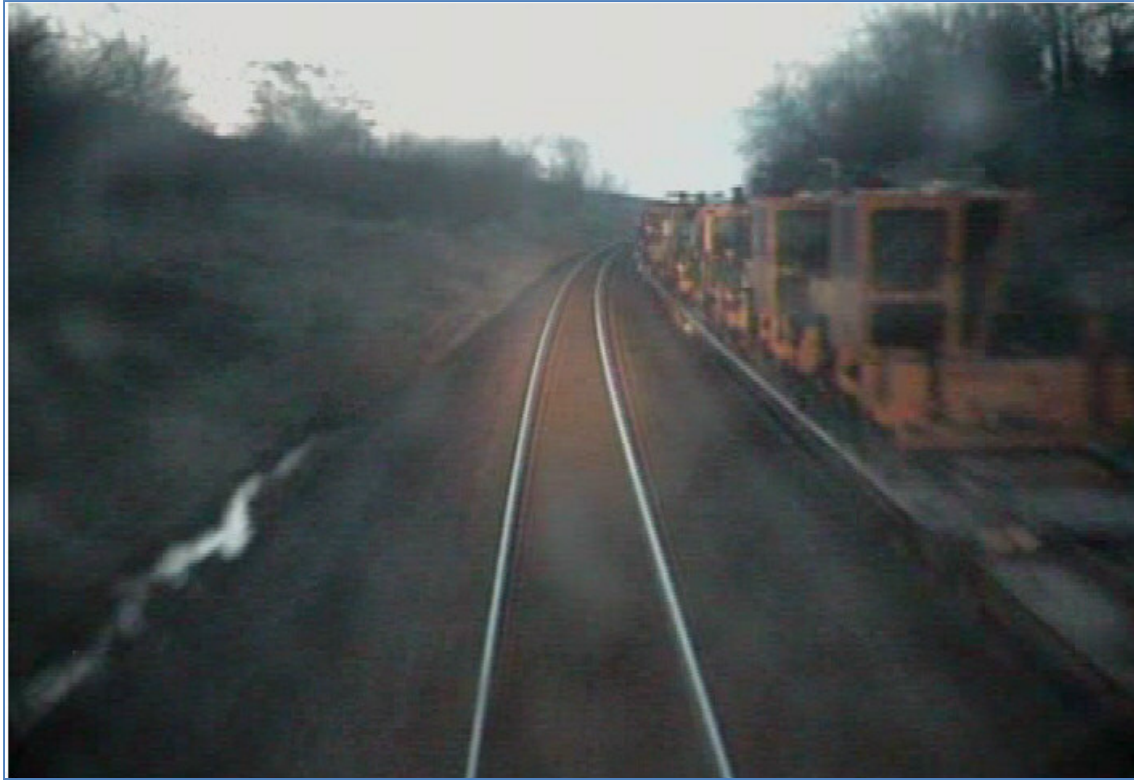
Figure 8. Line 28 payload.

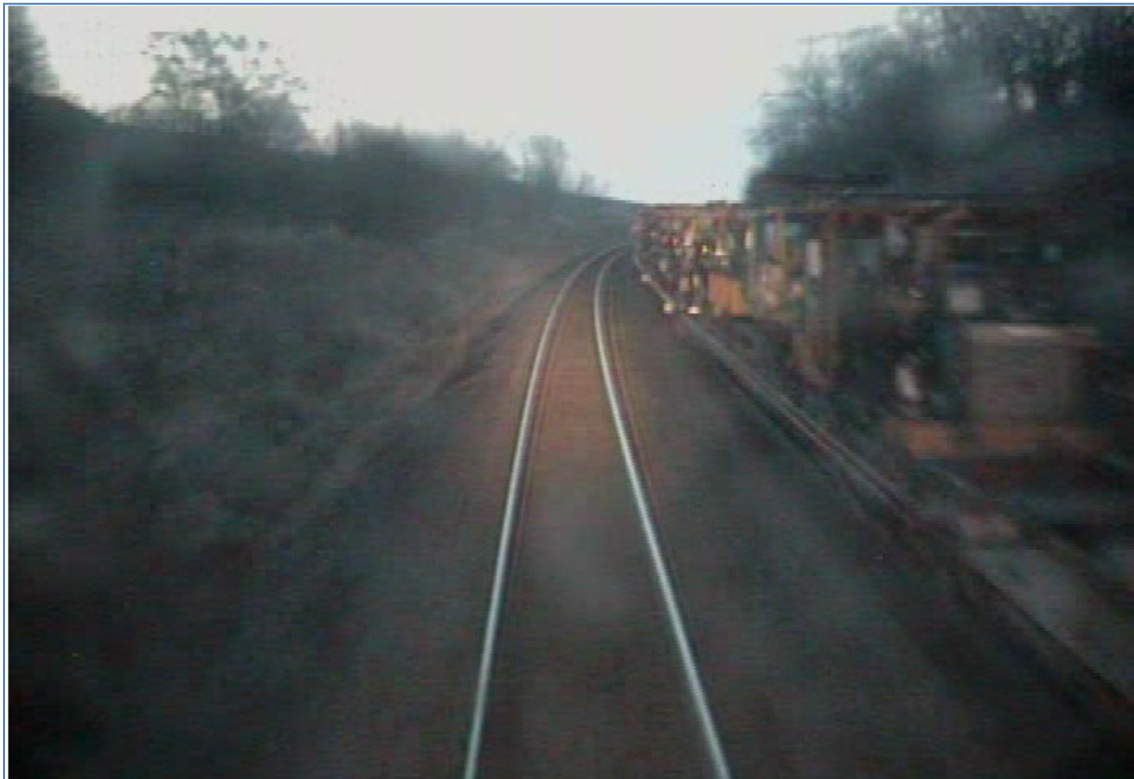
Figure 9. Line 27 payload.

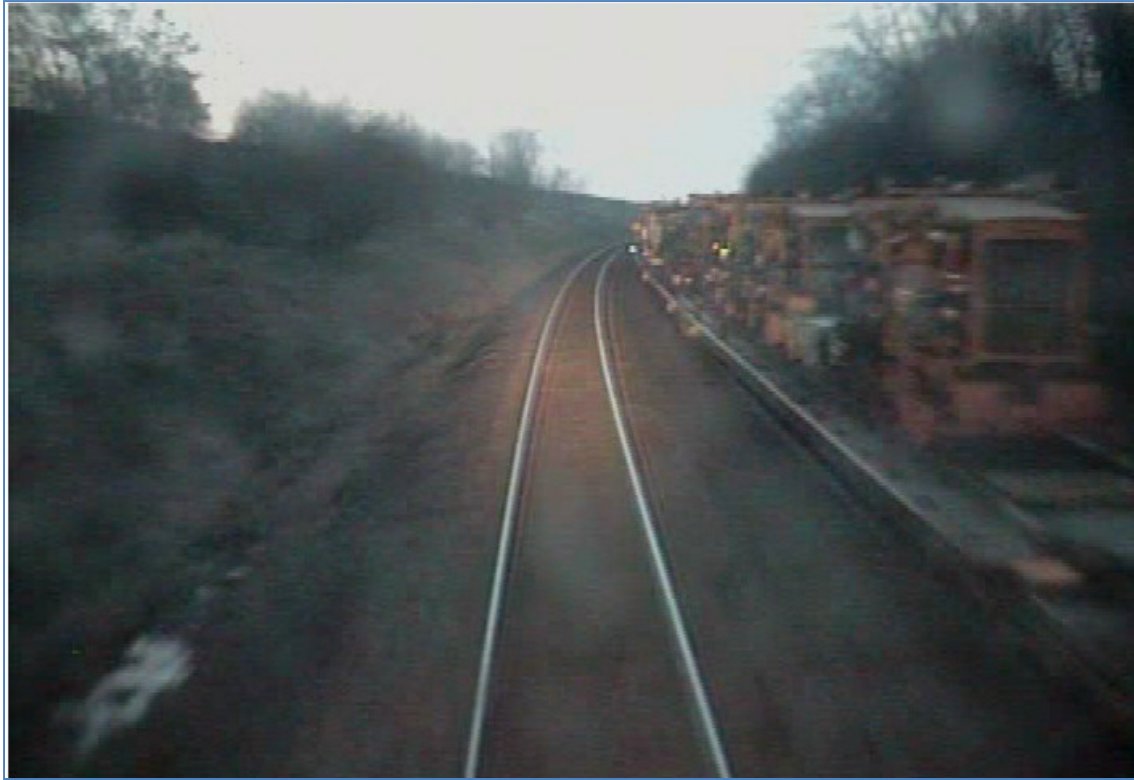
Figure 10. Line 26 payload.

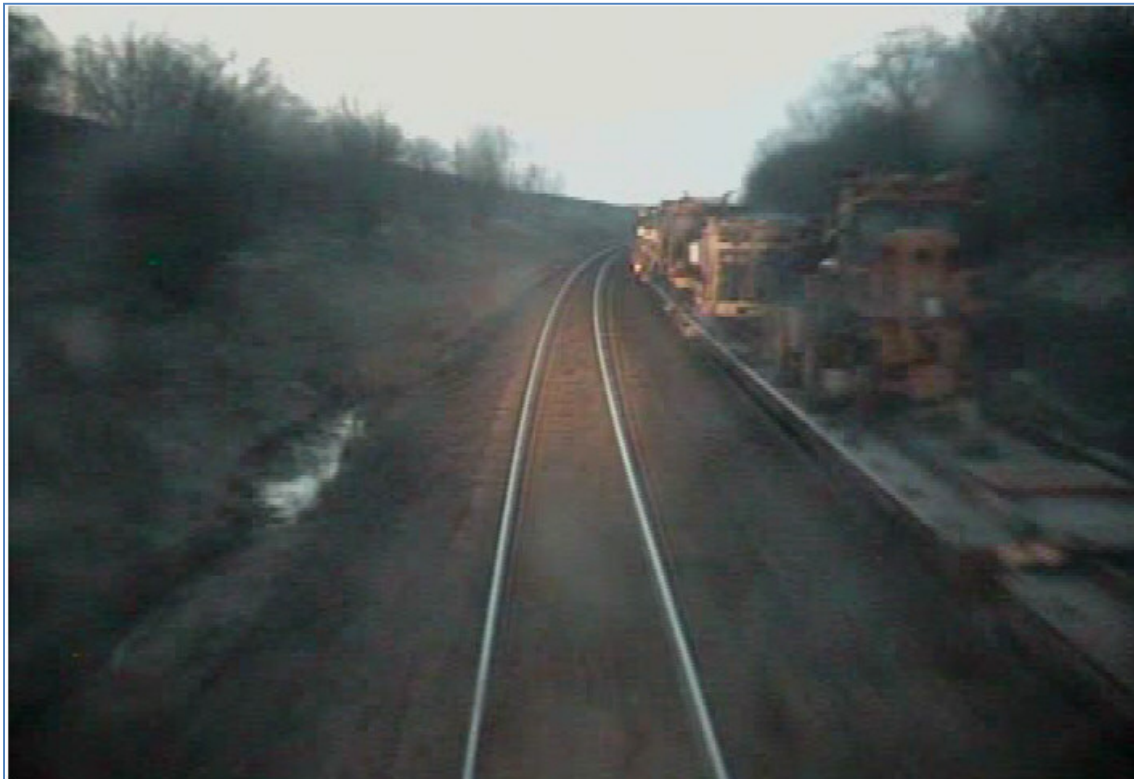
Figure 11. Line 25 payload.
