National Transportation Safety Board

Performance Study

Specialist Report Marie Moler

Location: New York, New York
Date: March 11, 2018
Time: 1908 EDT
Aircraft: Airbus Helicopters AS350B2, N350LH
NTSB Number: ERA18MA099

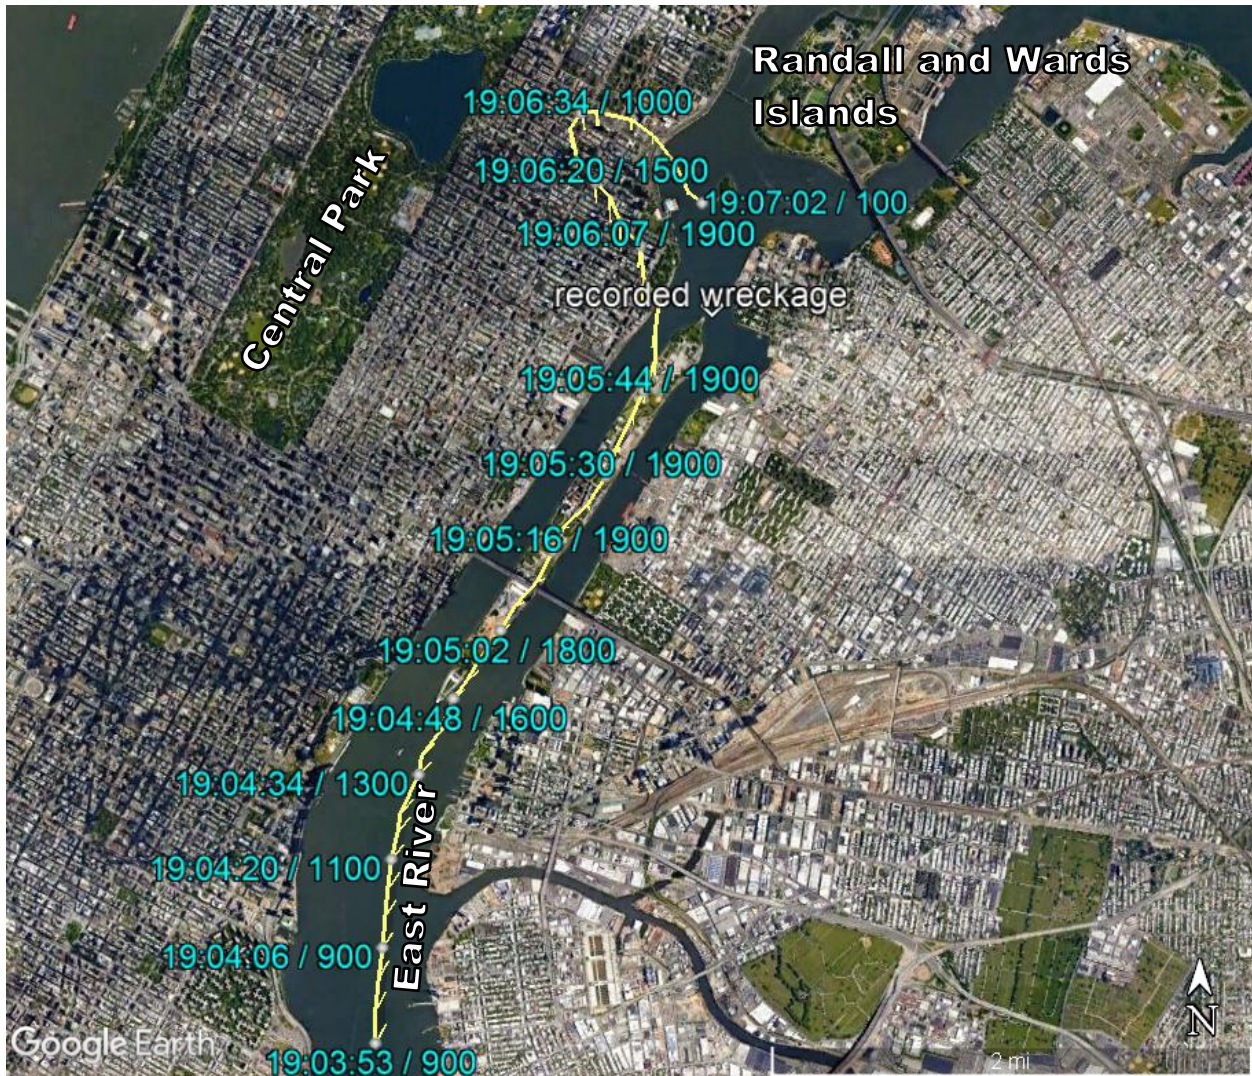
Figure 1. Aircraft flight path north along the East River.

The helicopter was flying north along the East River (Figure 1 and Figure 2) and had climbed to an altitude of 1,900 ft (Figure 3) while at an airspeed of about 80 kts. The helicopter maintained 1,900 ft for about a minute and was turning along a track of about 330° as it traveled over the island of Manhattan. At 19:06:11 the helicopter began losing altitude. The helicopter continued on the 330° track until 19:06:30 when, at an altitude of 1200 ft, it began a 180° right turn toward the East River. By 19:06:53, the helicopter was over the river and at an altitude of 300 ft. The last recorded radar return was at 19:07:02, when the helicopter was at an altitude of 100 ft and passing Mill Rock, a small island in the East River. Figure 2 shows the location of the wreckage as recorded by local law enforcement and the estimated point of water impact determined from two witness cell phone videos. The difference between the two points was due to the helicopter drifting downstream in the current.

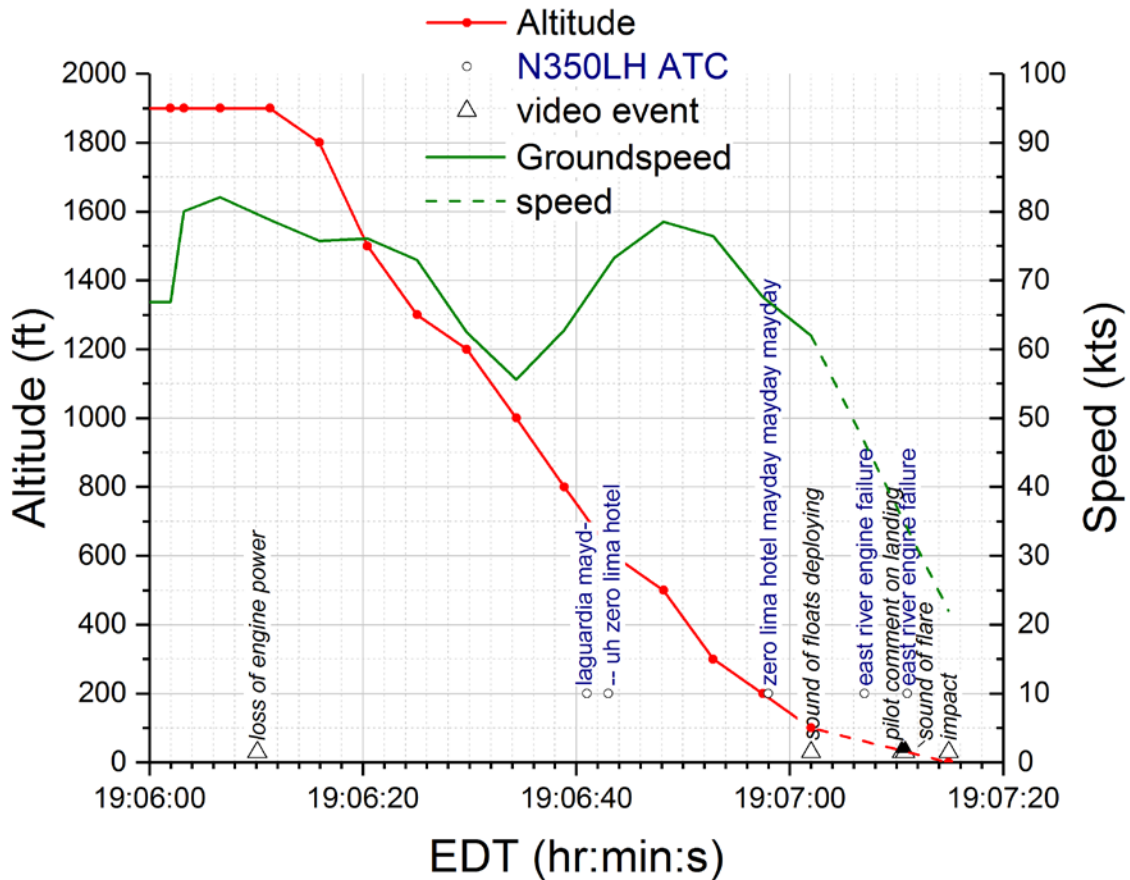
Figure 4. Aircraft altitude, speed (from radar and cell phone video), events from GoPro video, and accident helicopter ATC communications.

The onboard video recorded the timing of the loss of engine power, float deployment, a comment from the pilot to the passengers about landing, a sound similar to a helicopter flare maneuver, and impact with the water. Figure 4 shows an overlay of these events with the radar altitude, calculated speeds, and ATC communications from the accident helicopter. The loss of engine power occurred at 19:06:10 when the helicopter was at an altitude of 1,900 ft. The helicopter autorotated for the remainder of the flight, flared at 19:07:11, and impacted the water at 19:07:15. The cell phone video study estimated the helicopter impacted the water at about 22 kts of groundspeed, which is included in the figure. Emergency procedures recommend a maximum groundspeed for water contact to be 10 kts or less [4]. The sound of the floats deploying corresponded with the last radar point as the helicopter was passing Mill Rock and about 100 ft above the water, 13 seconds before

impact. The groundspeed at the time of float deployment was about 60 kts, approximately equivalent to airspeed. Procedures specify that floats should not be deployed until the airspeed is less than 75 kts. The total time between loss of engine power and water impact was 65 seconds.

The accident helicopter had been in communication with the air traffic control tower at LaGuardia during the flight. At 19:06:41, the accident pilot communicated “laguardia may—” and then “—uh zero lima hotel” but the transmission was then interrupted by another aircraft and the tower’s response. At 19:06:58, 18 seconds after the earlier possible mayday, the accident aircraft called “zero lima hotel mayday mayday mayday”. The pilot made two more calls of “east river engine failure” before the helicopter impacted the river. The ATC communications of the accident aircraft after the loss of engine power are included in Figure 4, but the communications between the tower and other aircraft have been omitted for clarity.

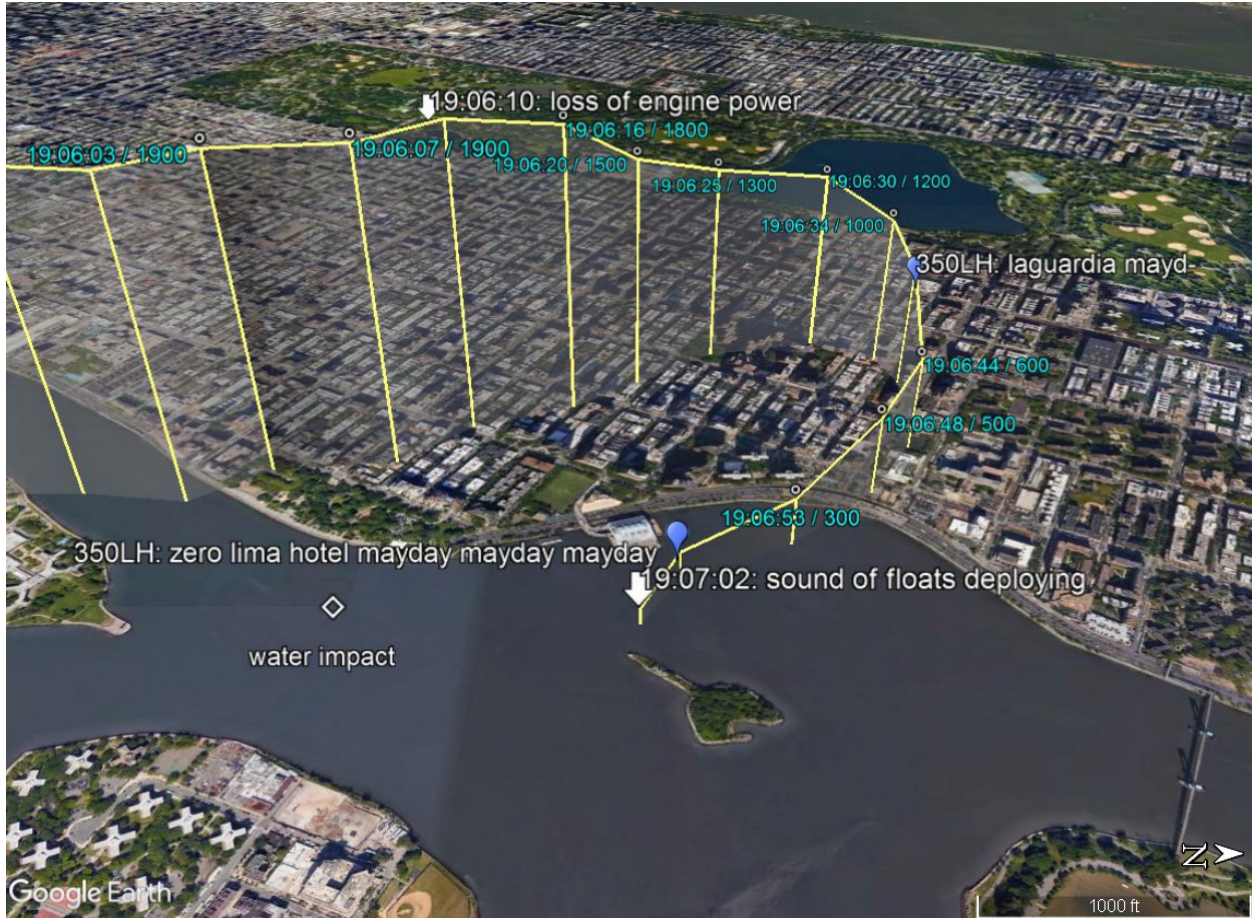
Figure 5. Radar track with selected ATC and GoPro events.

The time between the loss of engine power and the first attempt at a mayday call is 30 seconds. During this time the aircraft had descended 1,100 ft and was turning towards the East River (Figure 5). The full mayday call occurred over the river just before the floats were deployed. The pilot replied twice to ATC “east river engine failure” just before and as the aircraft flared for landing.

Figure 5 does not show events between the floats deploying and the water impact because they have only been located in time and cannot be accurately placed on a map as the aircraft's flightpath is uncertain.

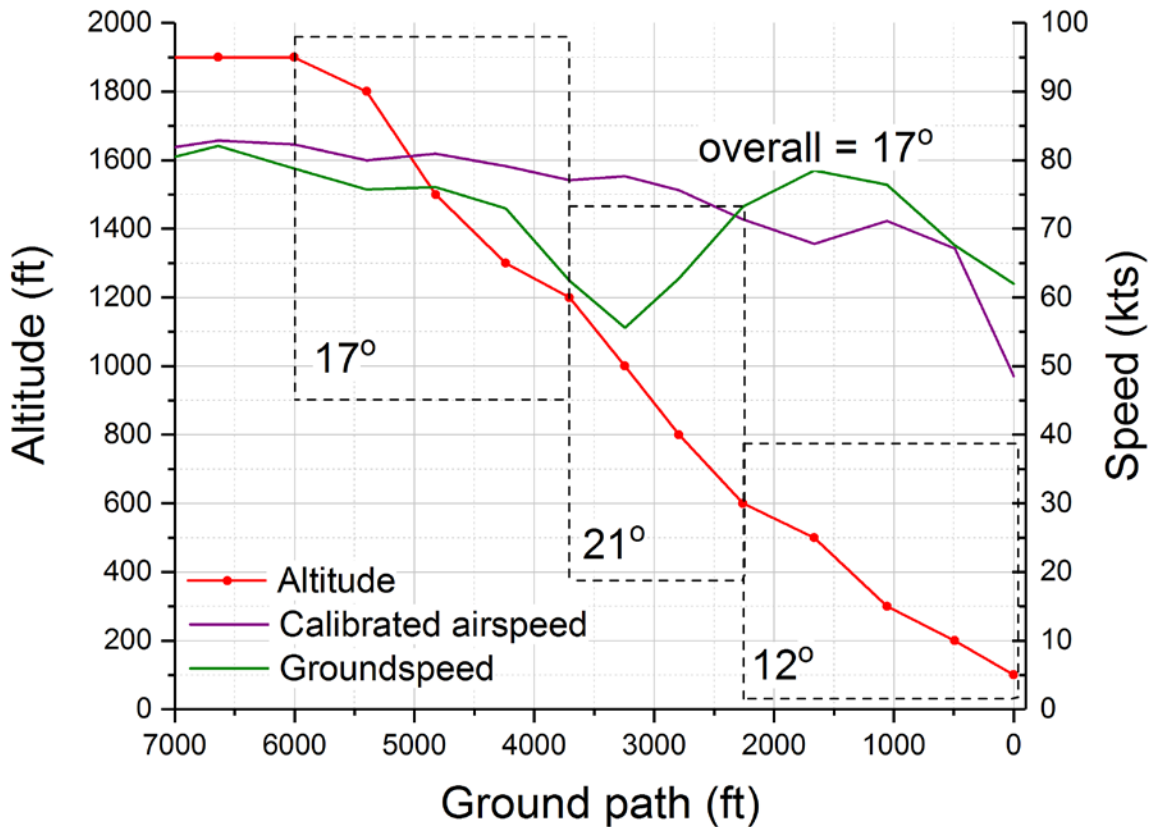
Figure 6. Aircraft altitude and calculated ground path distance, with descent angles.

The flight manual for the AS 350 B2 [5] states that the glide distance in autorotation is 0.54 NM per 1000 ft at an indicated airspeed of 65 kts and a rotor speed of 410 rpm. These values are equivalent to a descent angle of about 17°. Figure 6 shows that the helicopter on average achieved the glide distance specified in the manual. Including the distance between the final radar point and the water impact location, the helicopter travelled over 1 NM while descending 1900 ft. This is consistent with the manual stated performance.

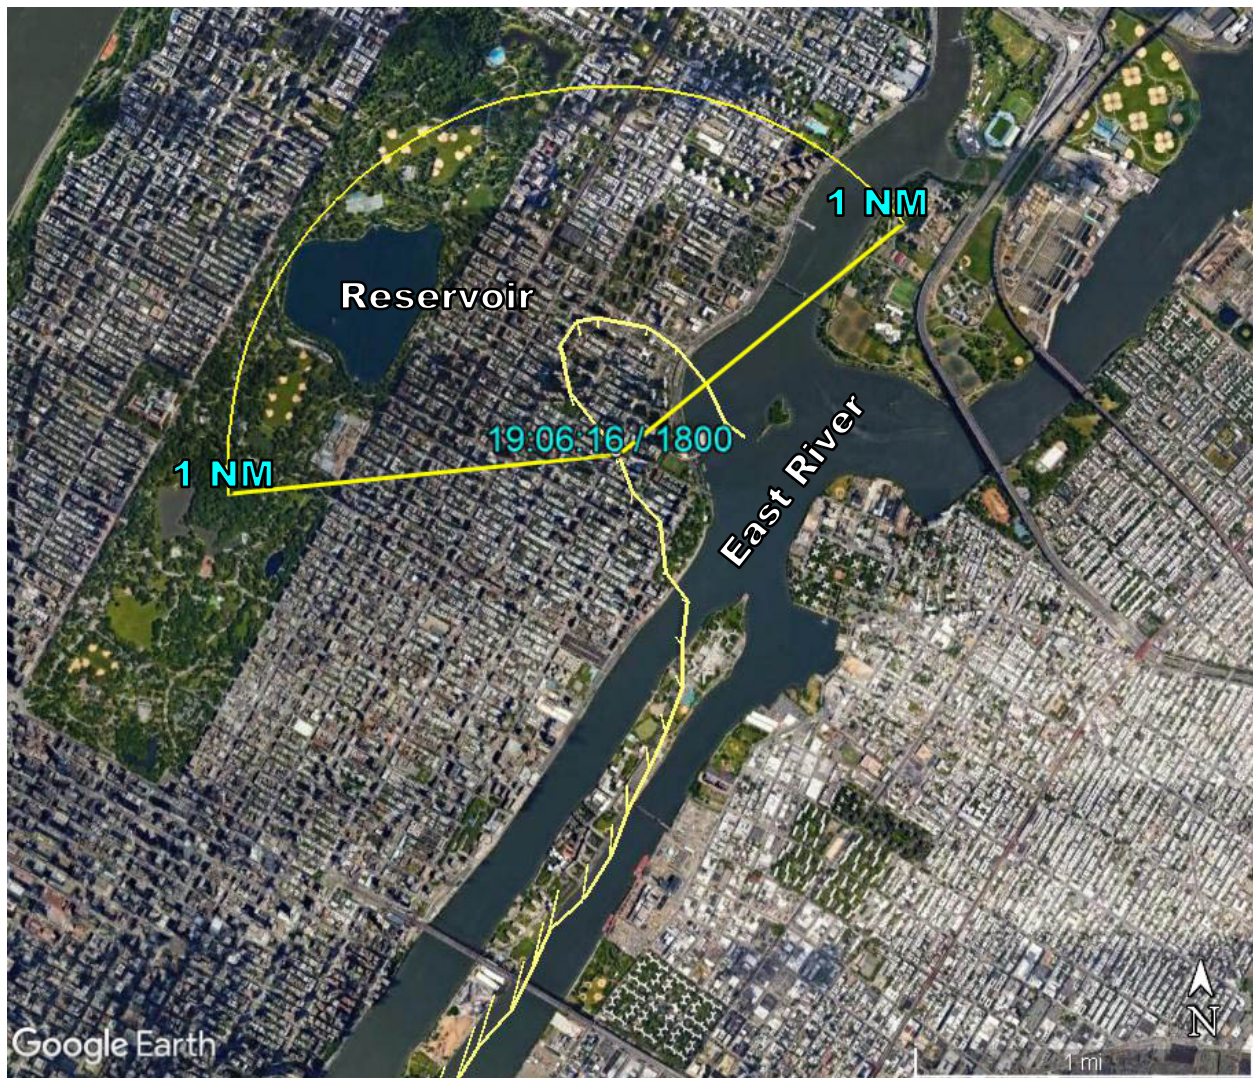
Figure 7. 1 NM of glide distance from 19:06:16, just after the helicopter began losing altitude.

The glide distance specified by the manual and achieved by the accident helicopter dictates that at 1800 ft of altitude, the aircraft had about one NM of range. Figure 7 shows an arc of one NM from 19:06:16, assuming a straight line of travel. At this point, the reservoir¹ in Central Park and the East River are both within the glide distance of the helicopter. The reservoir is 40 ft deep and does not permit boating².

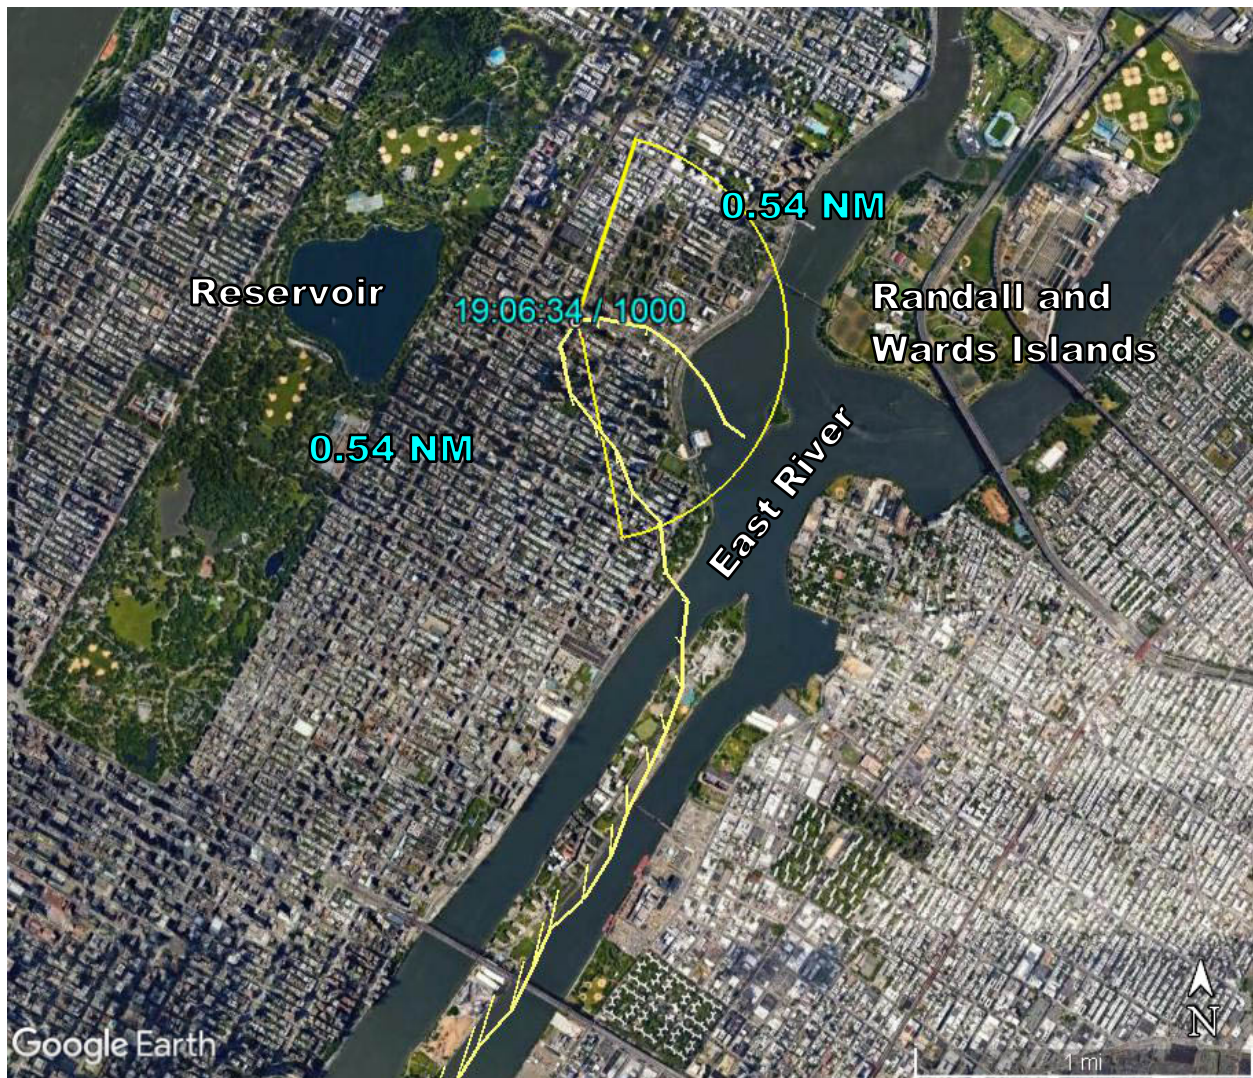
Figure 8. 0.54 NM of glide distance from 19:06:34, as the helicopter turned towards the river.

At 19:06:34 the helicopter was at 1,000 ft and halfway through its turn towards the East River. Figure 8 shows an arc of the 0.54 NM range in autorotation. The playing fields on Randall and Wards Islands were no longer in range of the flight manual's stated glide distance.
