National Transportation Safety Board
Office of Research and Engineering
Washington, D.C. 20594

Performance Study

Location: Frisco, Colorado
Date: July 3, 2015
Time: 1339 MDT
Airplane: Airbus AS350 B3E, N390LG
NTSB Number: CEN15MA290

Performance Study
CEN15MA290, Airbus AS350 B3e, N390LG

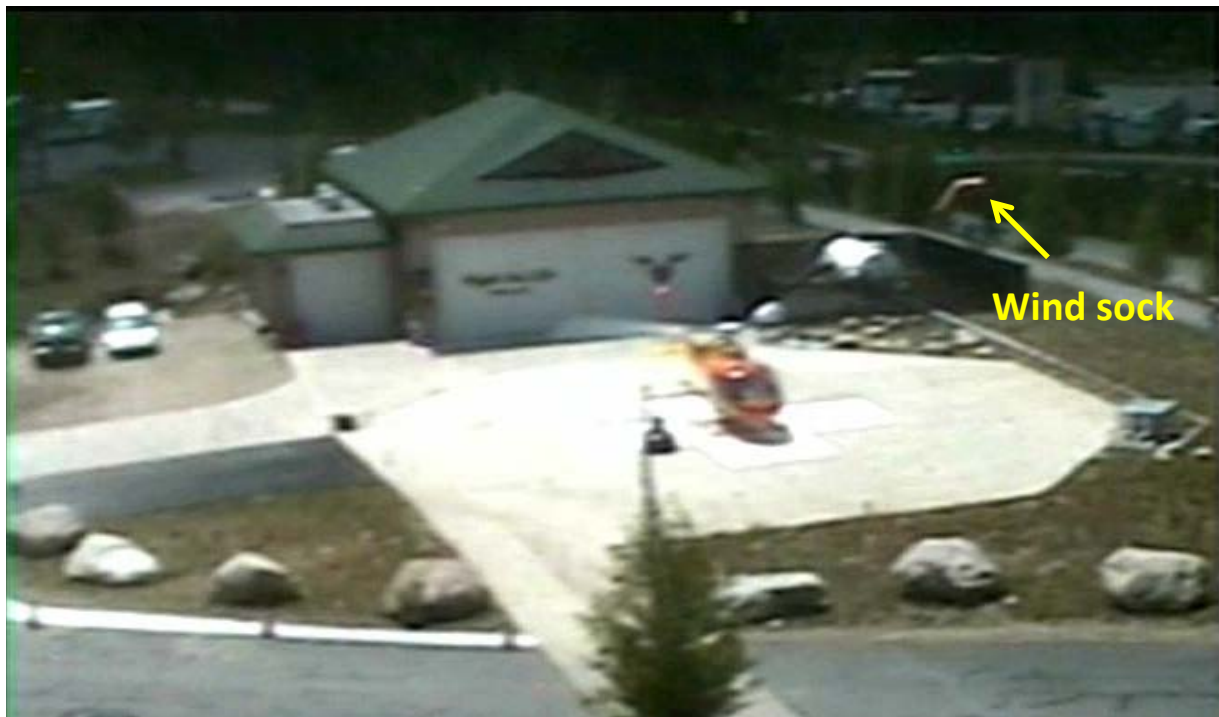
Data for the performance study came from security camera footage of the Flight for Life helipad. The camera recorded an average of 12 frames per second and recorded the helicopter's takeoff and the motion of a windsock at the site. Figure 1 shows a frame of video from the camera just before the aircraft took off. The wind sock is marked in yellow.

Figure 1. Aircraft prior to take-off.

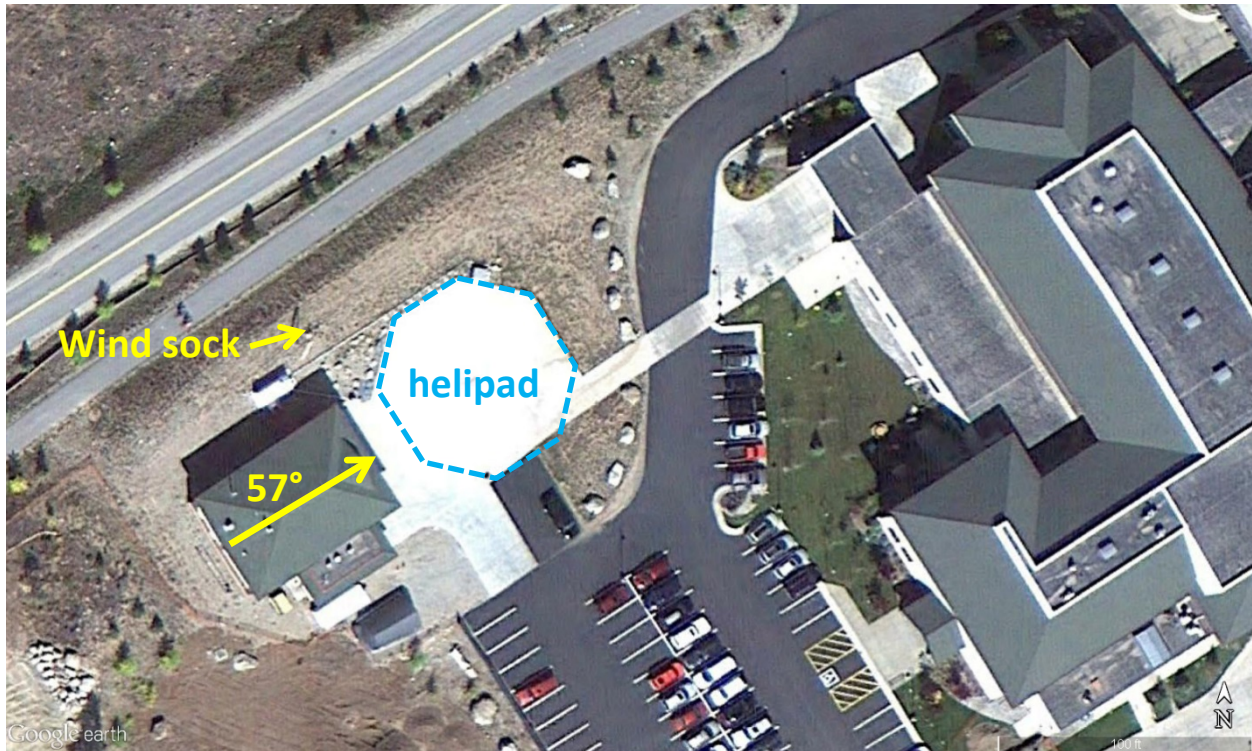
Figure 2 shows an overhead view of the helipad. The roof-line of the building behind the helicopter is along a heading of 57°. The helicopter initially seemed to be aligned with the

building. The wind sock position indicates the wind was coming from the aircraft's left, though the exact speed and direction of the wind was difficult to determine.

Figure 2. Overhead view of helipad.

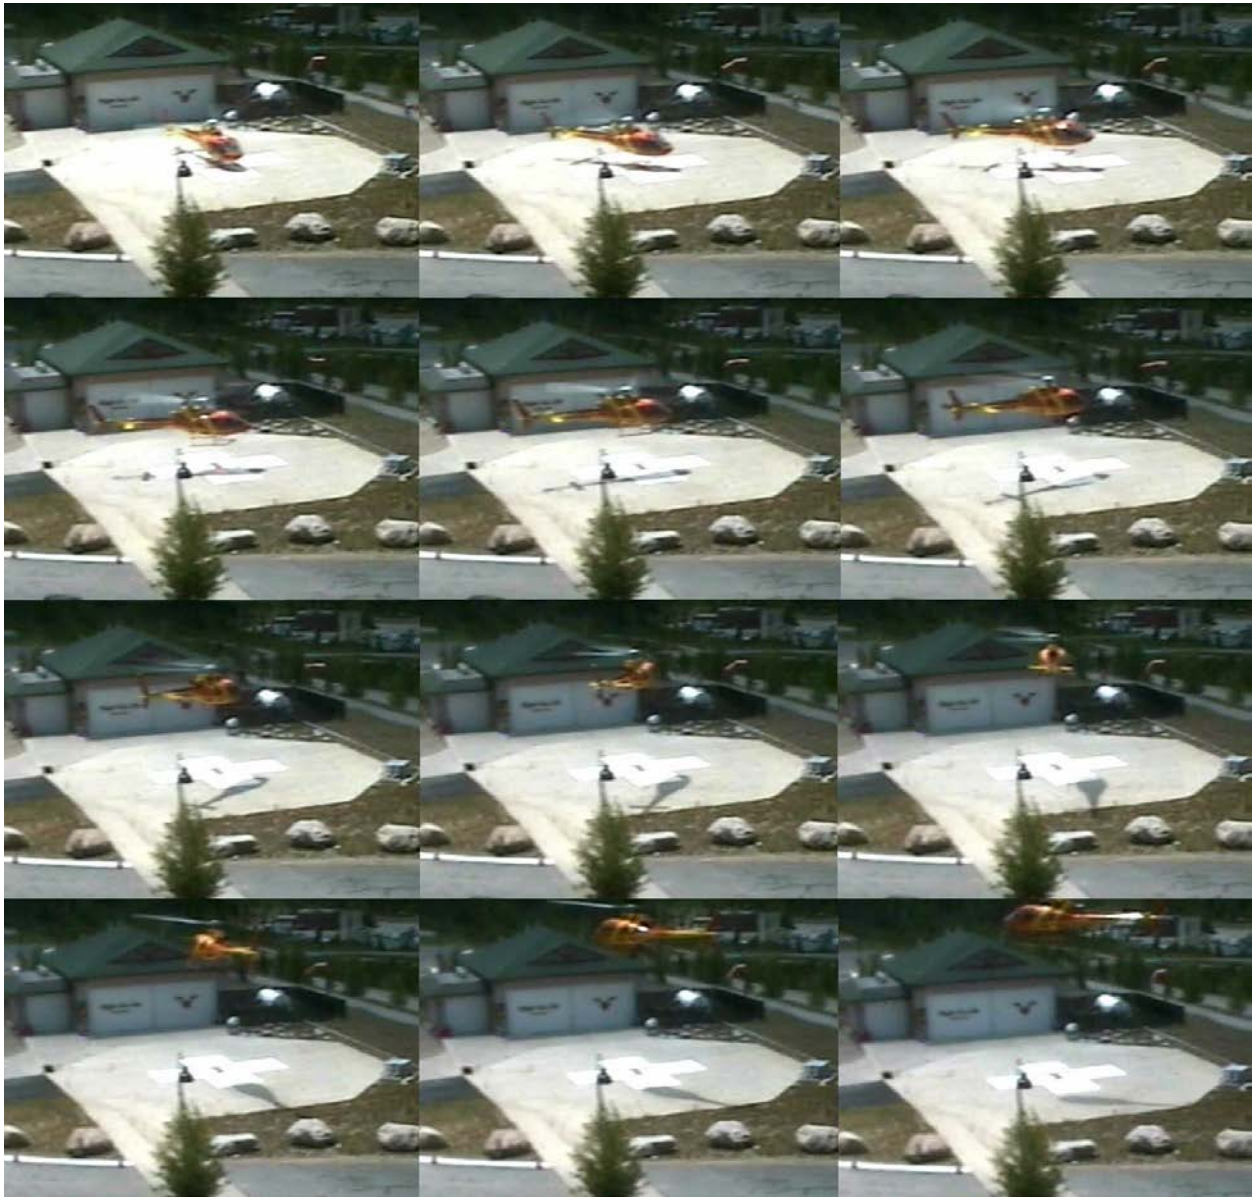
The image of the helicopter remains steady until the aircraft, without an appreciable change in altitude, begins to yaw to the left. Figure 3 shows the complete helicopter take-off sequence from first movement until just out of the video frame. The Video Study estimated the average yaw rate for the first eight seconds after takeoff was 22 deg/s and it increased to 45 deg/s as the aircraft gained altitude. The aircraft's estimated vertical speed shortly after takeoff was 5.6 ft/s [2].

Figure 3. Helicopter take-off sequence.

The aircraft climbed while rotating to the left until out of the frame of the video. Approximately 23 seconds later the helicopter can be seen descending in the top left corner of the camera frame. The aircraft subsequently impacted the parking lot surface and caught on fire.

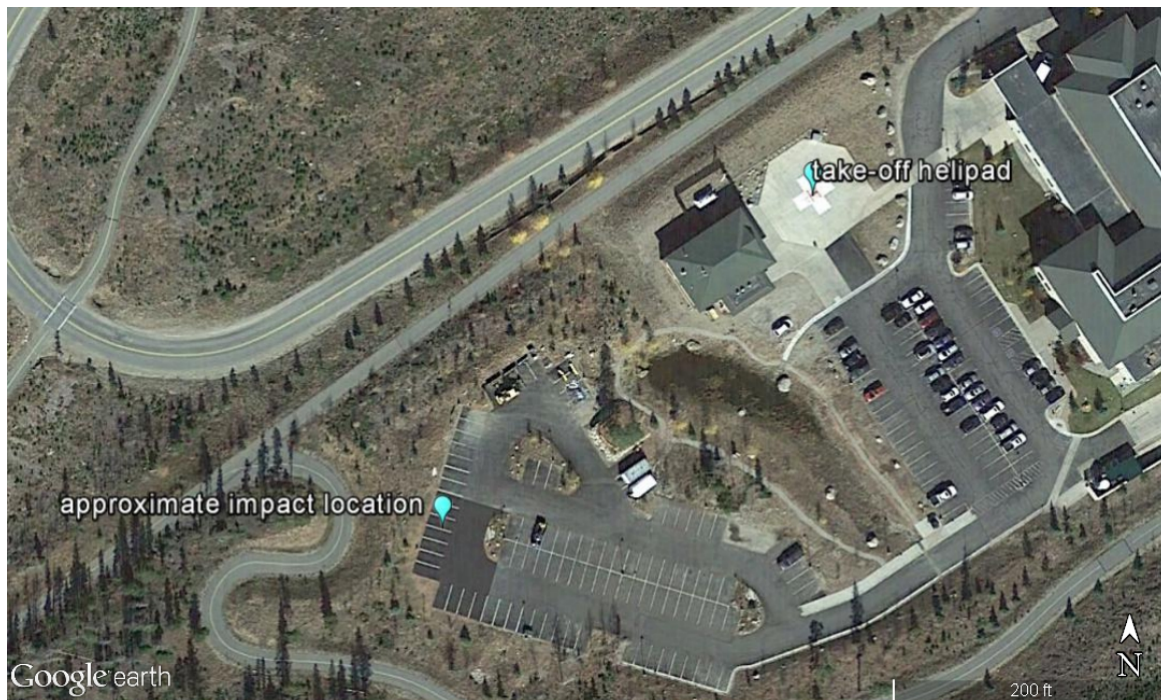
The parking lot the helicopter crashed in was approximately 350 ft to the southwest of the helipad (see Figure 4) and was covered by another video camera. The video from that camera was also evaluated in the Video Study. In the study, the aircraft was described as “undergoing 3D translation and rotation with the rotor spinning” as it impacted the ground.

Figure 4. Helicopter take-off helipad and approximate impact location.

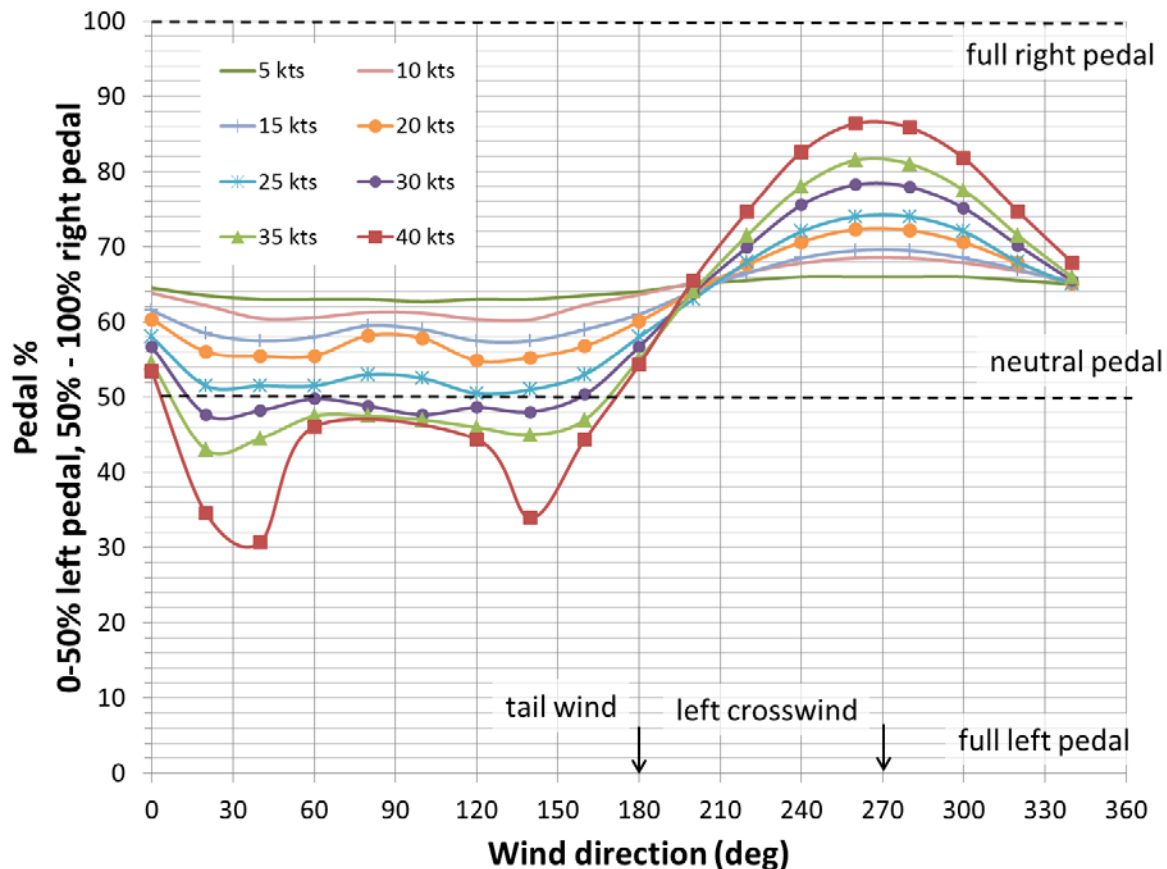
The main rotor of an Airbus helicopter turns in a clockwise direction and imparts a left yaw on the aircraft. A wind from the aircraft's left would exacerbate this left yaw tendency and require more right pedal to keep the aircraft's heading constant. The FlightLab helicopter simulation tool¹ was used to model the pedal required to hold the aircraft steady for different wind magnitudes and azimuths. The simulations were of an AS350 with a gross weight of 4,720 lbs at an elevation of 9,042 ft on a 73°F day to match the accident event. The simulation was run in ground effect (< 15 feet above ground) for wind magnitudes of 5, 10, 15, 20, 25, 30, 35, and 40 kts at every 20° of azimuth (see Figure 5). Pedal input was reported in percentages: 0% for full left pedal, 50% for neutral/no input, and 100% for full right pedal. The result was that wind directly from the aircraft's left side required the greatest amount of right pedal to hold the aircraft's heading constant. For 15 kts of wind 67.5% pedal (right pedal depressed about 1/3rd) was needed to maintain heading. For 35 kts just less than 80% pedal was required (right pedal depressed 2/3rds of the way).

Figure 5. FlightLab simulation of AS350 helicopter. The figure shows pedal input for the aircraft to hold a steady 0° heading in varying winds in ground effect.

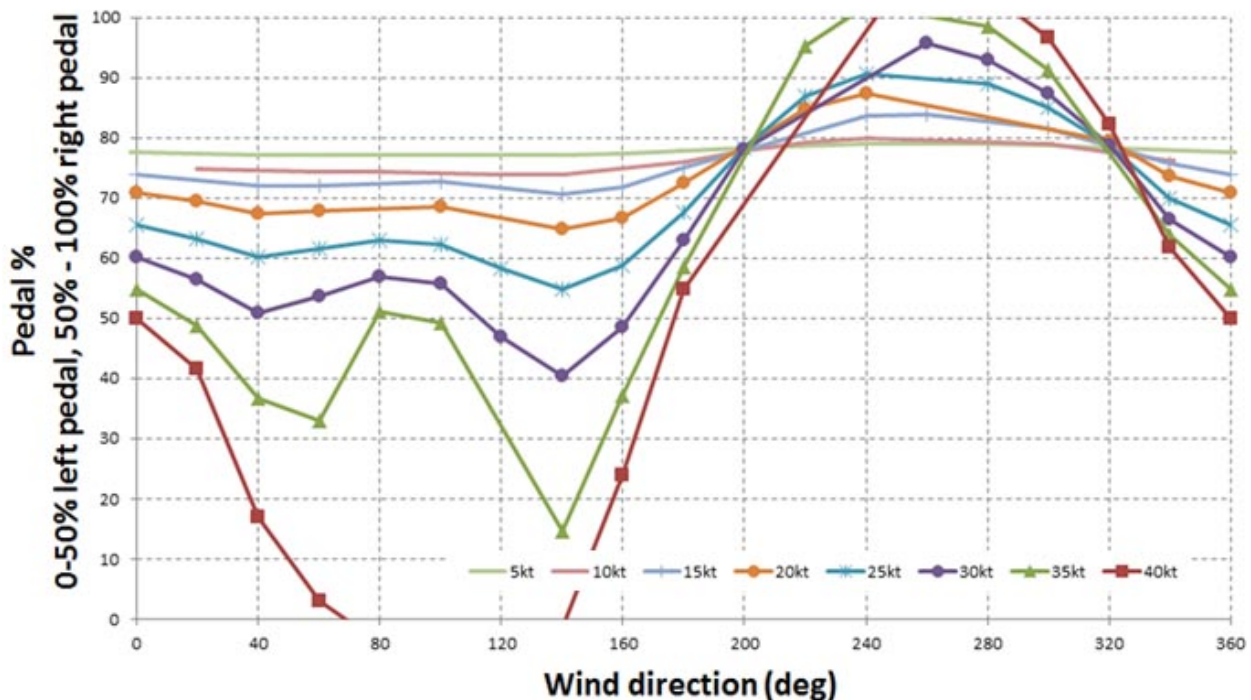
Airbus Helicopter also performed a simulation of the AS 350 B3e for different wind speeds and azimuths for the specific condition of the day of the accident (Figure 6). In no wind, 78% pedal is needed to hold the aircraft on a steady heading while in ground effect. In a 15 kts left crosswind, 83% pedal was needed to hold the aircraft on a steady heading. The Airbus simulation showed the aircraft had adequate tail rotor authority through the pedals to maintain its heading in a 30 kts crosswind. The results shown in Figure 6 are from a computer simulation of the aircraft and should not be considered definitive performance data.

Figure 6. Airbus simulation of AS350 helicopter. Shows pedal input for aircraft to hold a steady 0° heading in varying winds.

Both simulations agreed that at the accident altitude, temperature, and aircraft weight, there should be enough tail rotor authority to counteract the yaw imparted by a left crosswind of up to 30 kts.

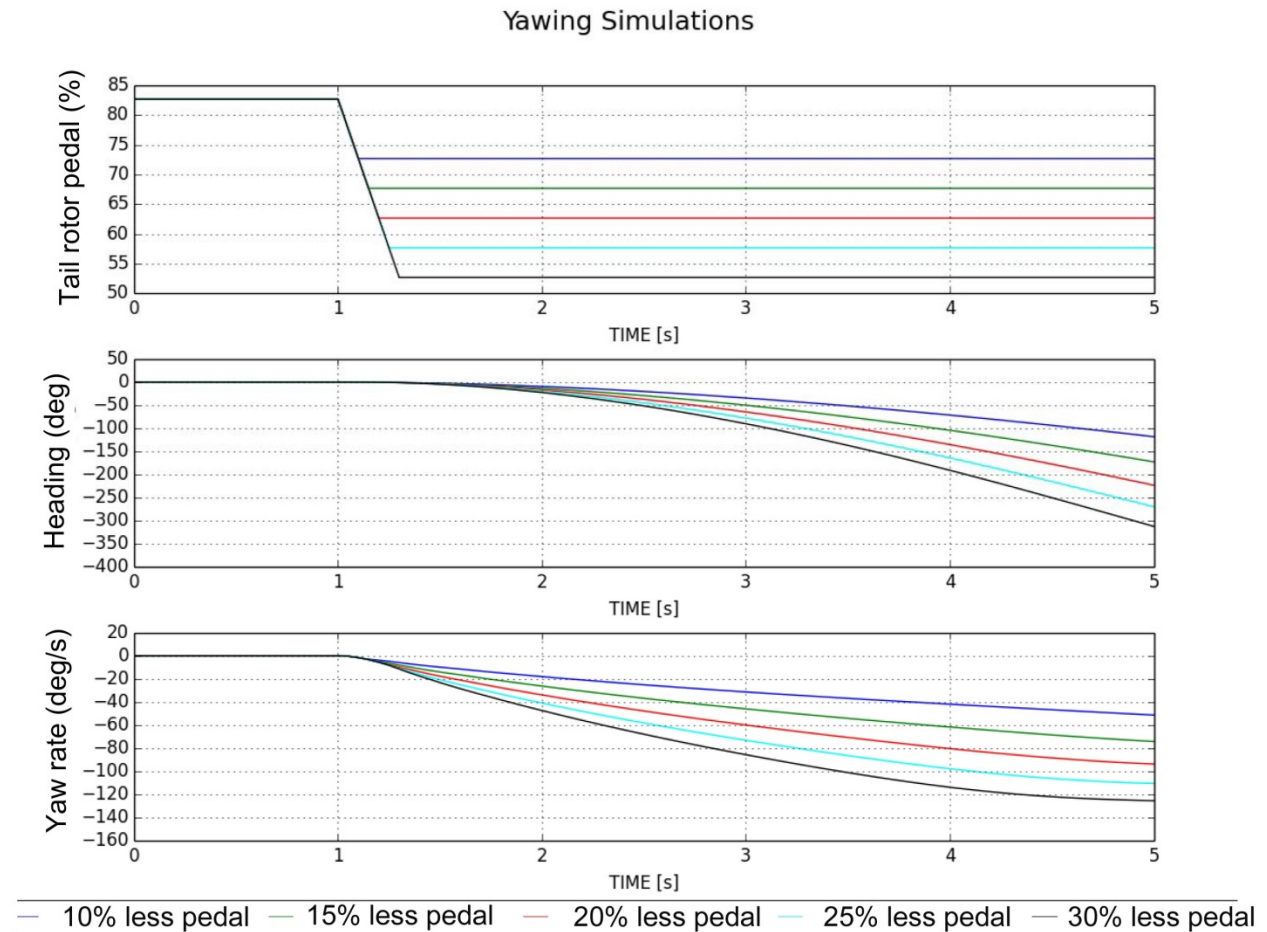
crosswind and the accident configuration, which as discussed earlier required 83% pedal to hold a steady heading. In Figure 7, the pedal input was released the prescribed amount at the one (1) second mark. Four seconds after the reduction in pedal the yaw rates were approximately 50 deg/s (10% reduction in pedal), 75 deg/s (15% reduction), 95 deg/s (20% reduction), 110 deg/s (25% reduction), and 125 deg/s (30% reduction in pedal input). Note this simulation may overestimate the yaw rate because it uses a simplified model and does not account for the aerodynamic effects of the tail fin at given angles, the interaction between the tail fin and tail rotor at a given yaw rate, inertial factors, the dampening effects of the tail boom, or wind effects during rotation.

Figure 7. Airbus simulation of AS350 helicopter. Shows resultant heading change and yaw rate when 83% right pedal is reduced by 10%, 15%, 20%, 25%, and 30%.

The simulated yaw rates were higher than those for the accident flight calculated in the Video Study. For further comparison, a similar video study was performed on a different accident involving an AS350 in Albuquerque, New Mexico (CEN14FA193 [4]). The pilot, who survived the accident, reported that the pedals were jammed or locked in the neutral position and he was unable to apply any countering tail rotor torque. After approximately eight seconds the aircraft's
