National Transportation Safety Board
Office of Research and Engineering
Washington, D.C. 20594

Performance Study

Location: Danbury, Connecticut
Date: August 21, 2015
Time: 1420 EDT
Airplane: ECLIPSE AVIATION CORP EA500, N120EA
NTSB Number: ERA15LA322

Performance Study
ERA15LA322, ECLIPSE AVIATION CORP EA500, N120EA

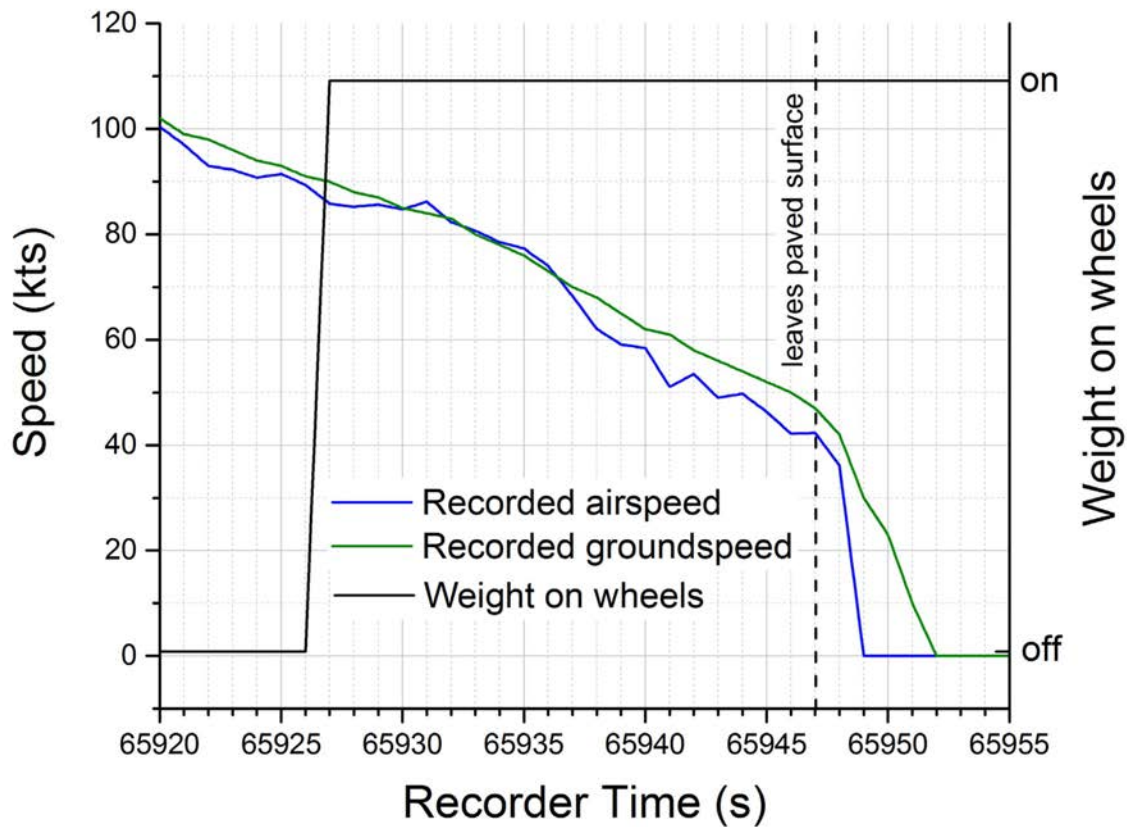
In the accident landing, the airplane touched down at an airspeed of 88 kts and a groundspeed of 90 kts (Figure 1). Recorder time at touchdown was 65926 seconds. The airplane left the paved surface of the runway at 65947 s. The groundspeed slowed to zero by 65952 s.

Figure 1. Recorded speeds and weight on wheels versus time.

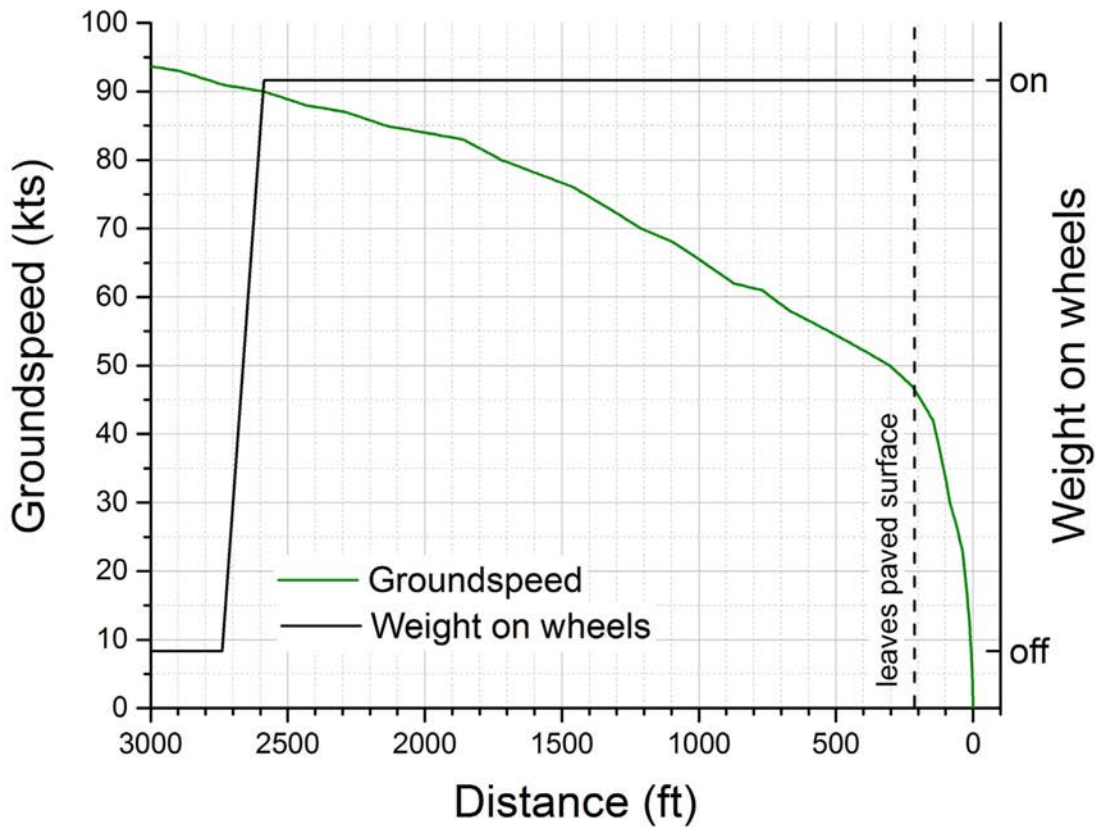
Recorded groundspeed was integrated with respect to time to determine the distance traveled between when the aircraft came to a stop and touchdown. Figure 2 shows the calculated distance traveled by the airplane. Weight on wheels occurred about 2600 ft from the final resting point of the airplane.

Figure 2. Groundspeed and weight on wheels versus integrated distance traveled.

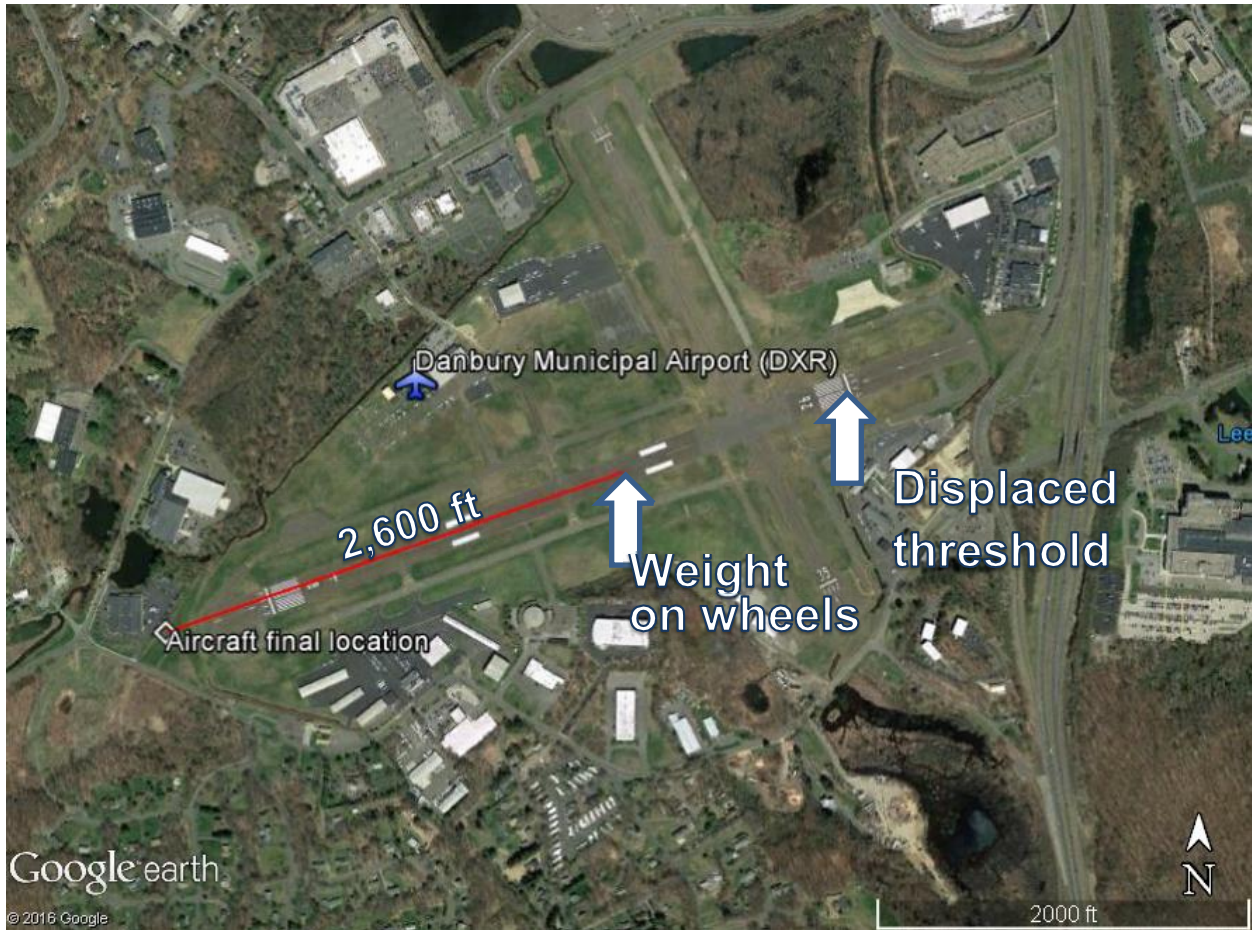
Figure 3 shows the Danbury Municipal Airport and a red line 2,600 ft long extending from the aircraft’s final location to a point on the runway corresponding with weight on wheels. Runway 26 is 3,680 from the displaced threshold to the end of the paved surface¹. The airplane touched down about 1,280 ft from the displaced threshold of runway 26². The distance from the touchdown point to the end of the paved surface was about 2,400 ft.

Figure 3. Groundspeed and weight on wheels versus integrated distance traveled.

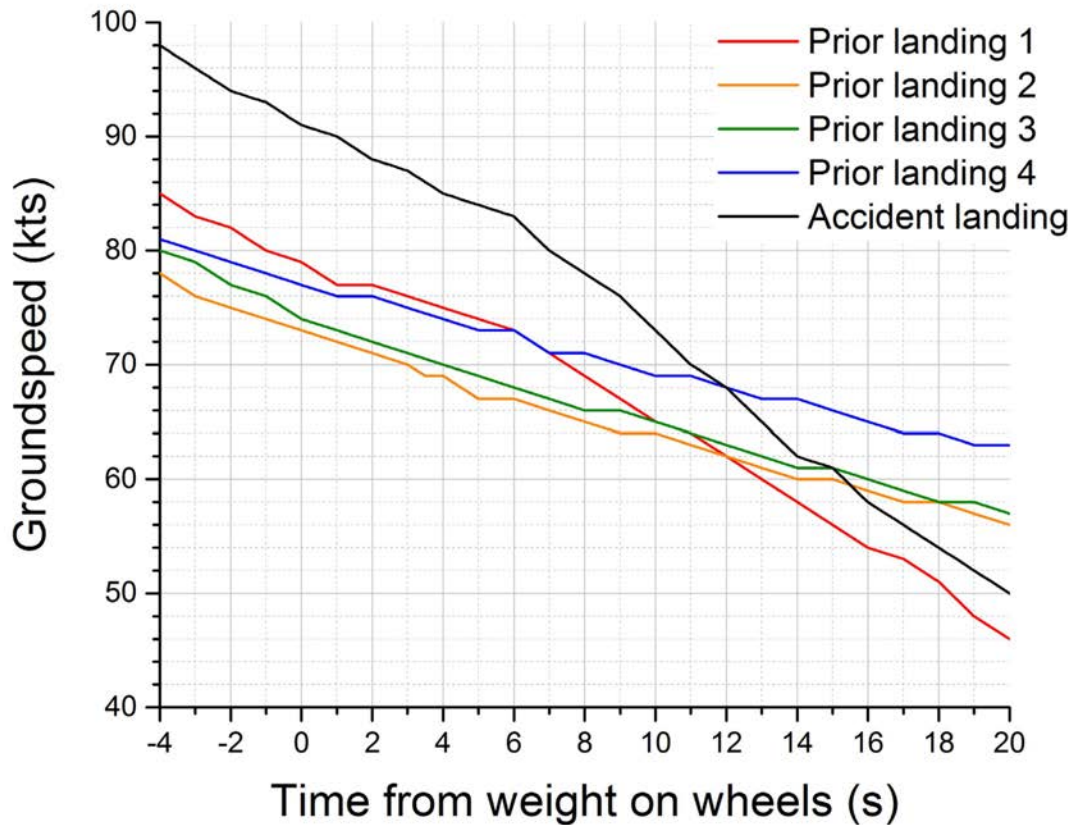
The groundspeeds from four prior landings are shown in Figure 4 along with the accident landing. The accident landing's touchdown groundspeed was 91 kts while the four prior landings touchdown speeds were between 73 and 79 kts.

Figure 4. Groundspeed versus time for the accident landing and four prior landings.

The accident landing's deceleration rate was 2.2 kts/s (0.12 g's) for the first 20 s after touchdown, all of which was on the paved runway surface. Prior landing 1's deceleration rate was 1.7 kts/s (0.09 g's) and the average deceleration rate for prior landings 2, 3, and 4 was 0.8 kts/s (0.04 g's). This indicates that at the time of the accident, the airplane's braking systems were working as well as or better than they were during the prior four landings.
