NATIONAL TRANSPORTATION SAFETY BOARD

Personal Electronic Device

**Specialist's Factual Report
By Bill Tuccio, Ph.D.**

Location: Lee's Summit, Missouri
Date: September 20, 2016
Aircraft: Piper PA-28-235
Registration: N8983W
Operator: TEKO Air LLC
NTSB Number: CEN16FA378

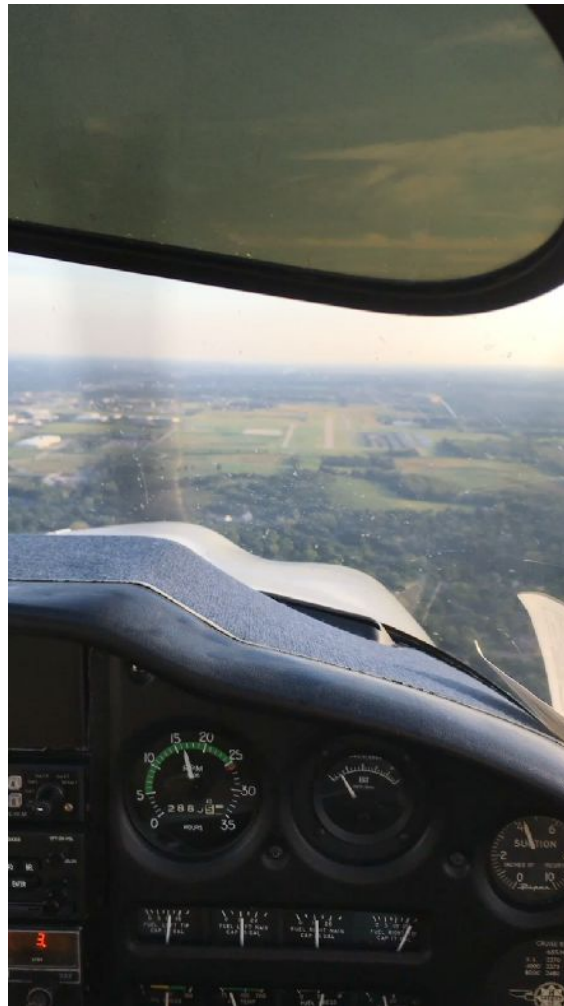
Figure 2. Frame at [00:00:00.0].

[00:00:11.6] The camera angle remained substantially in the same position from [00:00:00.00] until this frame. By this frame, the VASI² on the left side of the runway was indicating white over white. The RPM was indicating 1,600. The audio of the engine remained constant (since [00:00:00.00]) and, starting with this frame, mostly unintelligible radio activity was recorded.

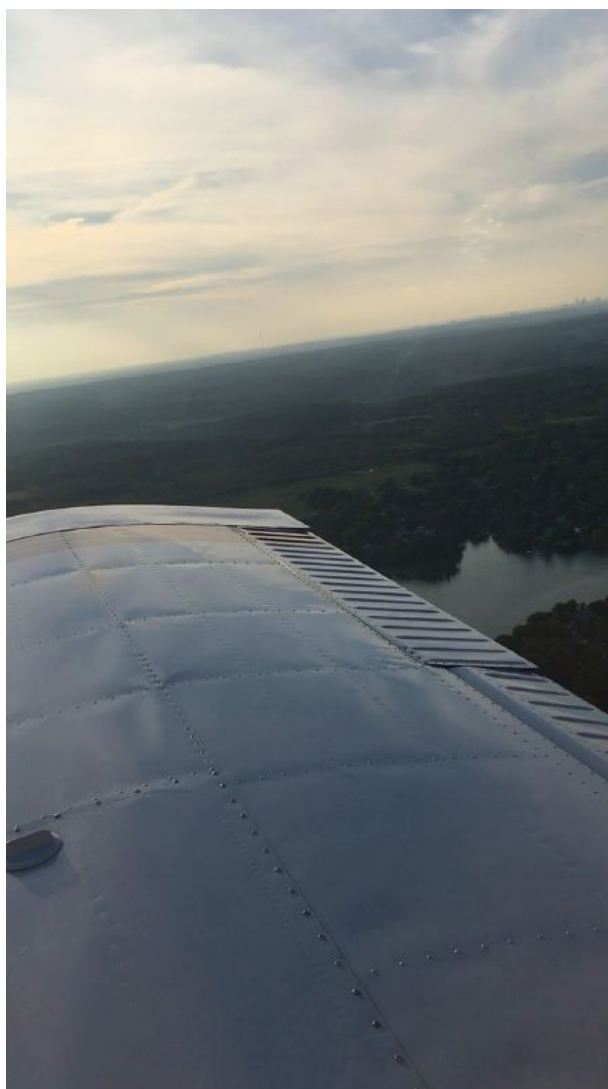
Figure 3. Frame at [00:00:18.6].

[00:00:18.6] Camera panning reached its maximum rightward extent (before panning left and forward), as shown in figure 3. This maximum right-rear angle provided a view of the right wing and outboard portion of the flap. Under the right wing, Lakewood Lakes were observed (these lakes are about 1.5 miles from runway 18 threshold). The right flap was deflected, consistent with the first notch of flaps. During the panning, the inward right fuel tank cap was on and aligned with the wing rib (i.e., wind stream). The right tip tank fuel tank cap was also observed in place. The visibility was greater than 10 miles, with less haze (than the forward-looking view), and a high broken cirrus layer (in the distance, the Kansas City skyline was identifiable) and the sun (observed during panning) was at the 2 o'clock horizontal position from the nose of the plane and about 30 degrees inclination above the horizon; the sun was reflecting off some lakes. The wind effect on the lakes was consistent with a light wind.

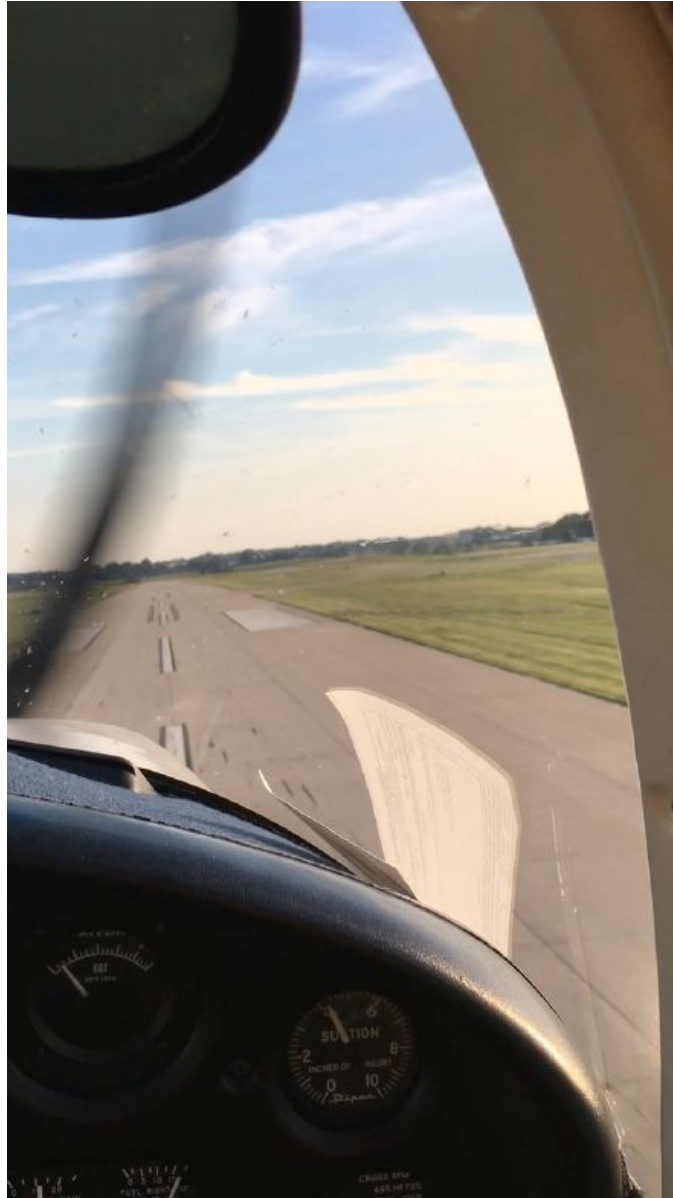
Figure 4. Frame at [00:01:21.9].

[00:01:21.9] The aircraft was close to the runway and in a pitch motion consistent with a flare to landing, as shown in figure 4. The aircraft was laterally over the runway centerline, still airborne, and about 2 centerline runway stripes (markings) before the runway aiming point markings. The engine sound remained consistent from prior descriptions. Right after this frame, the camera began to pan right.
