Carson Helicopters, Inc. is writing to the National Transportation Safety Board regarding the final report and findings of the NTSB on the Sikorsky S61N helicopter crash near Weaverville, California on August 5, 2008. By this letter Carson is hereby filing a Letter of Petition to review the findings in this accident. Carson contends that, A) there is new and additional information regarding contaminants in the fuel system that should be given careful consideration, and B) the Board was not given complete and accurate performance information for review in reaching its findings regarding aircraft flight performance.

**Comparison of four sets of FCU-PRV
Particle Contamination and E-Poly fuel
pump coating**

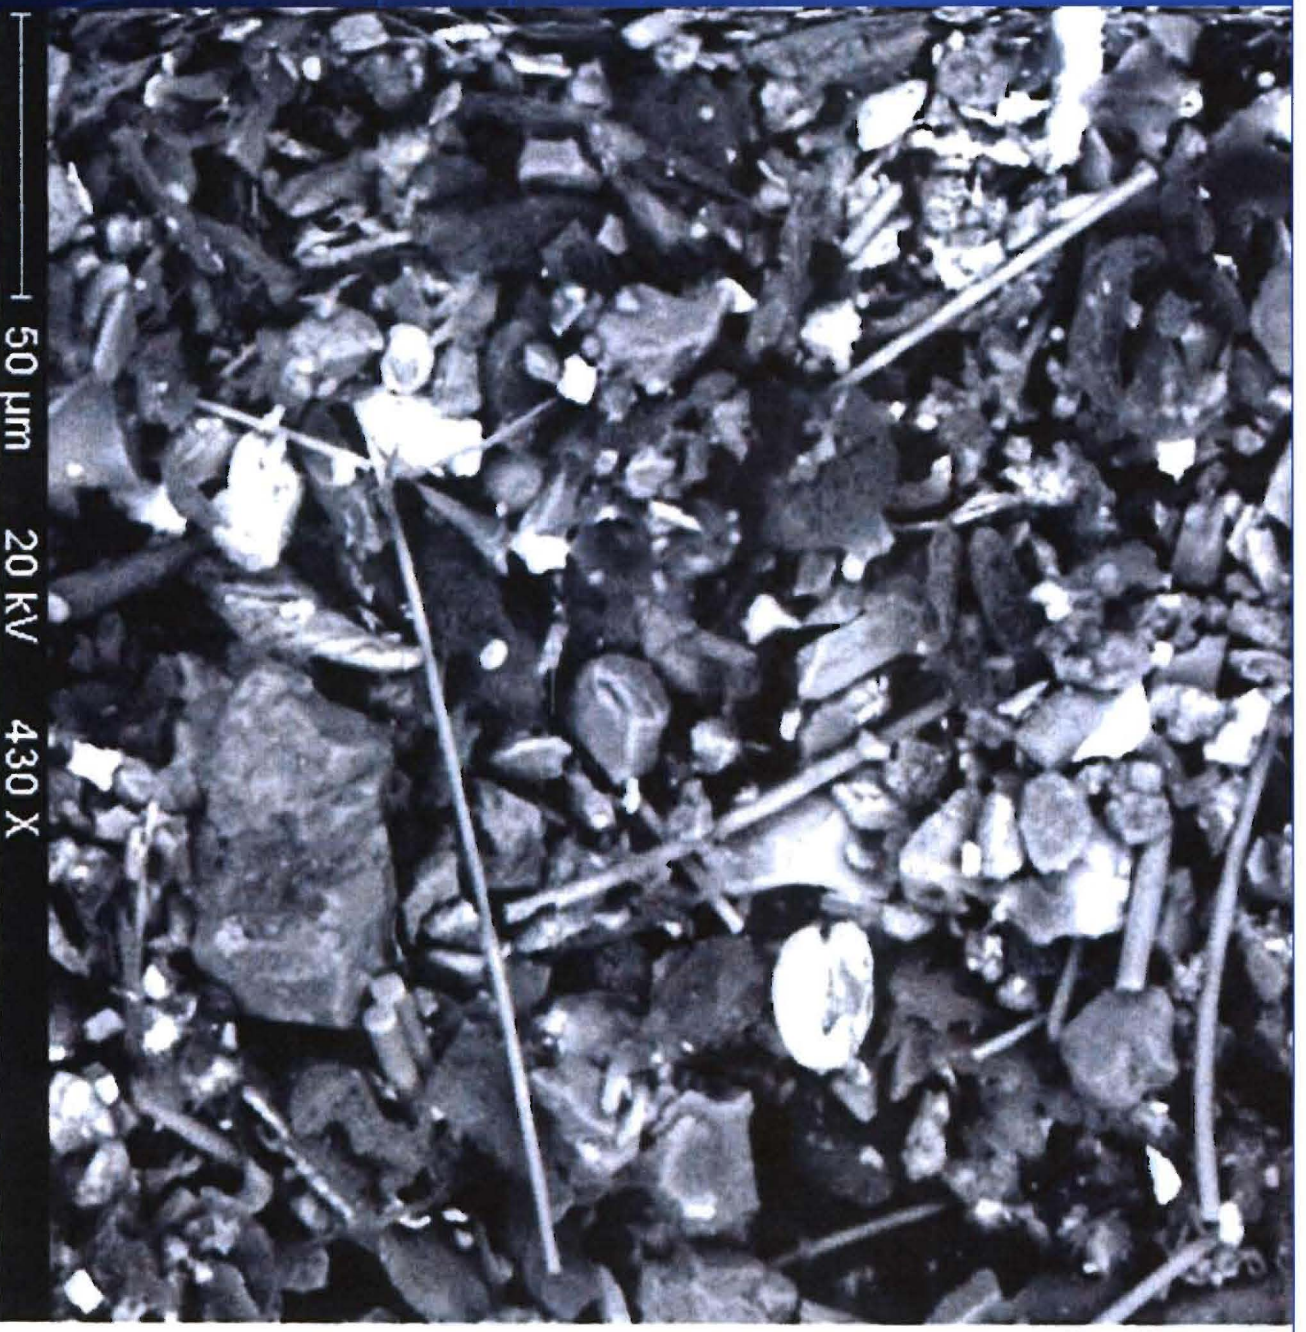
PRV-FCU
Contaminant
2002

Hayes Helicopter
(Canada)

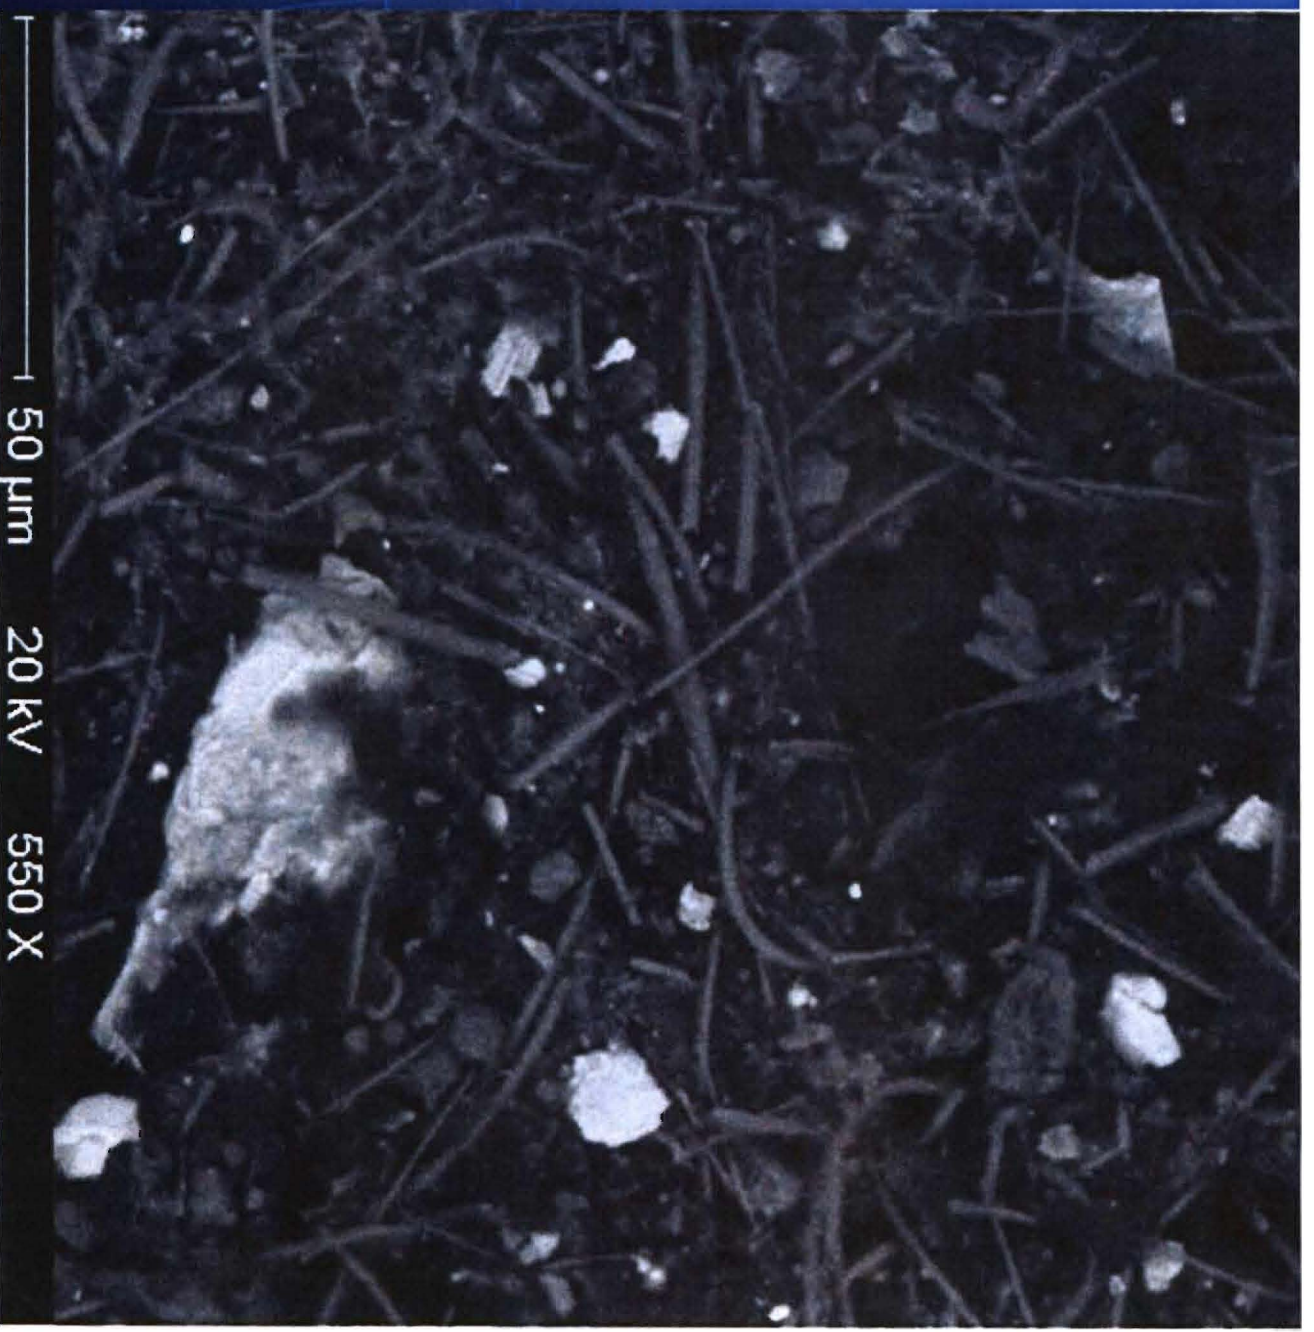
PRV-FCU
Contaminant
2004

Carson
Helicopters

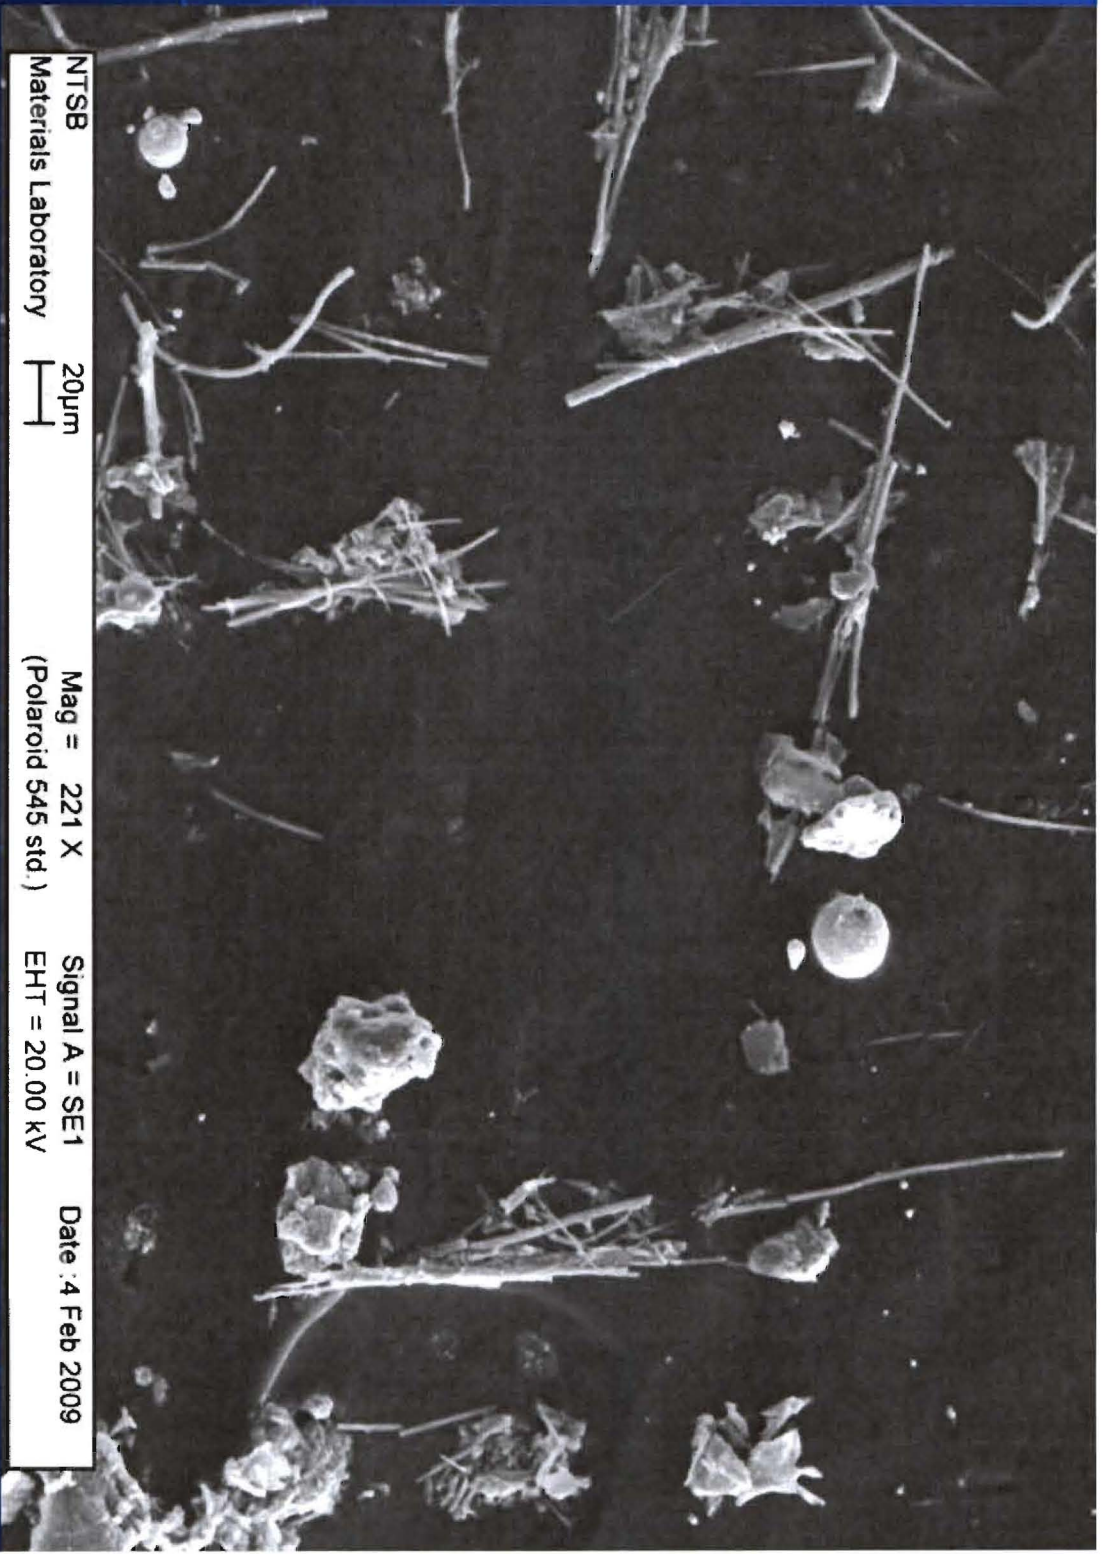
Accident Helicopter N612AZ
from # 2 FCU Filter 221 X

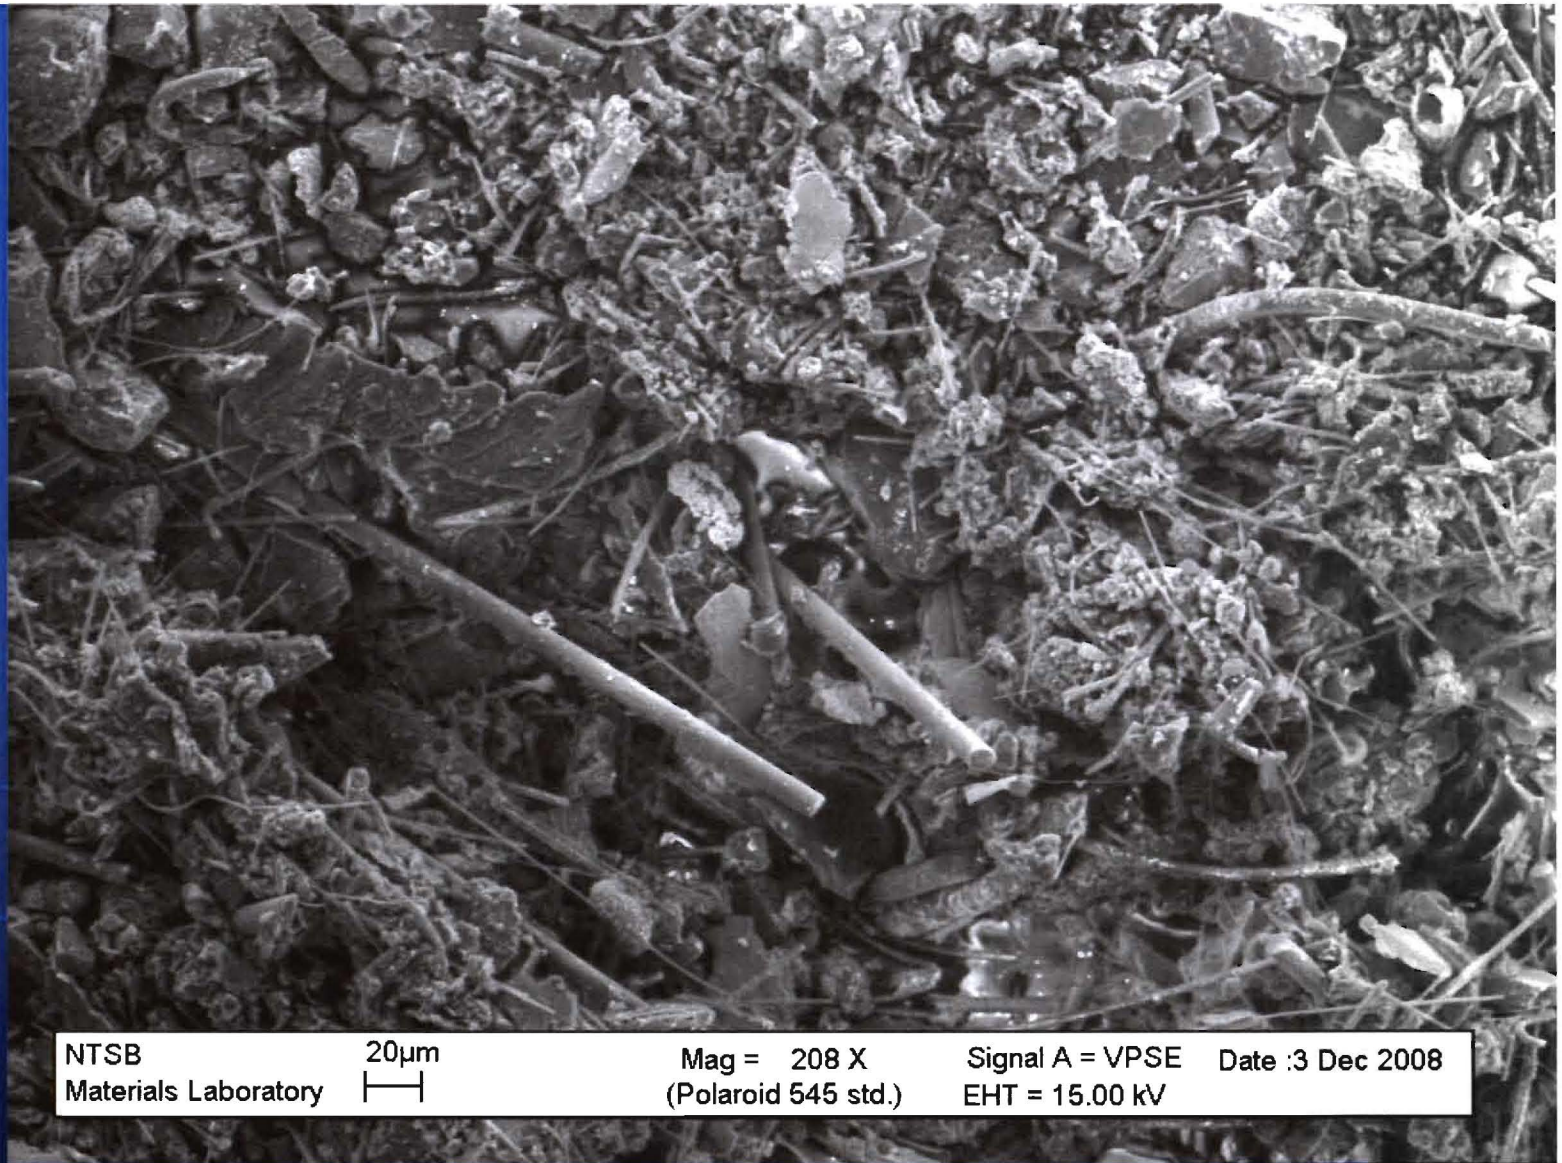
- a. The statement regarding “no other evidence of contamination” is incorrect and contradicted by the Materials Lab report 08-121. The NTSB Materials Lab report in the public docket details how numerous particles were removed from the interior of the PRV assembly when the spool was separated. Figure 14 shows a large quantity of contaminants from the PRV stub.

Accident Helicopter N612AZ # 2 FCU-PRV 208 X

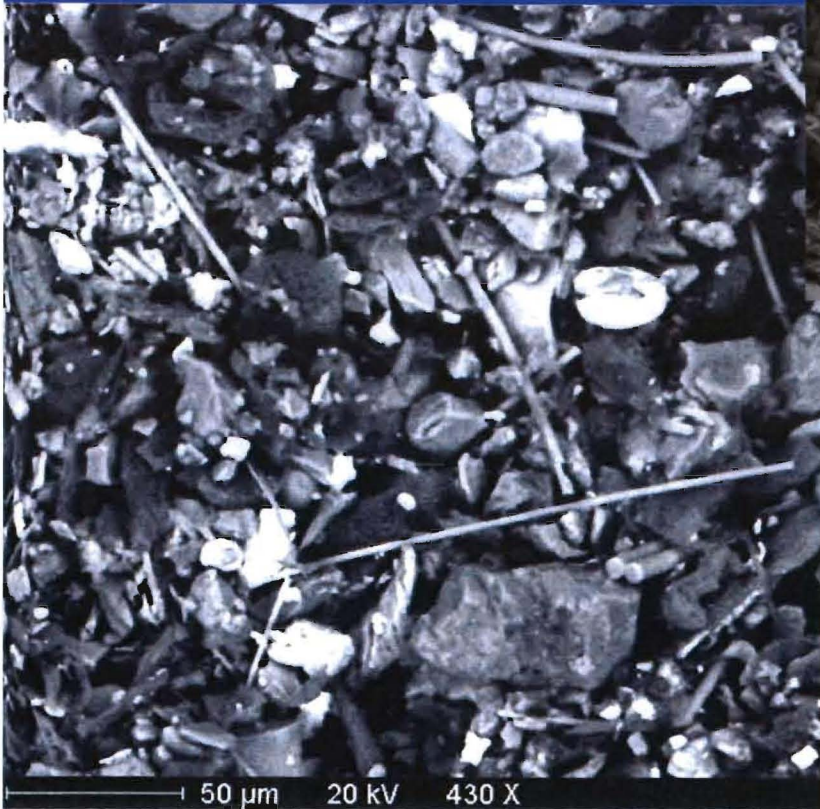
Hayes Helicopter
PRV 430 X

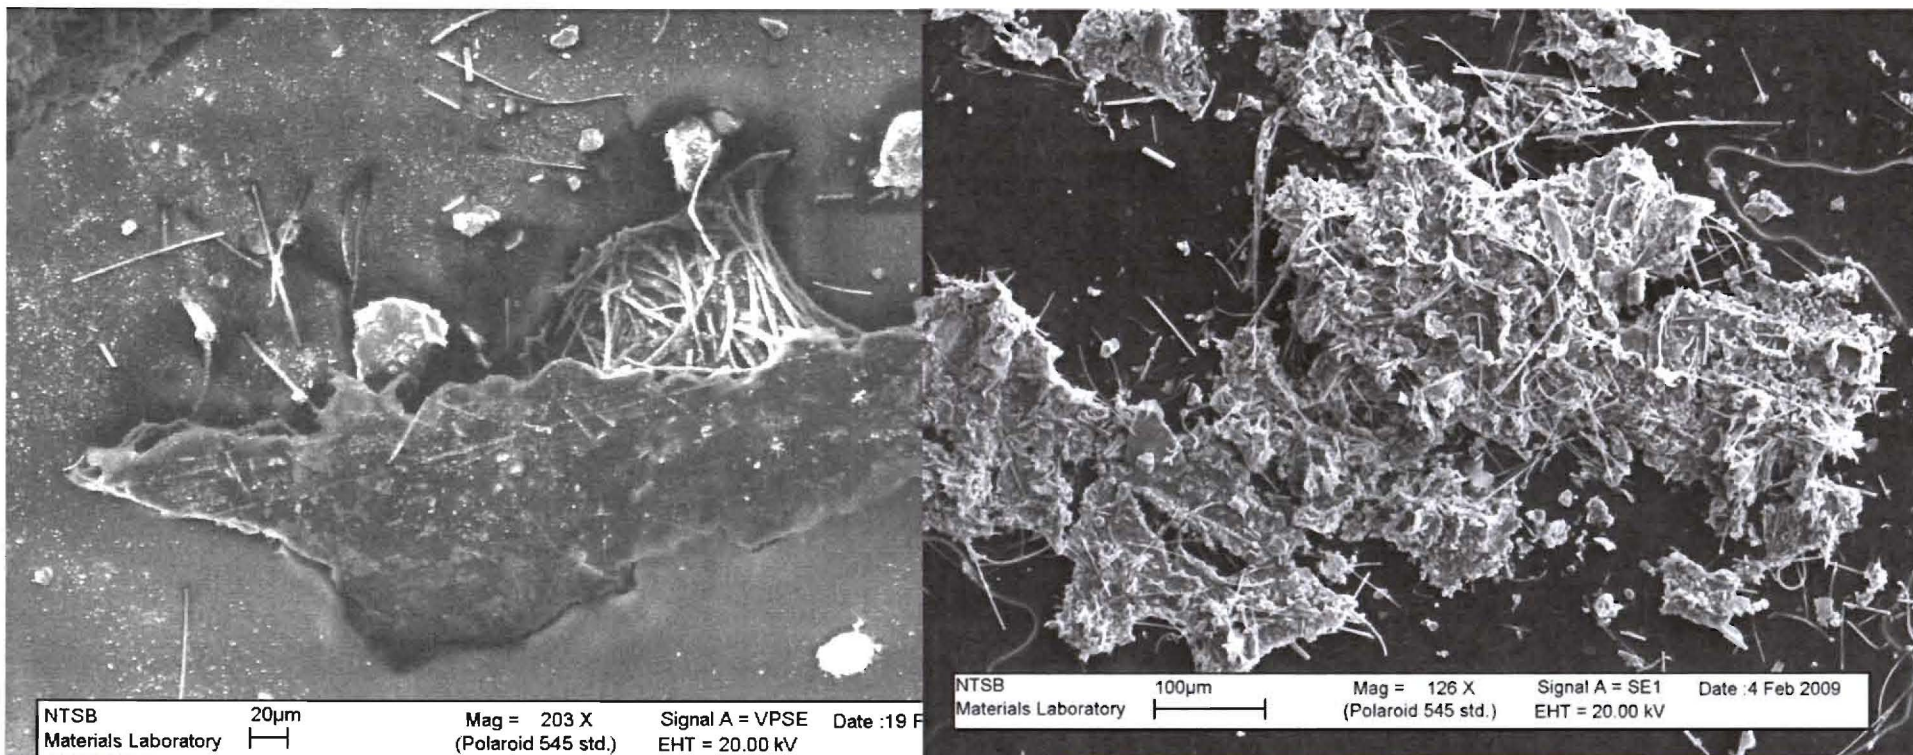
N612AZ #2 PRV – Note irregular flat-backing material on left photo.

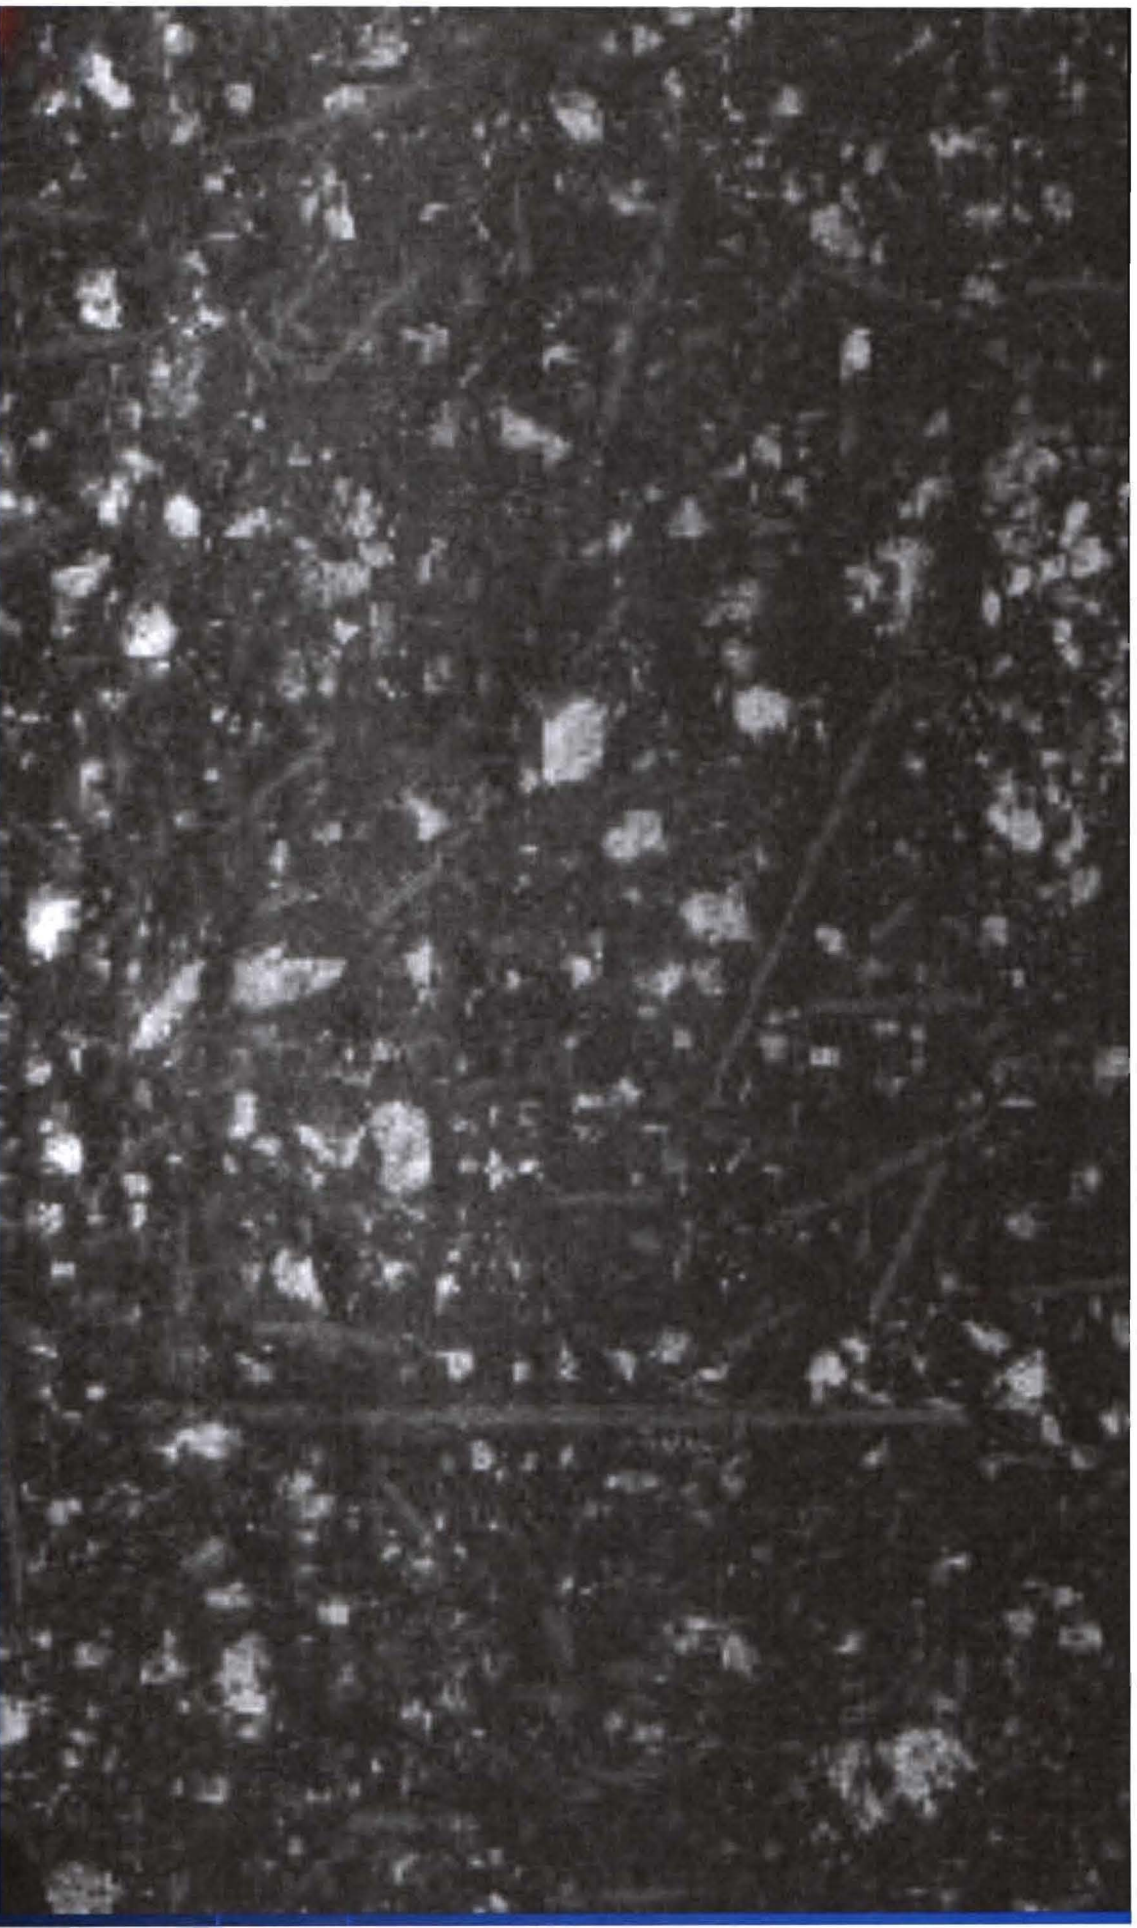
- b. Carson had a section of this coating examined at an independent laboratory via electron microscope and spectral analysis (*see attached photo section*). The coating contains long fiber particles and irregular flat particles that have spectral element peak signatures and physical characteristics that are nearly identical with the particles found in the FCU of N612AZ.

E Poly Coating matrix – Note long straight singular fibers and irregular flat pieces contained in matrix

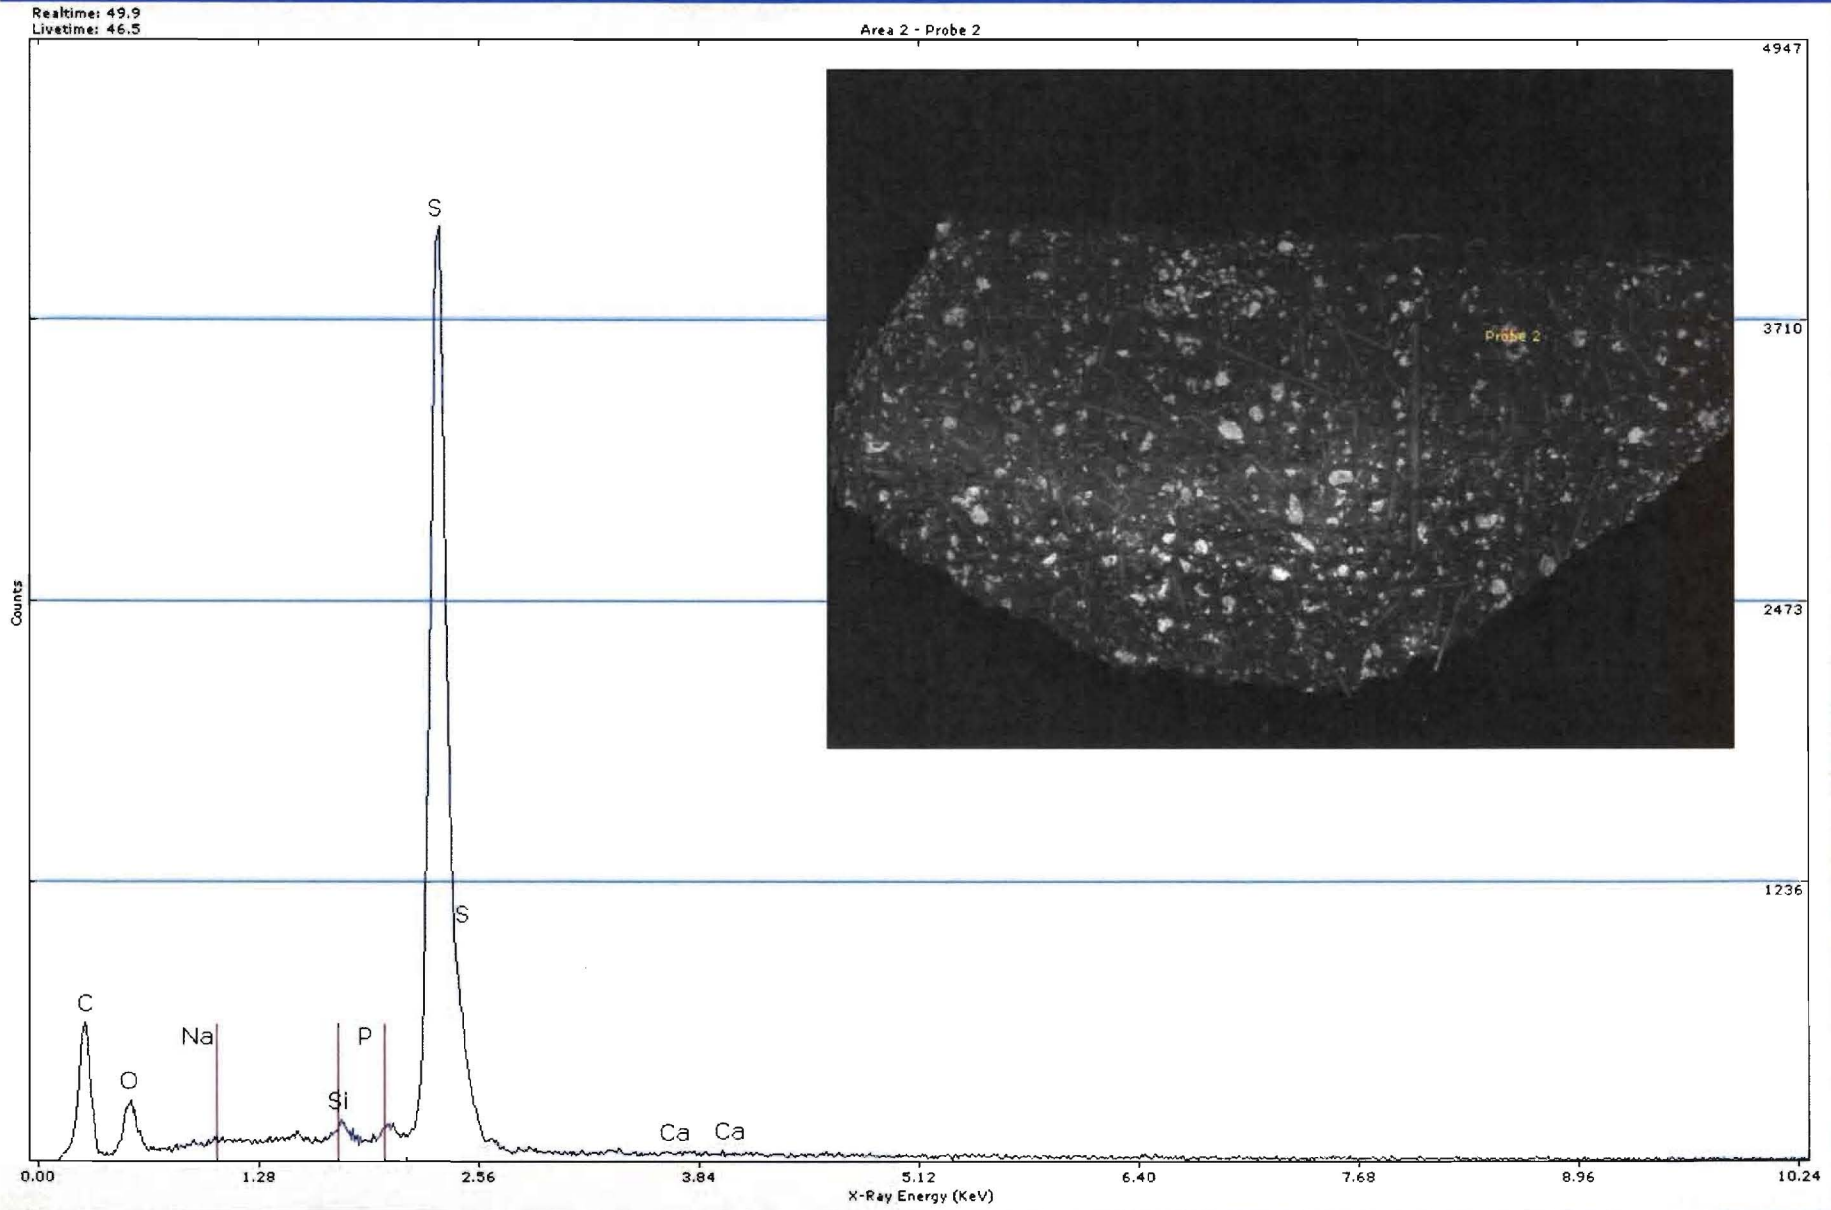
Blow-up scale of long straight fiber from matrix – note ED spectra.

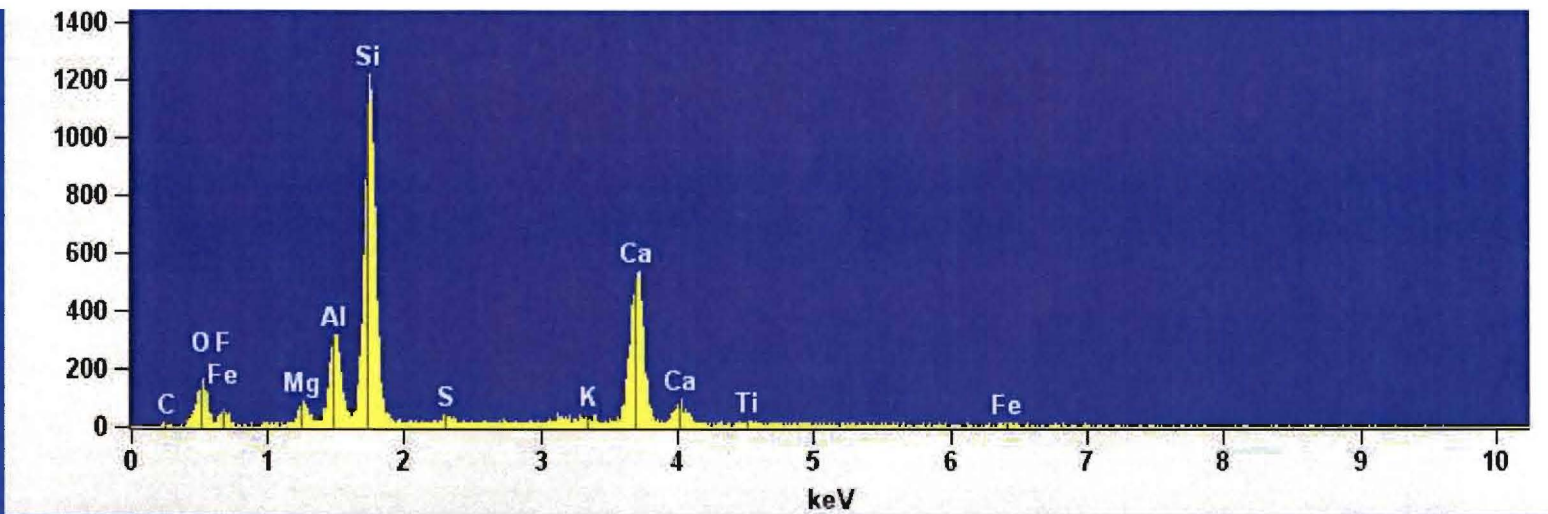
NTSB EDS spectrum of the straight fiber from N612AZ PRV contained major elemental peaks of silicon, aluminum and calcium with minor elemental peaks of iron, magnesium, carbon, and oxygen, consistent with e-glass. (direct from NTSB Materials report)

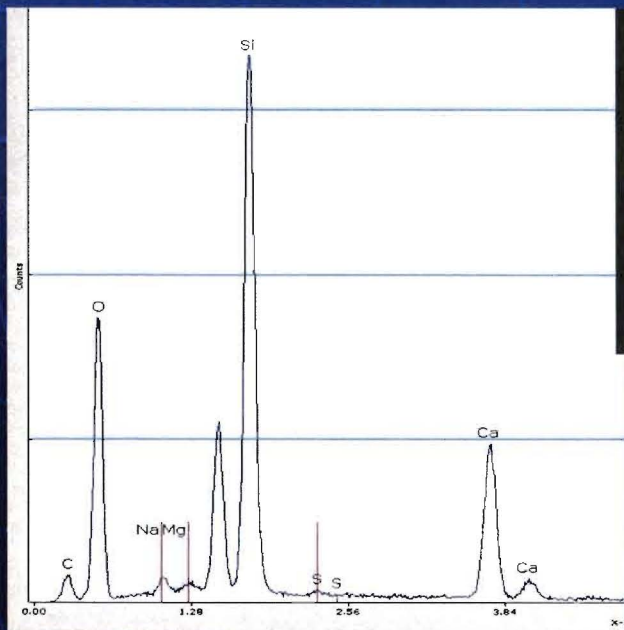
EDS Spectra from long straight fiber from E-poly coating .

Virtual identical match.

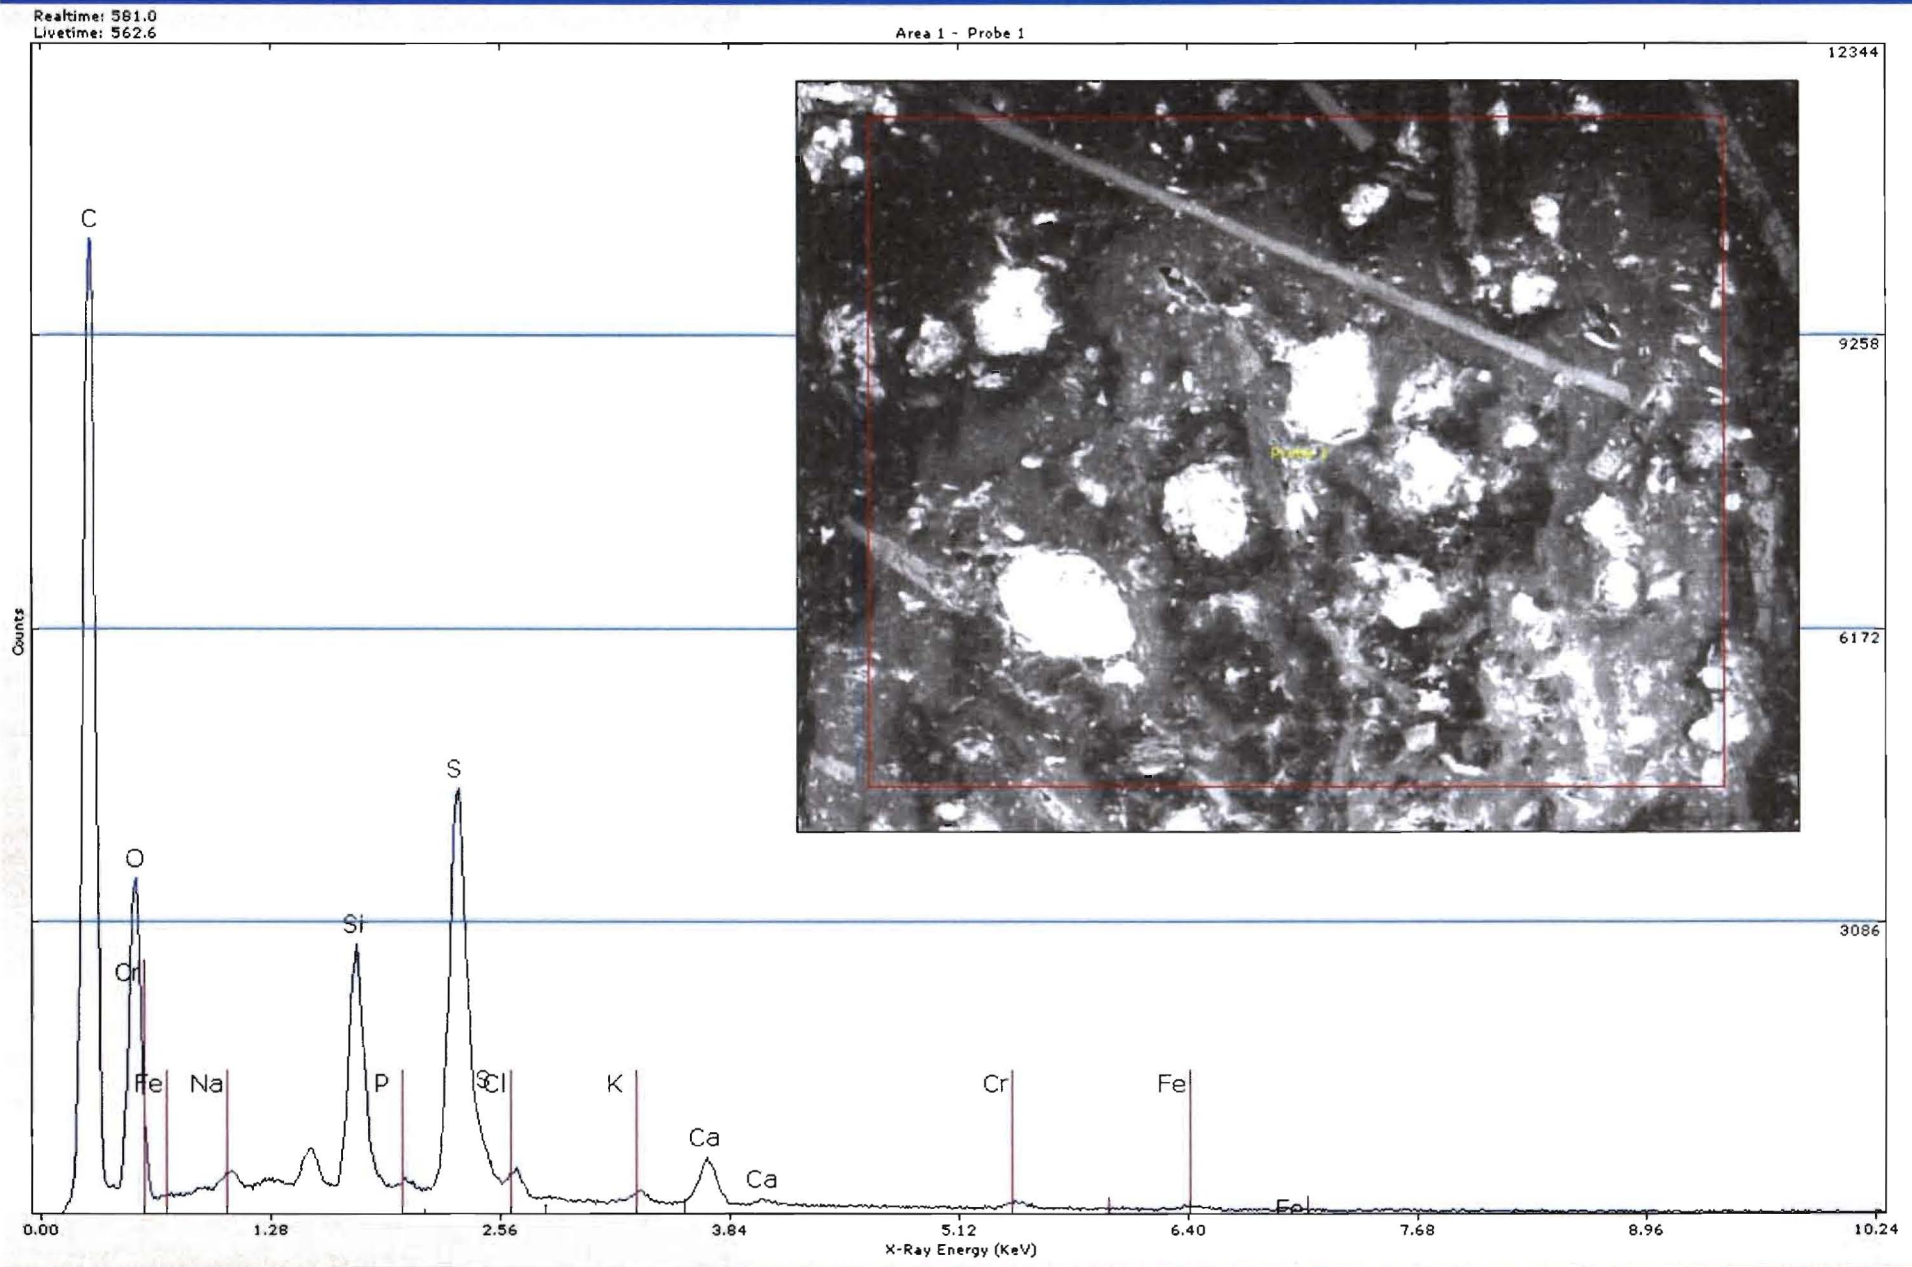
Blow-up scale of material with flat pieces in E-poly coating matrix.

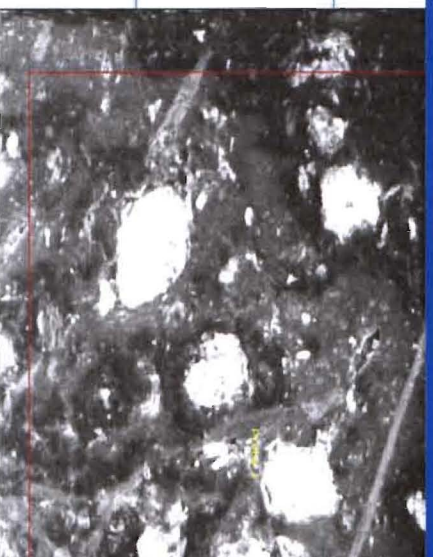
EDS spectrum irregular flat pieces in E-Poly matrix

Flat backing pieces
from E-Poly and
N612AZ

Extremely similar
Spectra match

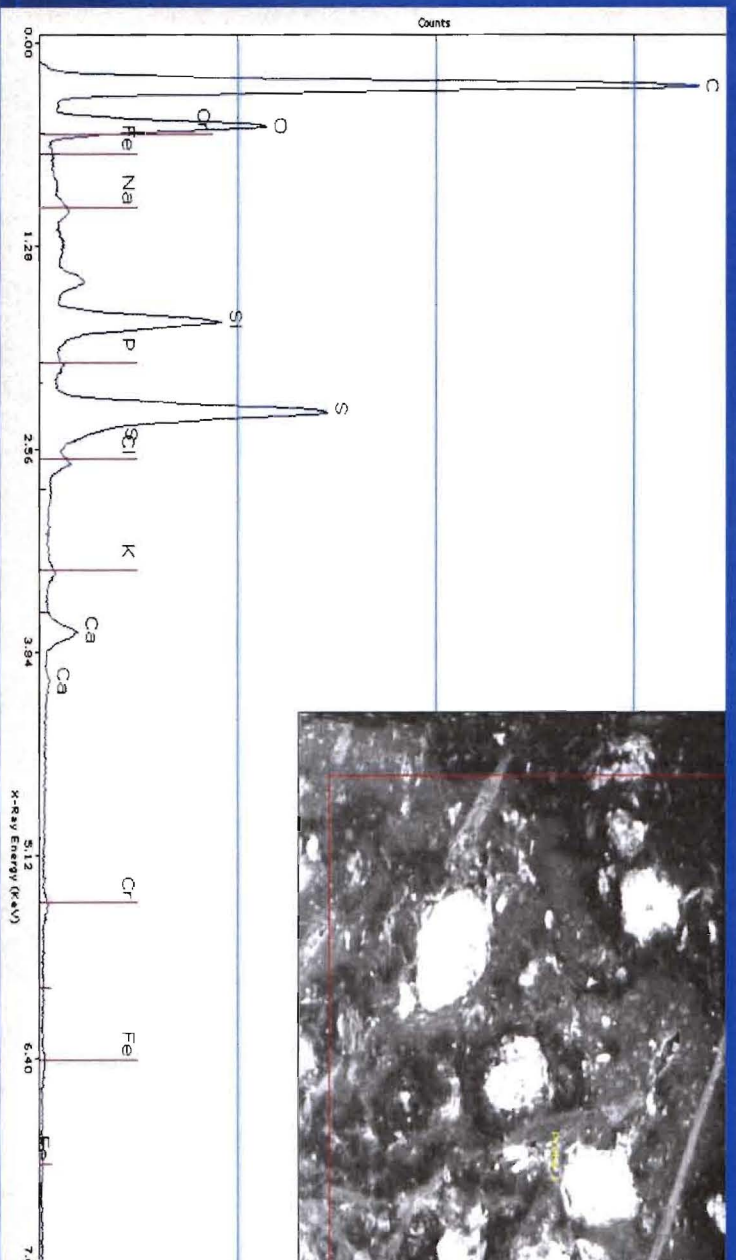
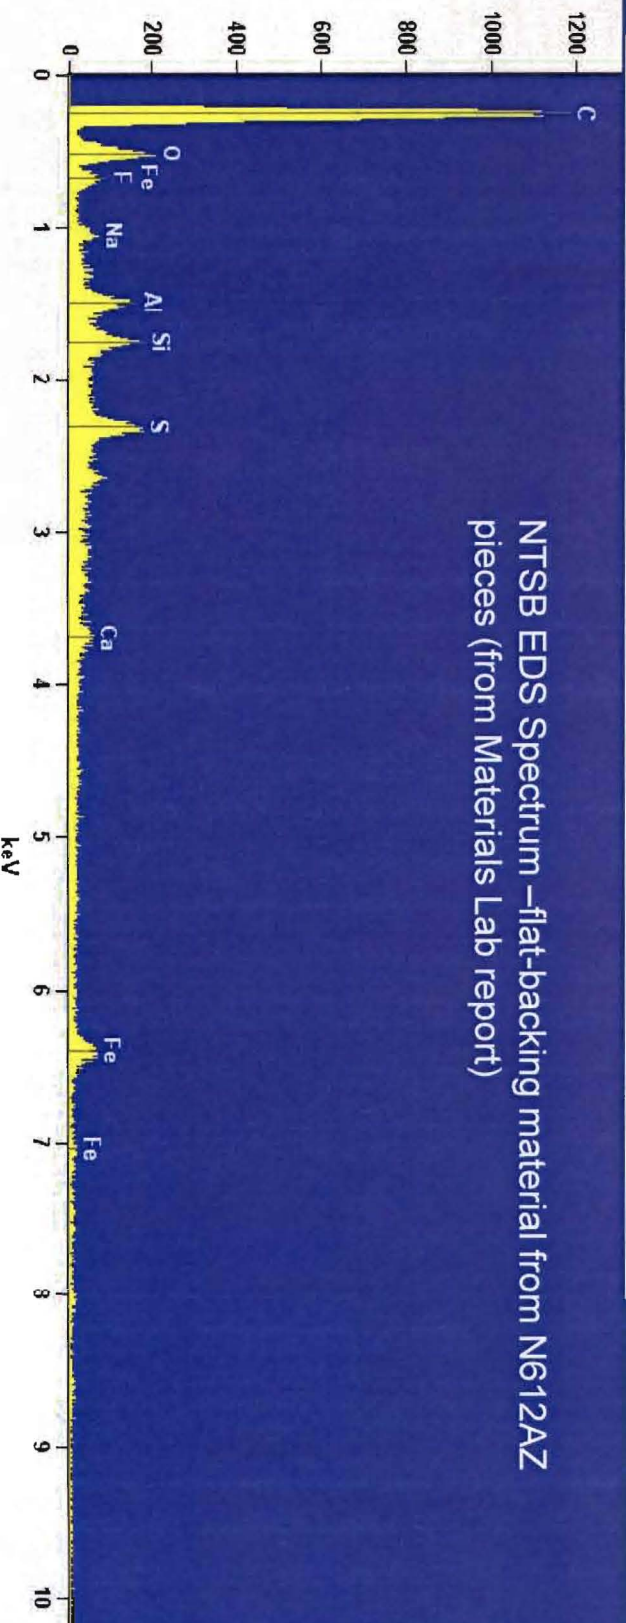
NTSB EDS Spectrum –flat-backing material from N612AZ
pieces (from Materials Lab report)

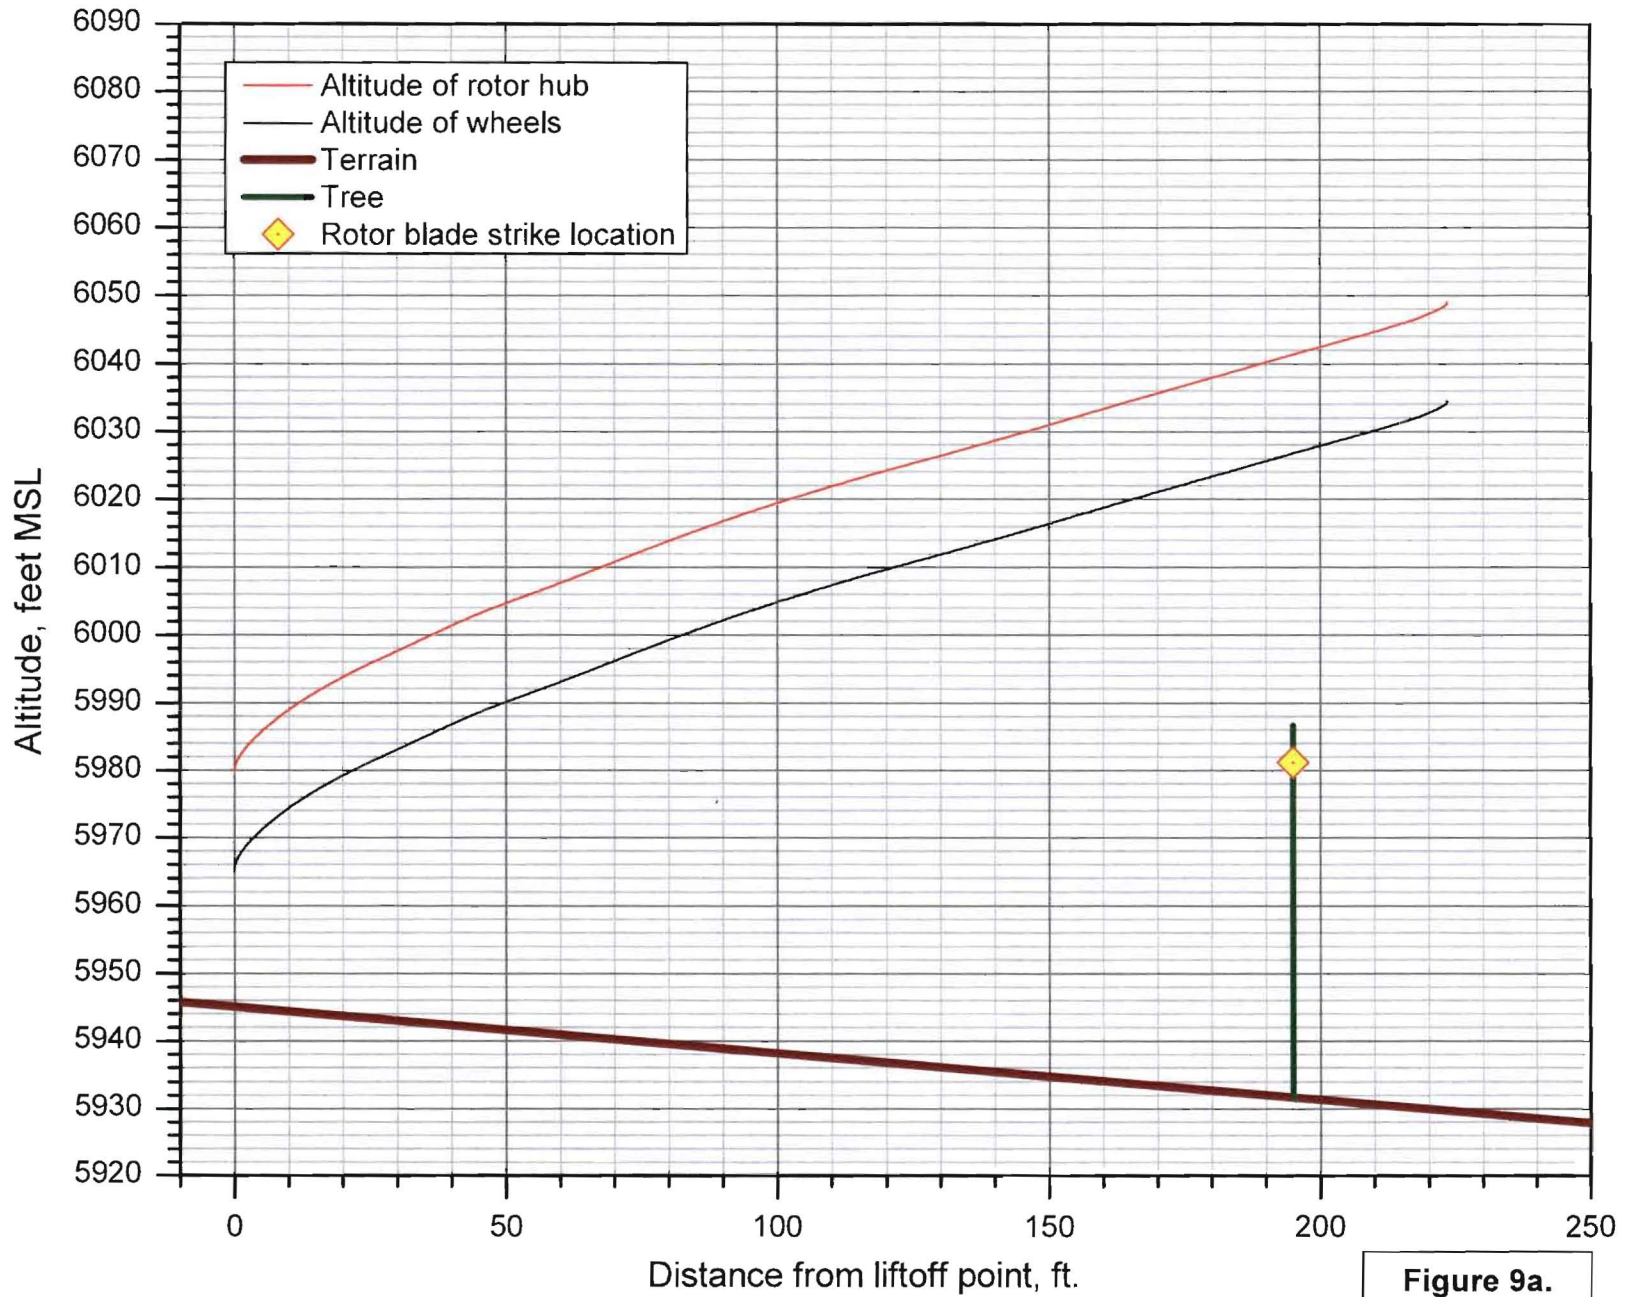
Figure 9a.

- b. The GenHel flight simulation that was done utilizing the FAA-approved performance for the aircraft clearly and conclusively shows that the S61 as equipped that day had more than adequate performance to clear the trees at the helipad H44, either at 20 deg. C or 23 deg. C (see attached simulation plots from NTSB Hover Study 9a, 9b). This data was not used or presented to Board members at the hearing.

GenHel simulation results, condition "a": RFMS #8 performance, 23° C Altitude of rotor hub and wheels vs. distance travelled
