Carson Helicopters, Inc. is writing to the National Transportation Safety Board regarding the final report and findings of the NTSB on the Sikorsky S61N helicopter crash near Weaverville, California on August 5, 2008. By this letter Carson is hereby filing a Letter of Petition to review the findings in this accident. Carson contends that, A) there is new and additional information regarding contaminants in the fuel system that should be given careful consideration, and B) the Board was not given complete and accurate performance information for review in reaching its findings regarding aircraft flight performance.

**Comparison of four sets of FCU-PRV
Particle Contamination and E-Poly fuel
pump coating**

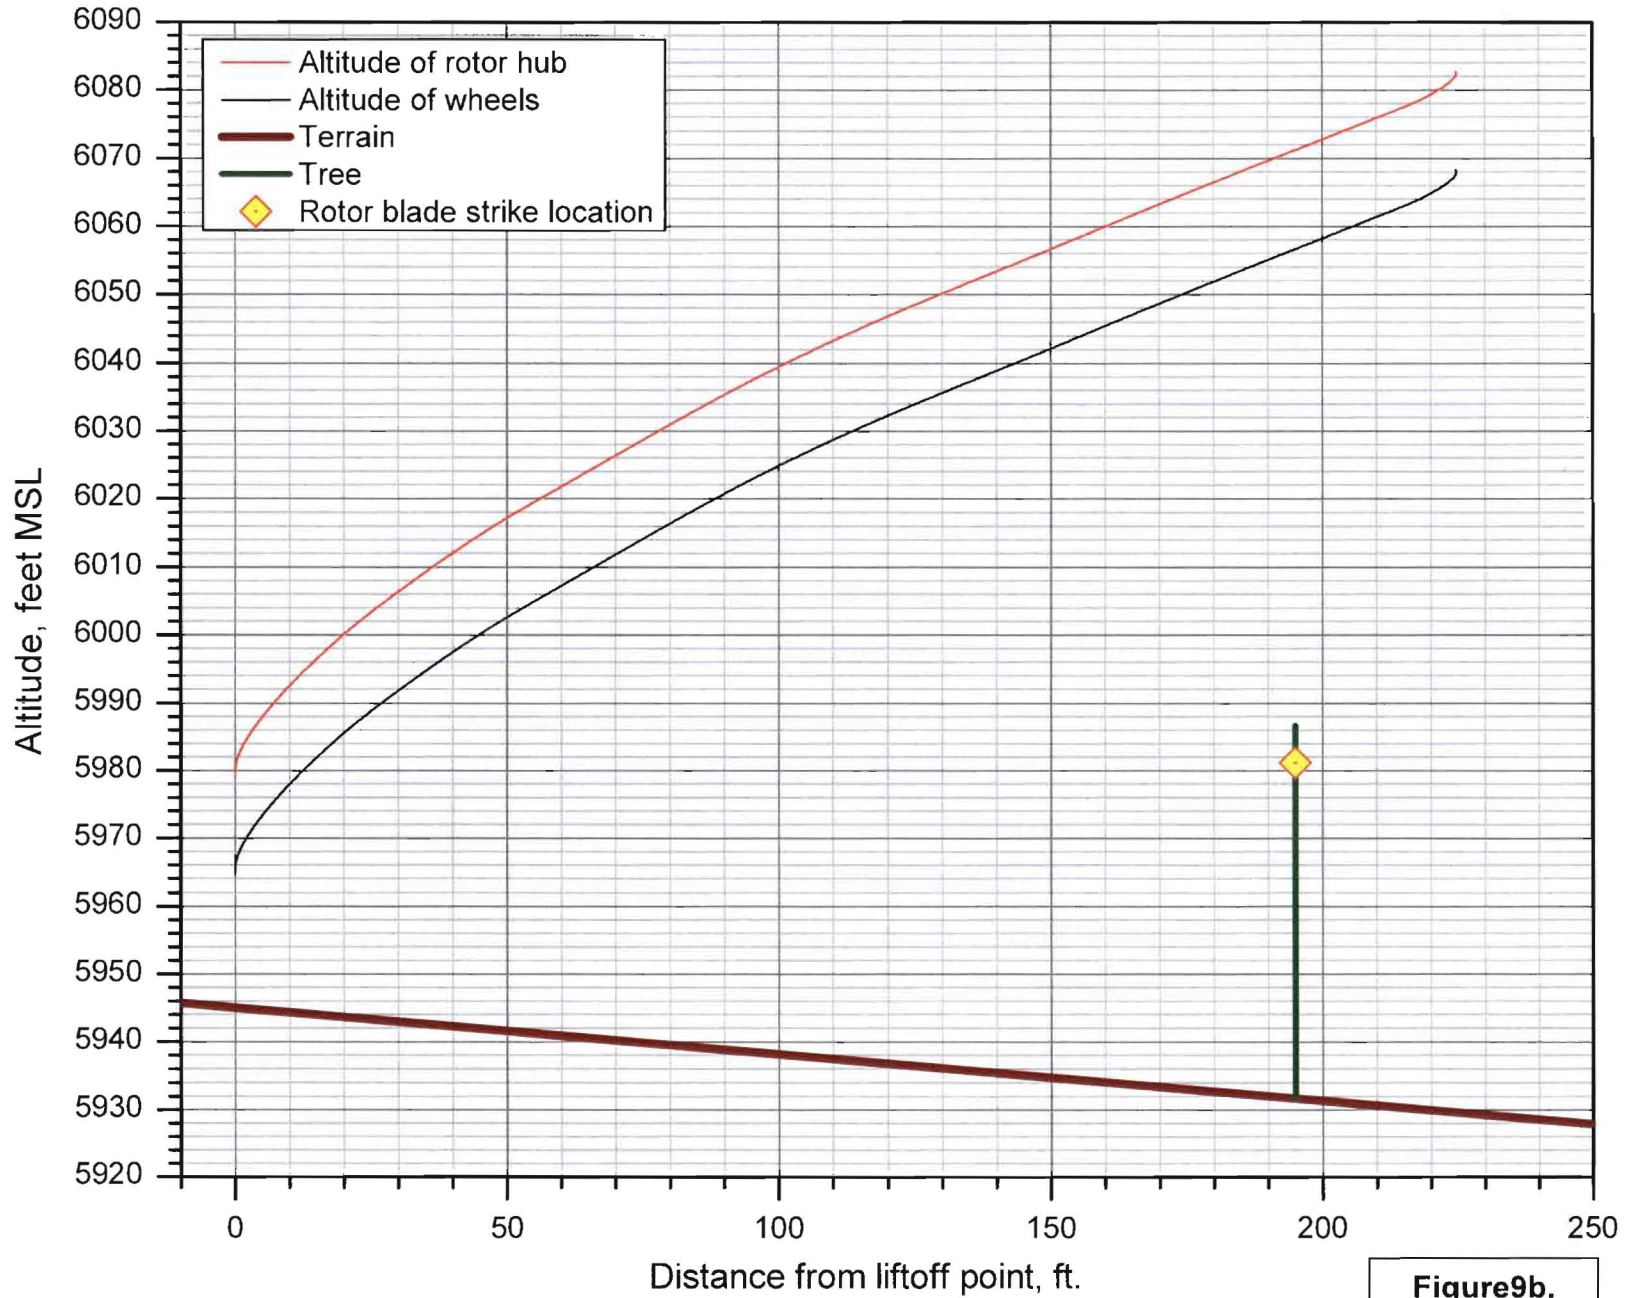
Figure9b.

- b. The GenHel flight simulation that was done utilizing the FAA-approved performance for the aircraft clearly and conclusively shows that the S61 as equipped that day had more than adequate performance to clear the trees at the helipad H44, either at 20 deg. C or 23 deg. C (see attached simulation plots from NTSB Hover Study 9a, 9b). This data was not used or presented to Board members at the hearing.

GenHel simulation results, condition "b": RFMS #8 performance, 20° C Altitude of rotor hub and wheels vs. distance travelled

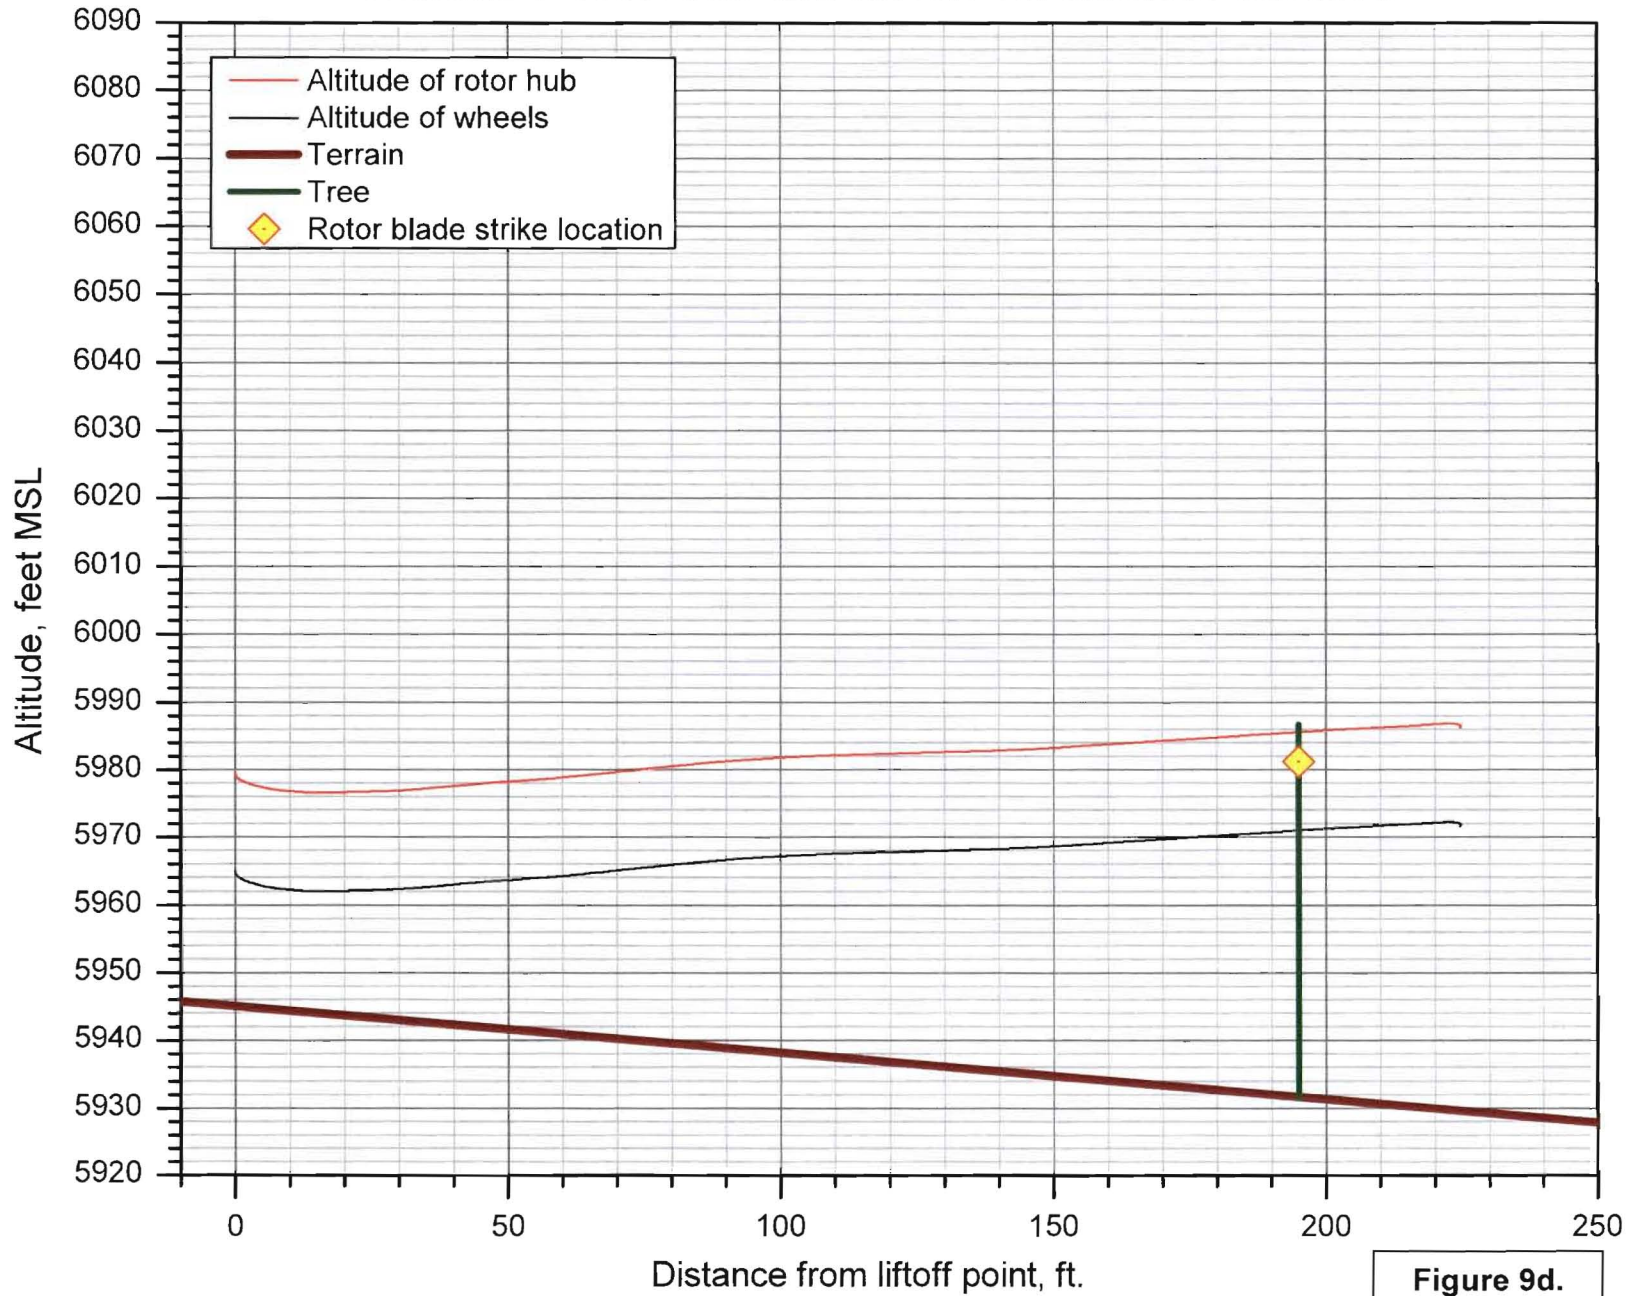
Figure 9d.

- d. This 2008 dataset with uncertified, one-off inferior CMRB blades is the only actual flight data that Sikorsky used in the GenHel simulation and which the NTSB investigators subsequently used in their final report (*see attached NTSB simulation results 9c, 9d*). It is no surprise that such a simulation would result in a flight path showing the aircraft without available performance to clear the trees, since by Sikorsky’s own admission this dataset does not remotely represent the actual superior performance of a commercial longbody S61N with regular FAA-approved CMRB blades.

GenHel simulation results, condition "d": SAC / USN performance, 20° C Altitude of rotor hub and wheels vs. distance travelled

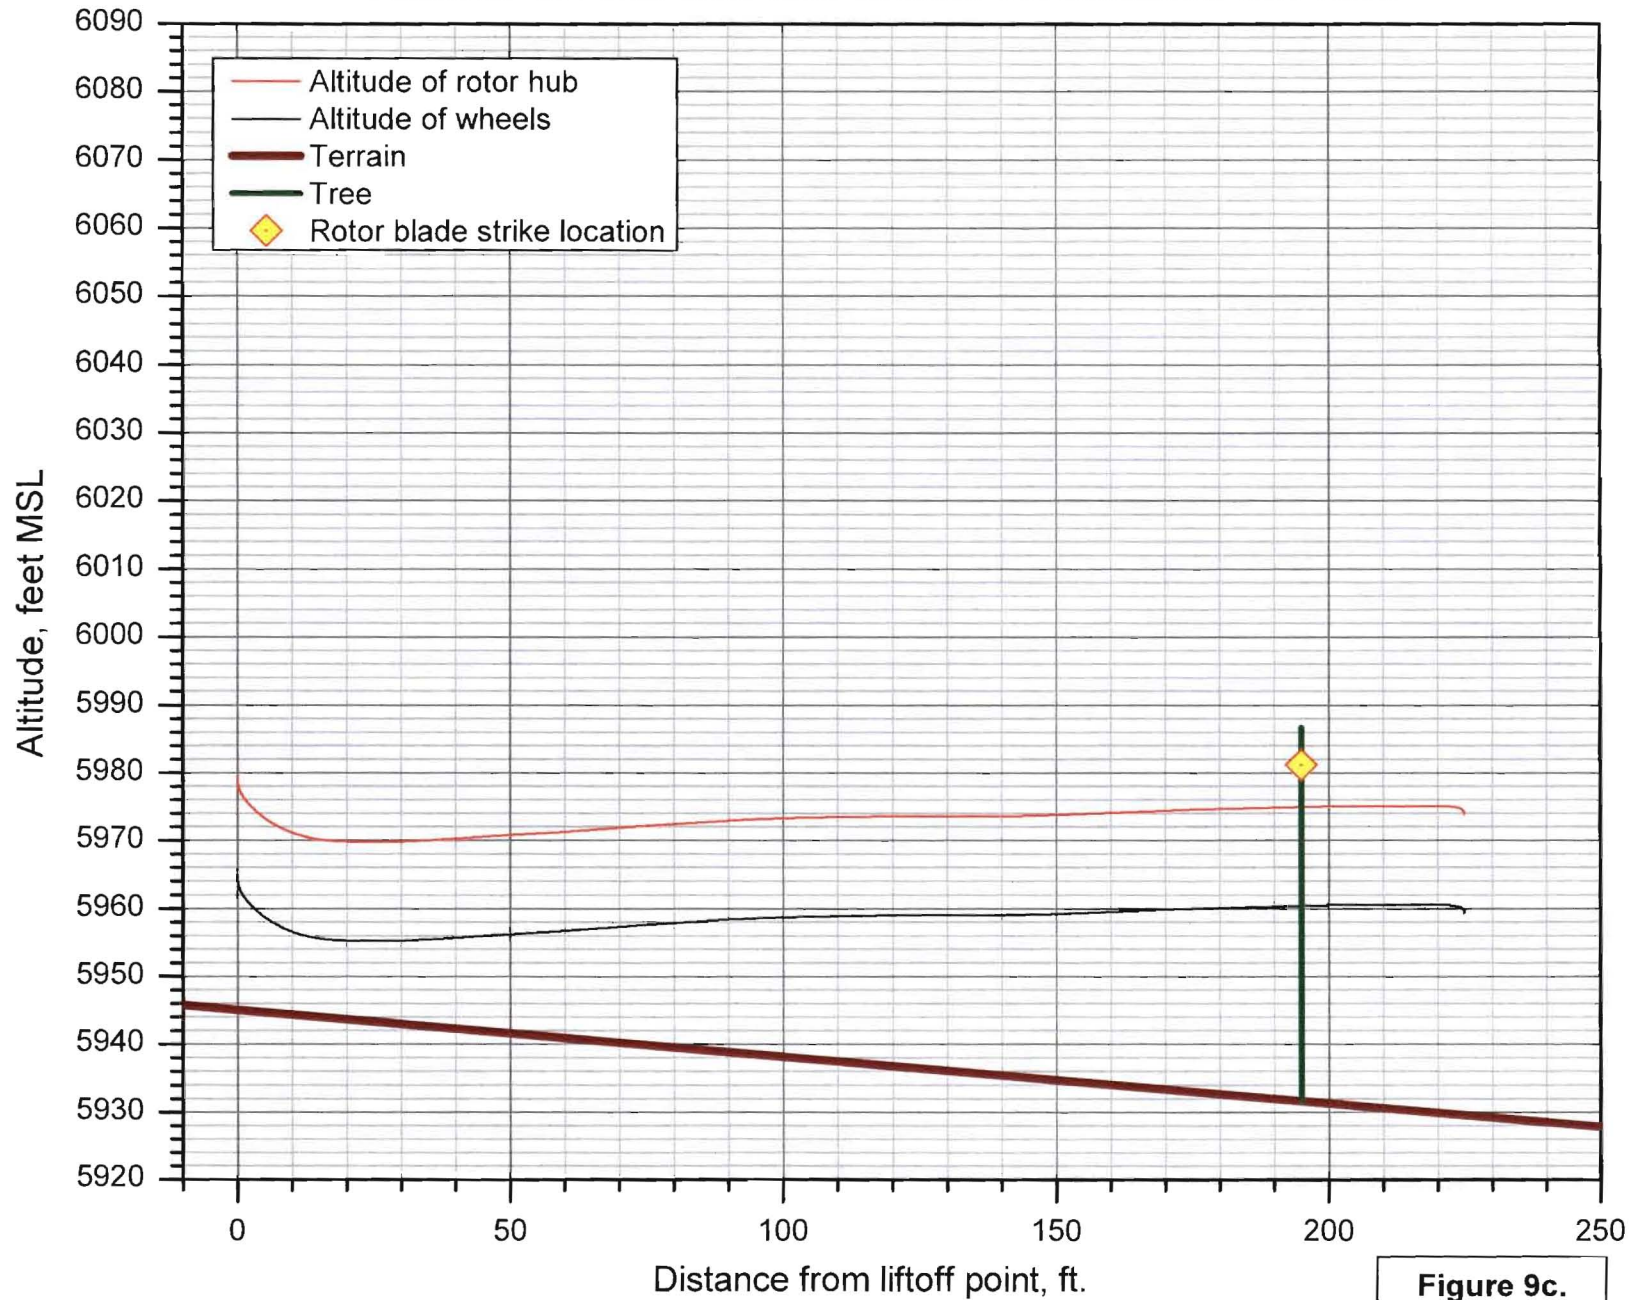
Figure 9c.

GenHel simulation results, condition "c": SAC / USN performance, 23° C
 Altitude of rotor hub and wheels vs. distance travelled
