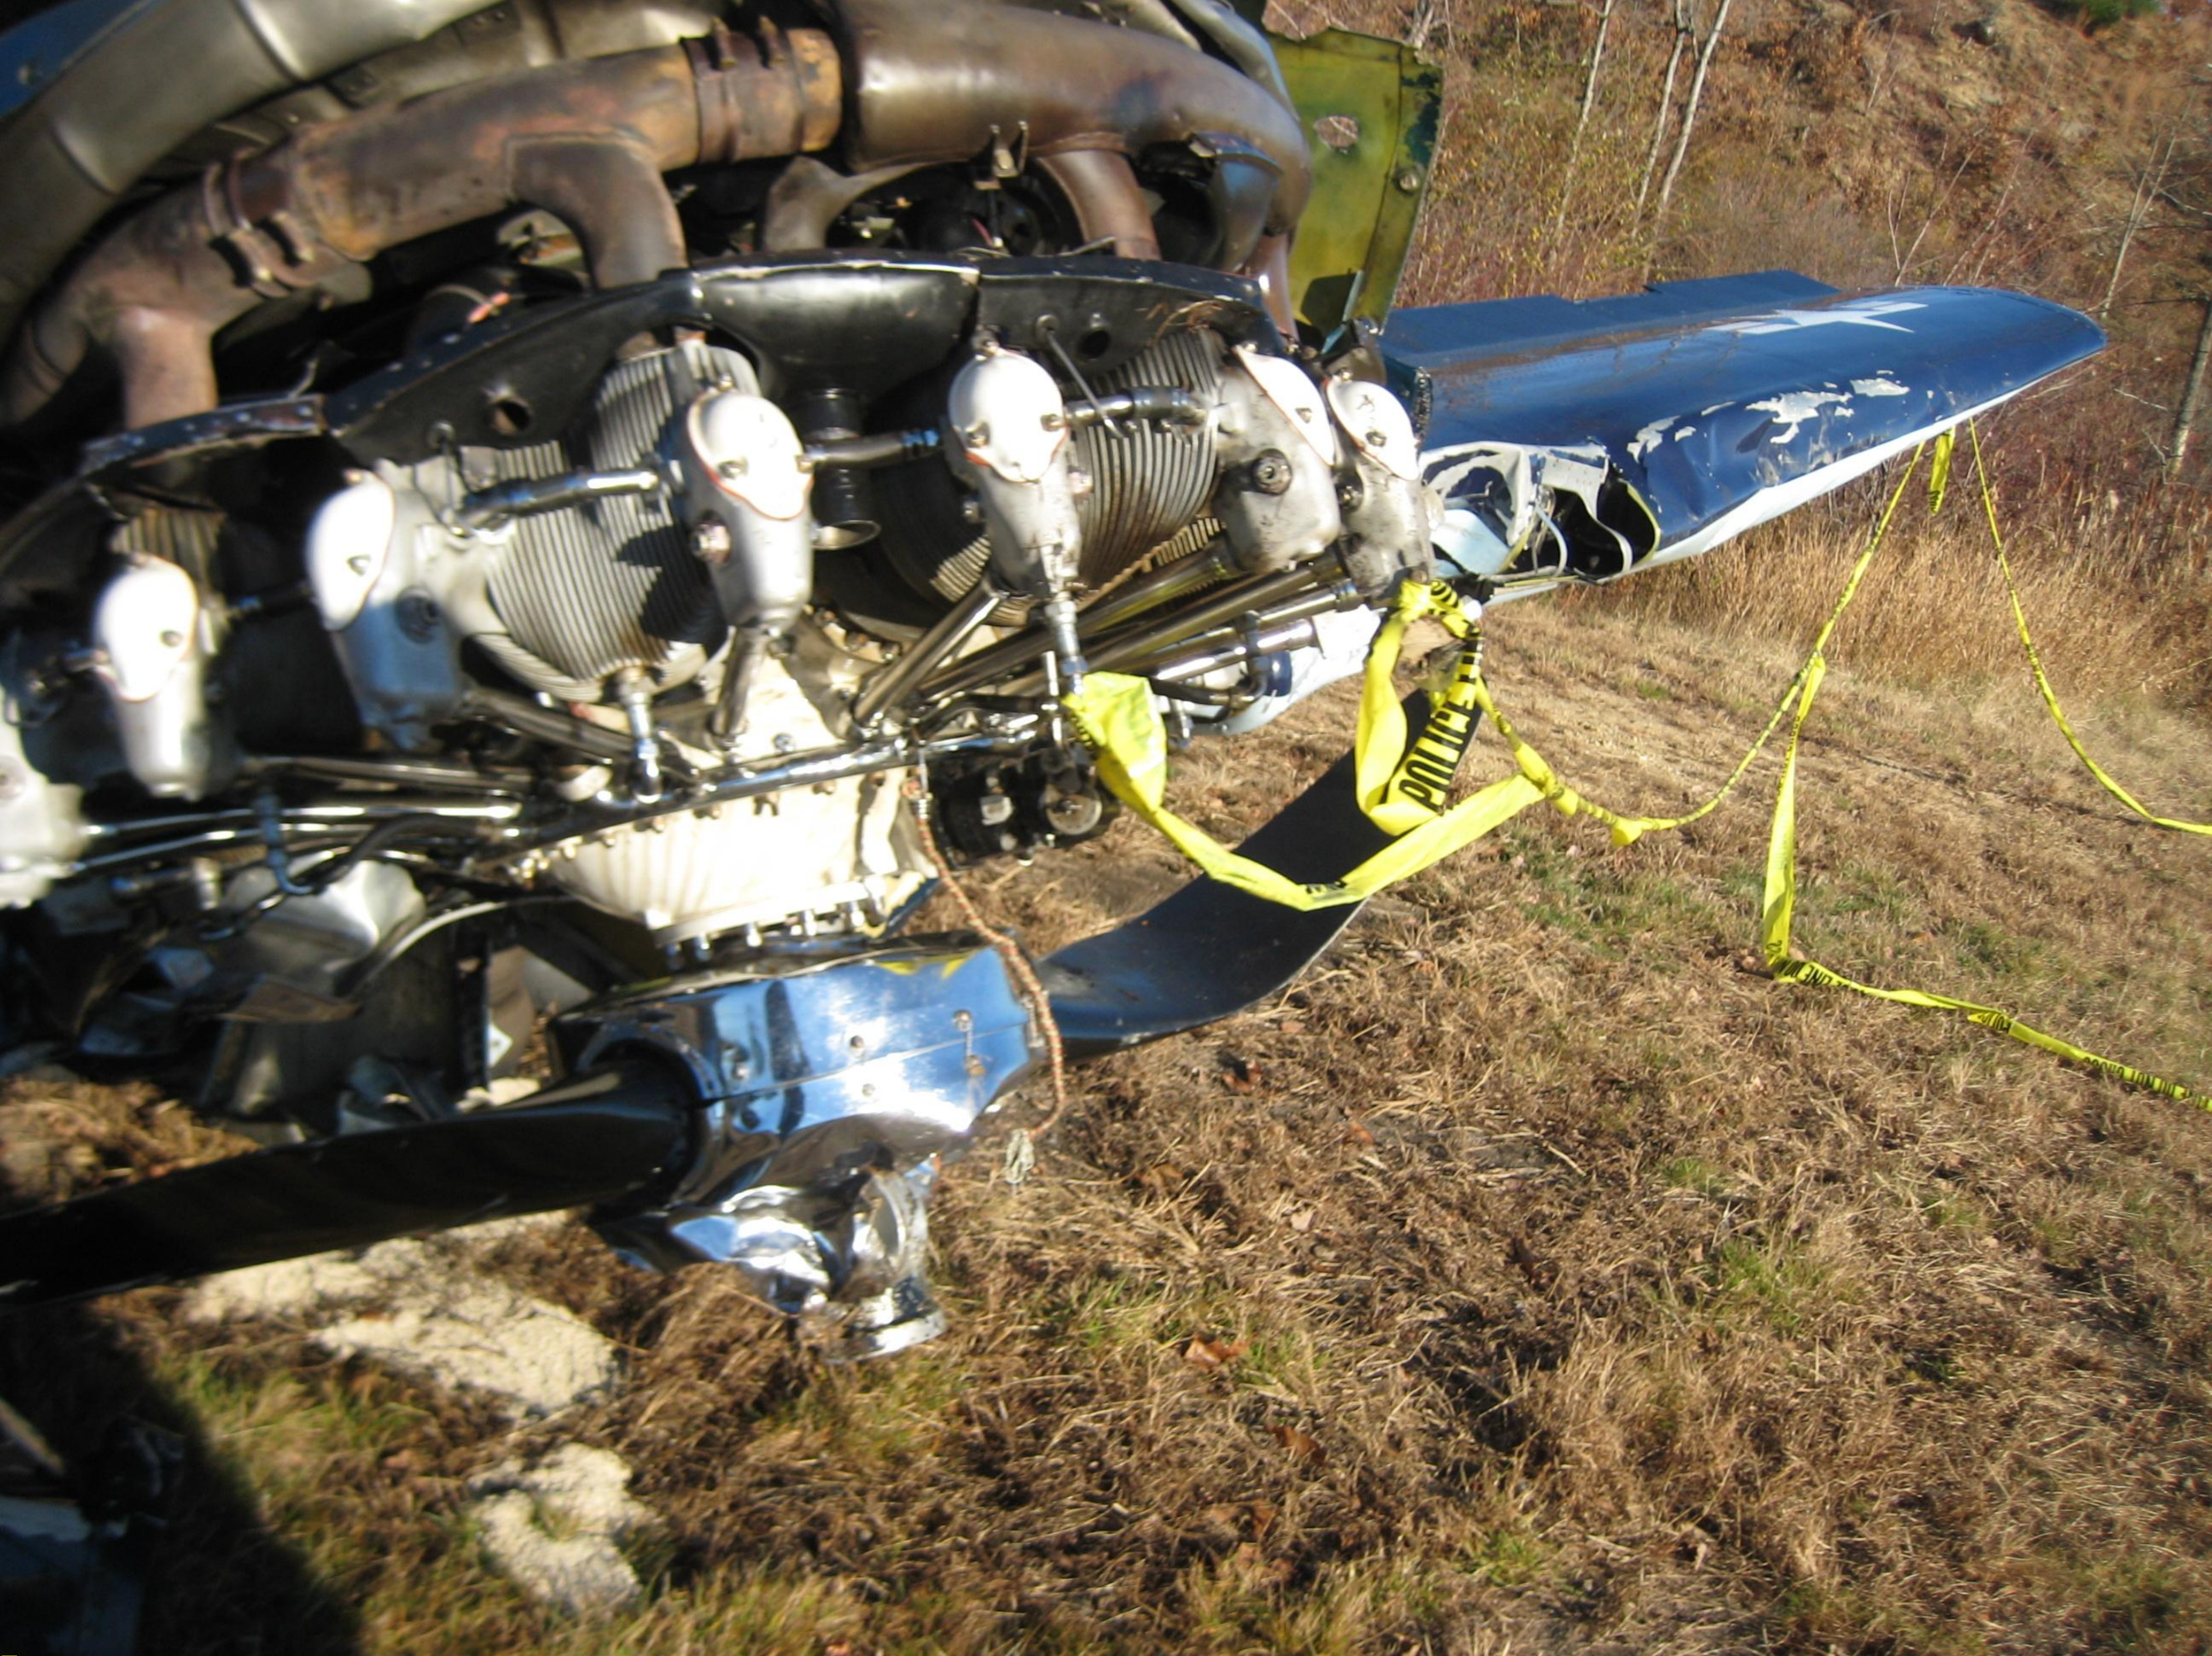
Photo 1: Engine, viewed from right side, (Courtesy Anglin Aircraft Recovery)
