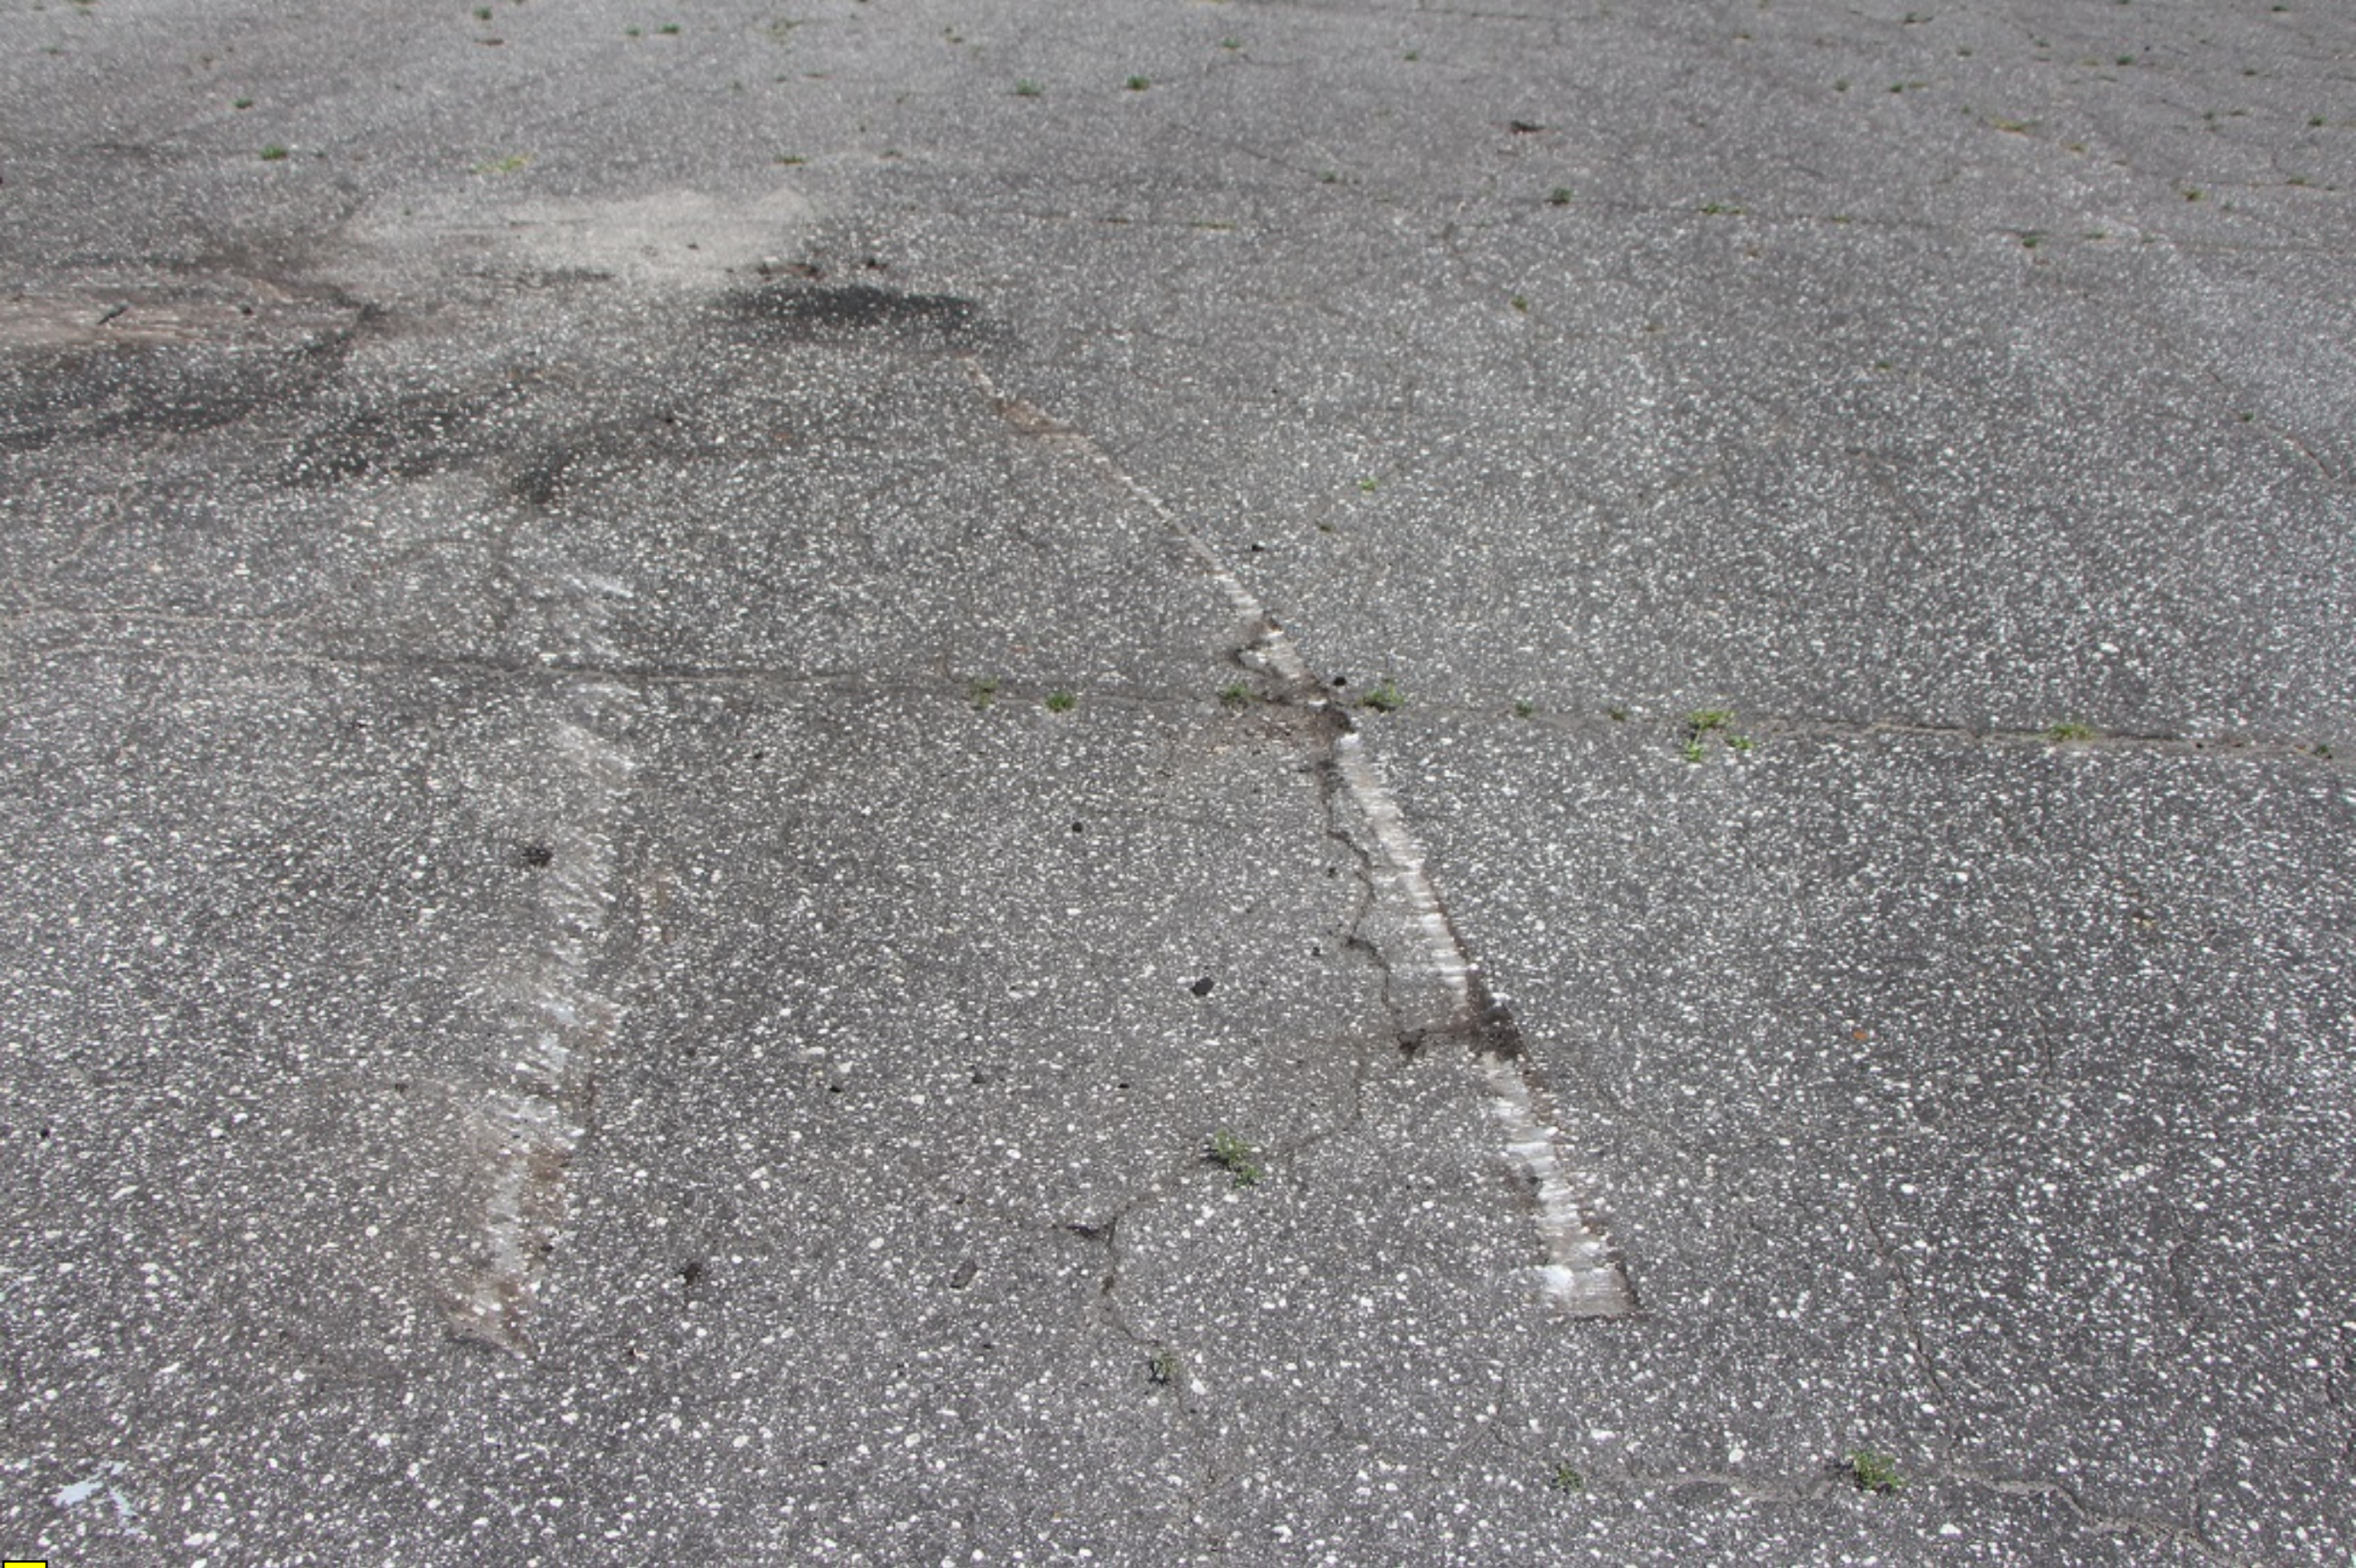
Photo 5: Ground Strikes from Rotor Blades.
