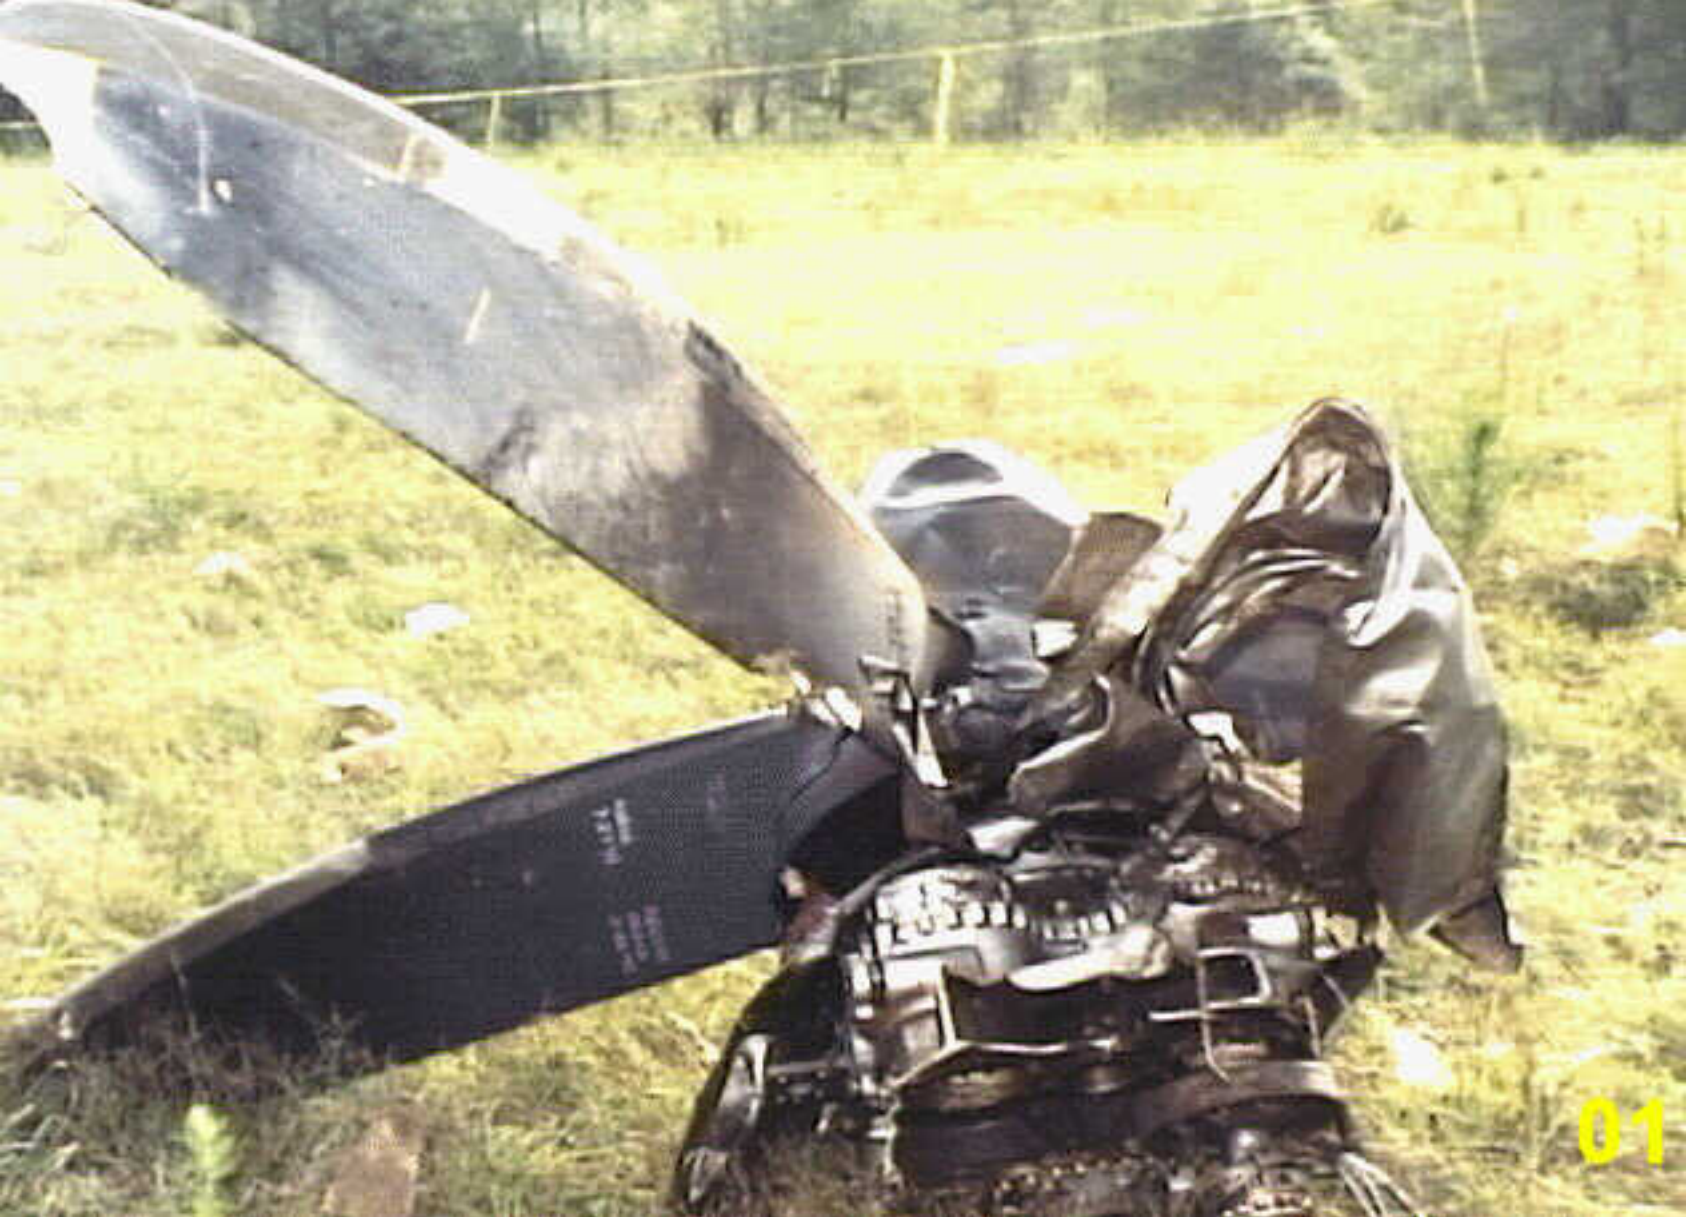
Photo 1 Left Engine and Propeller-Propeller and Reduction Gearbox at accident site.
