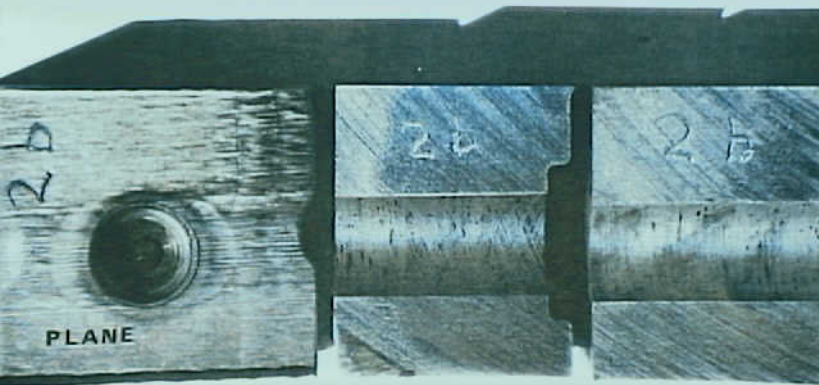
Photo 1. Hole #2B. Cutting without coolant with HSS drill to breakdown. Cutting data see report 9634-0101.
