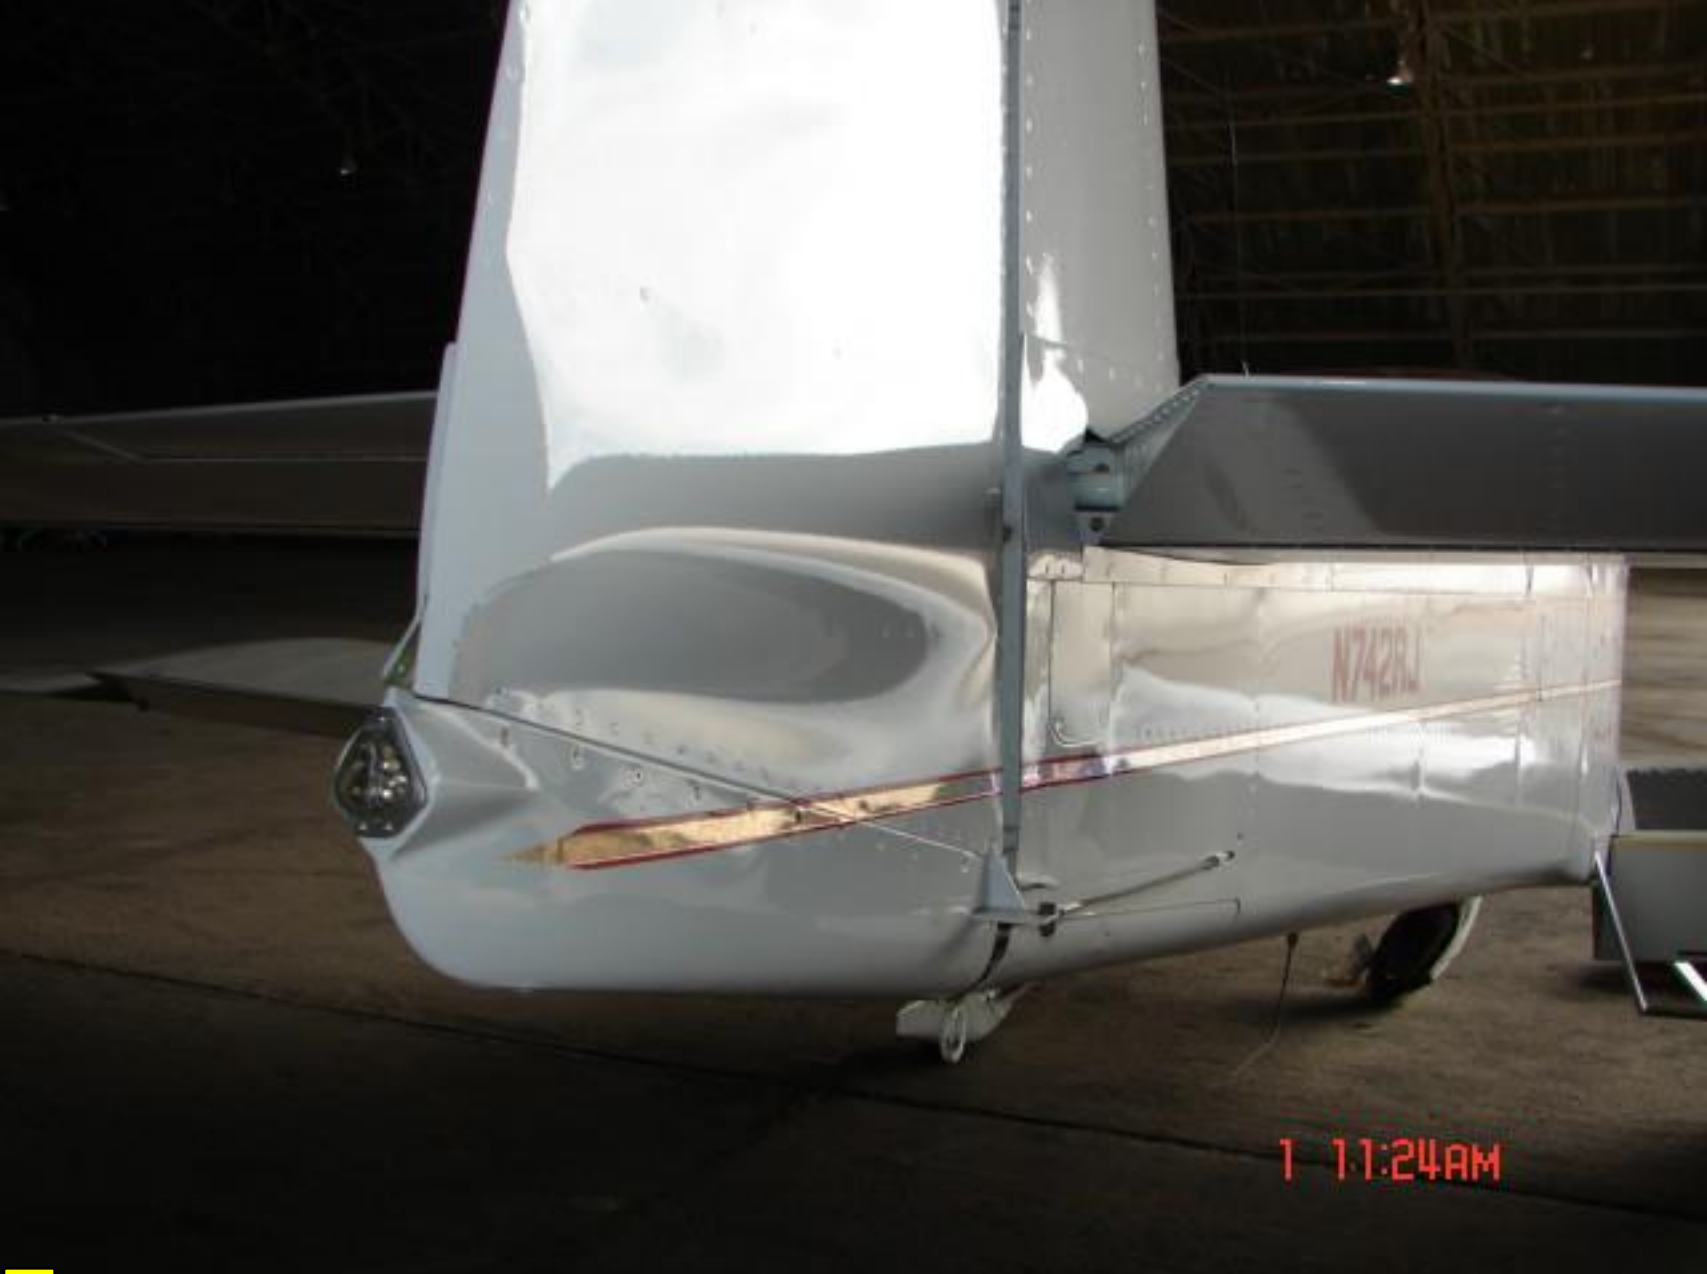
Photo 1. Damage to the rudder stiffener. Pilot
