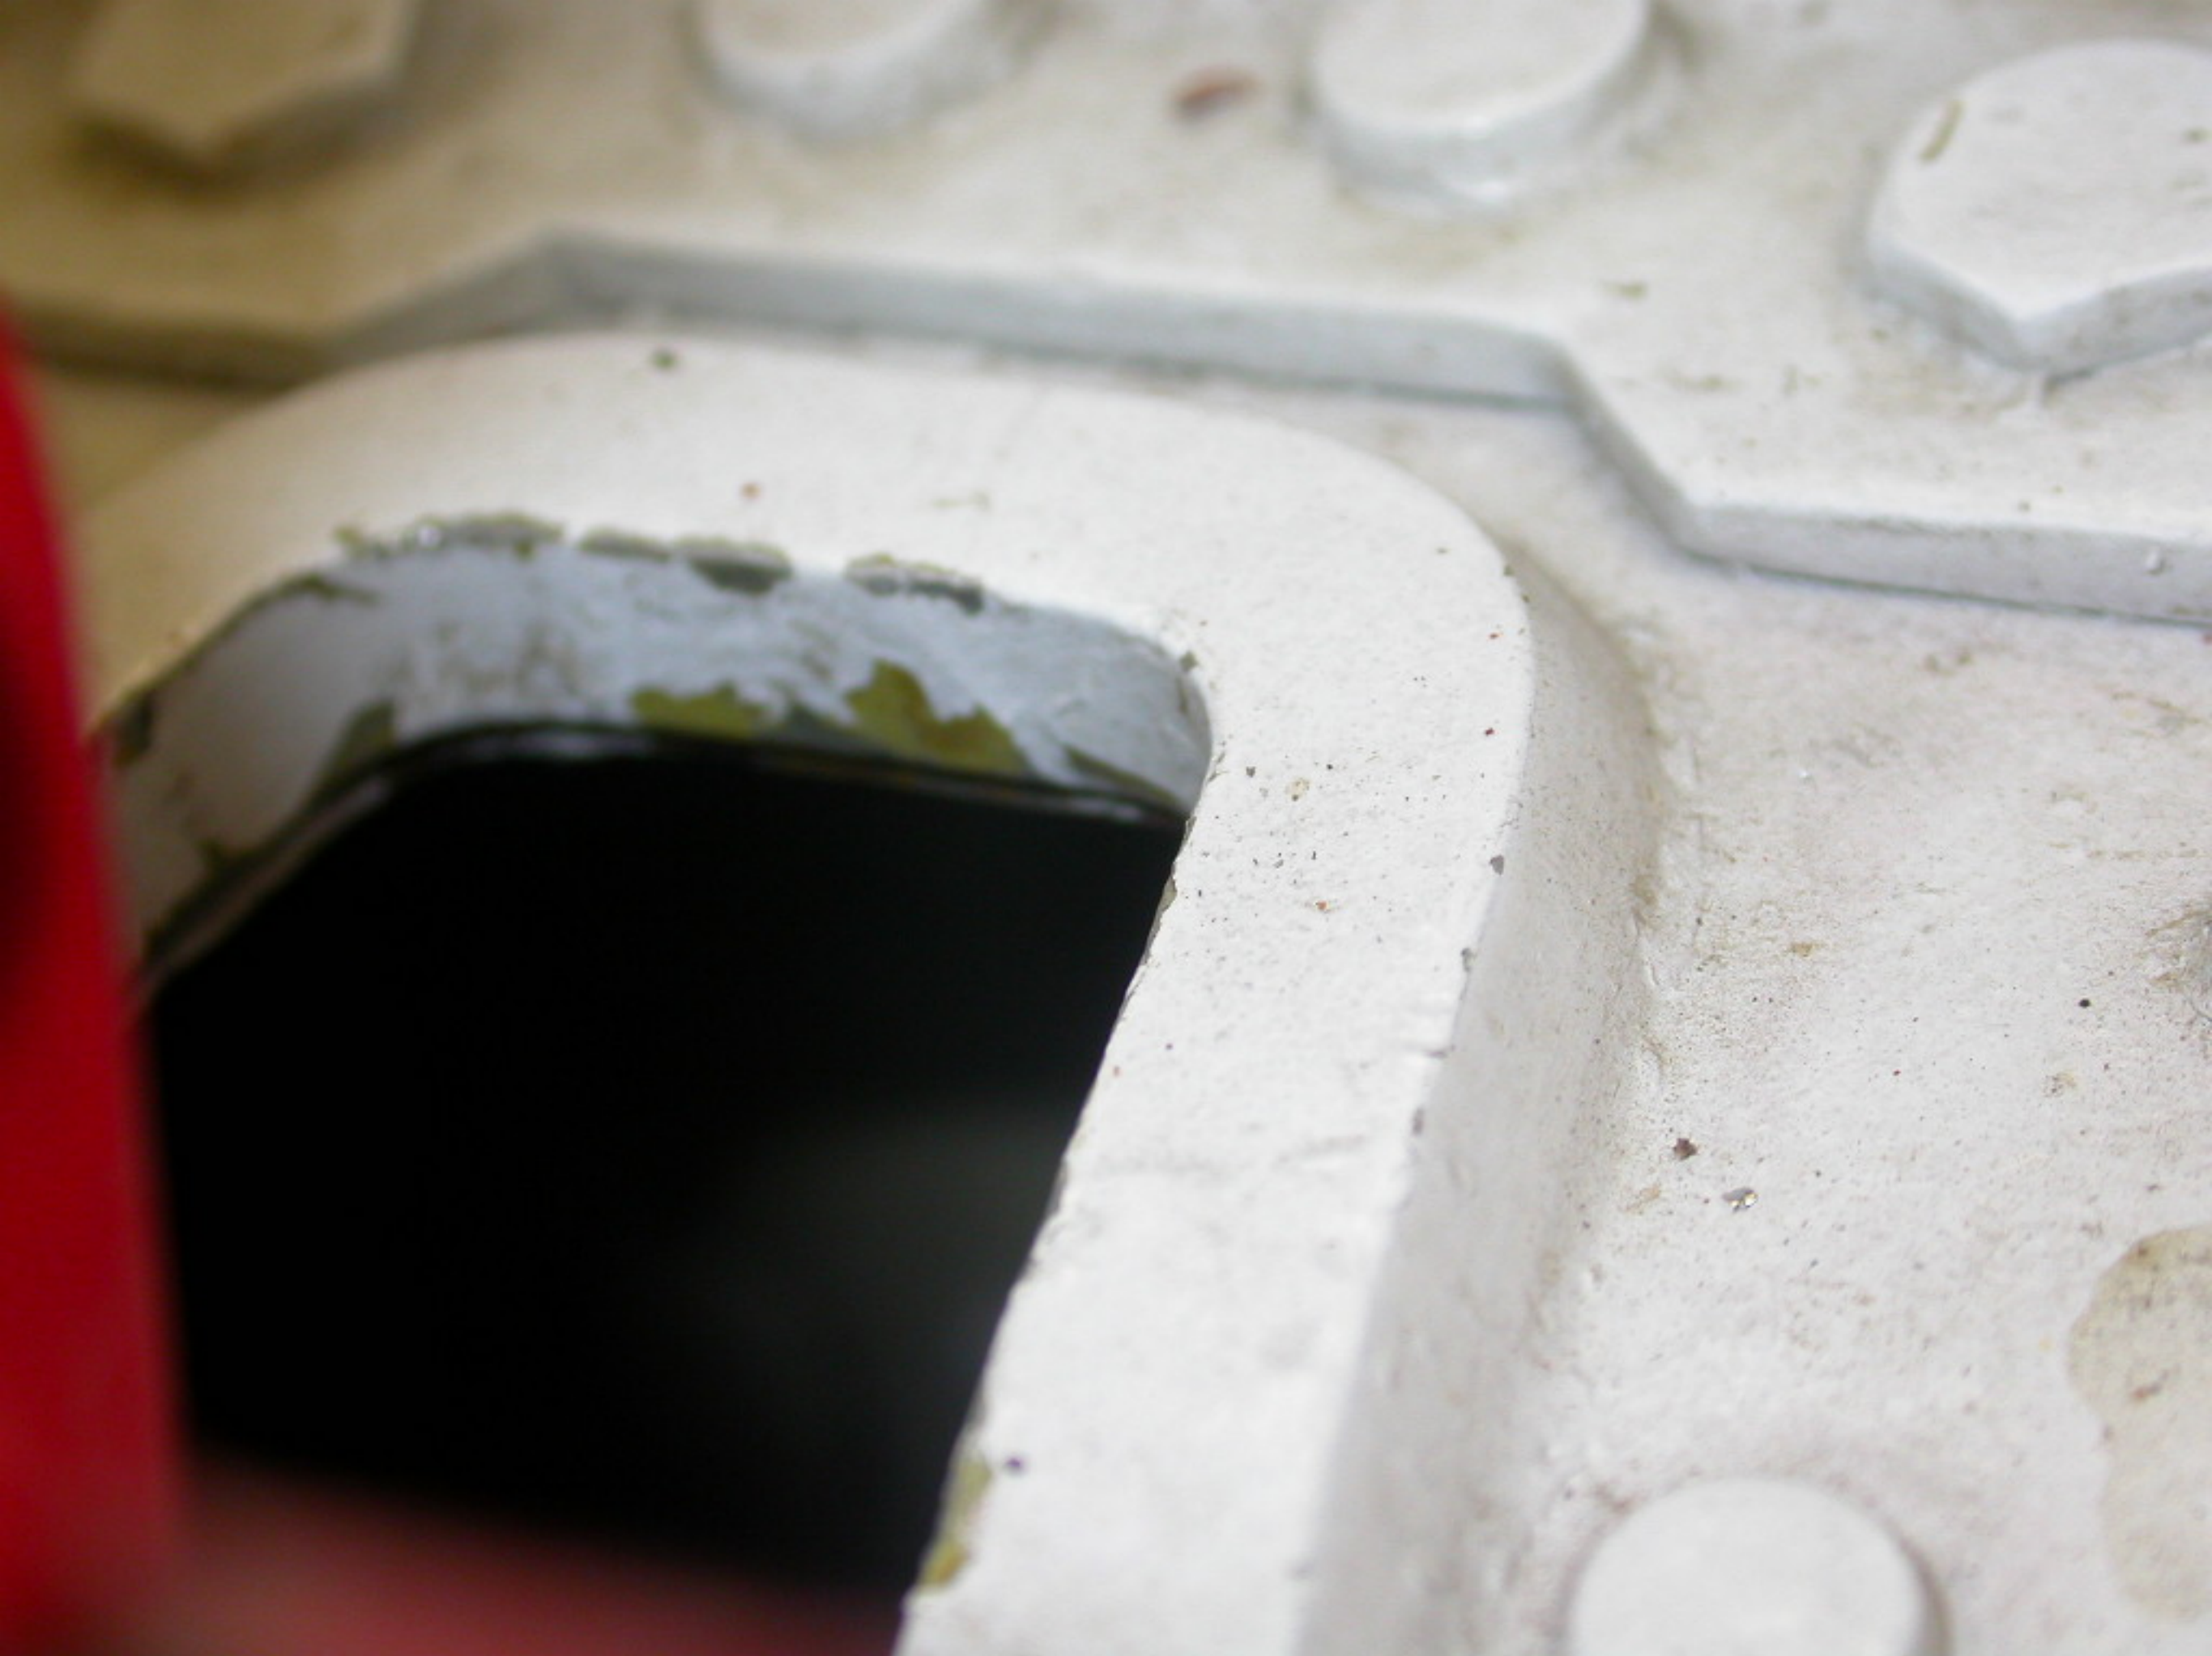
Photo 10: Markings on the aft section of the bellcrank housing area.
