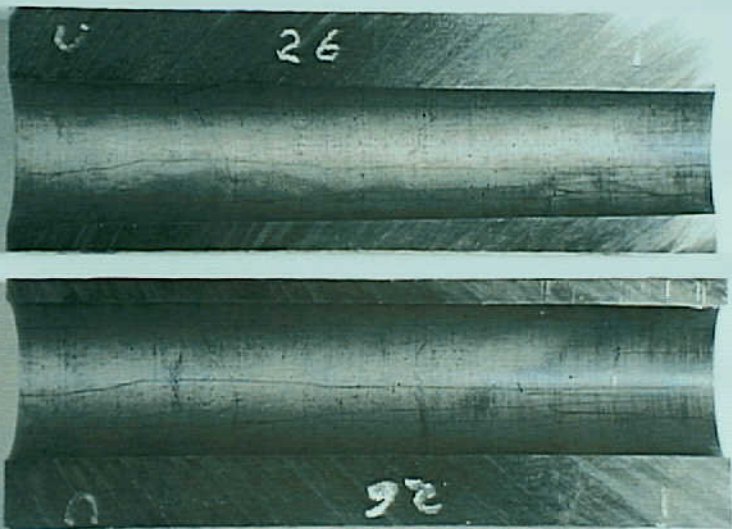
Photo 11. Hole #26 drilled with standard cutting data with HSS and fine bored. No indications came up to view a tBEA.
