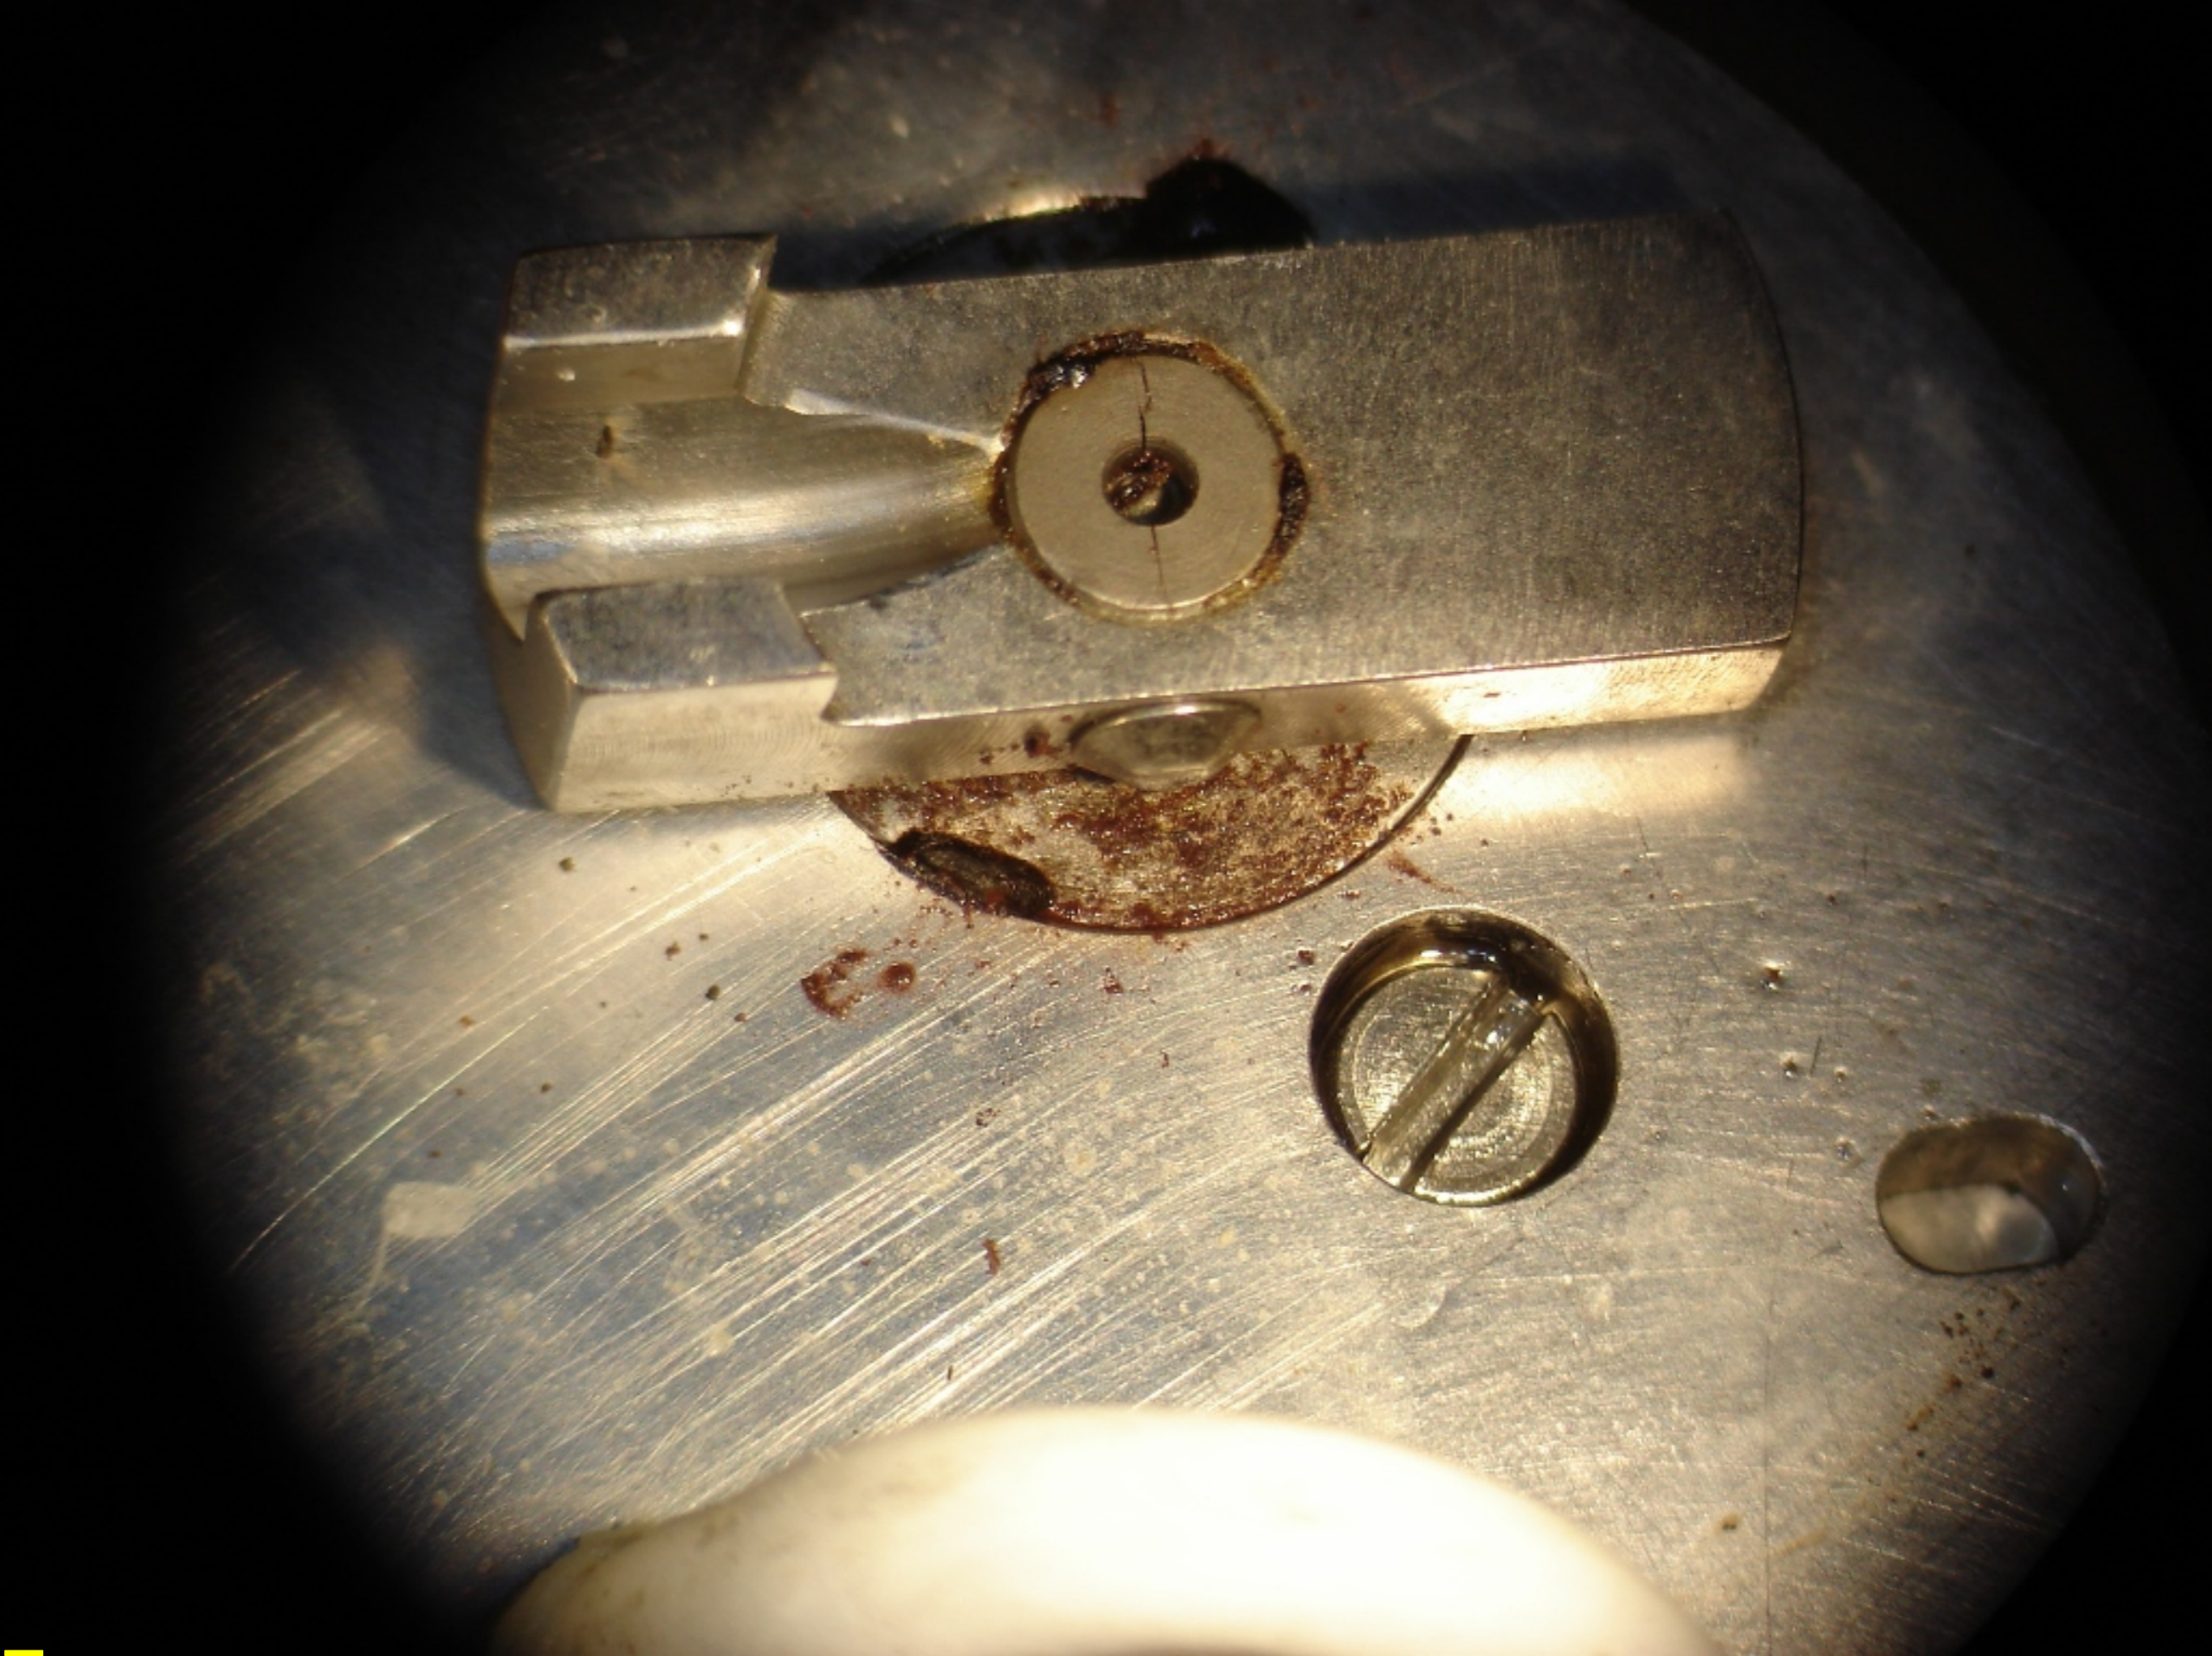
Photo 12. Stepper motor shaft with the crack visible.
