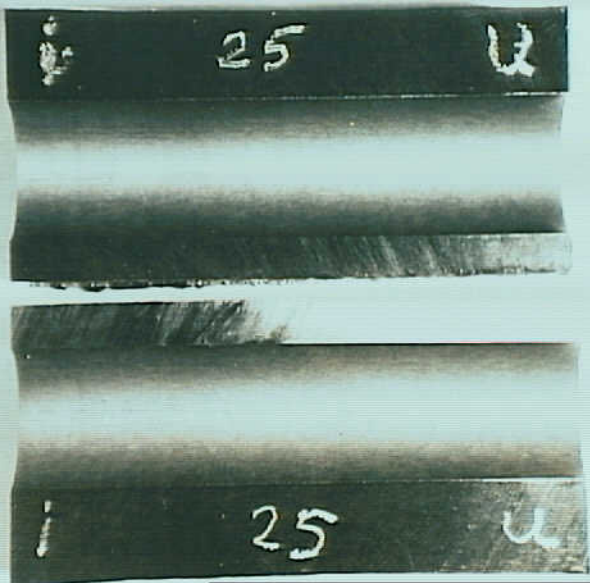
Photo 13. Hole #25 drilled with standard cutting data with HSS, fine bored and honed. BEA shows no indications.
