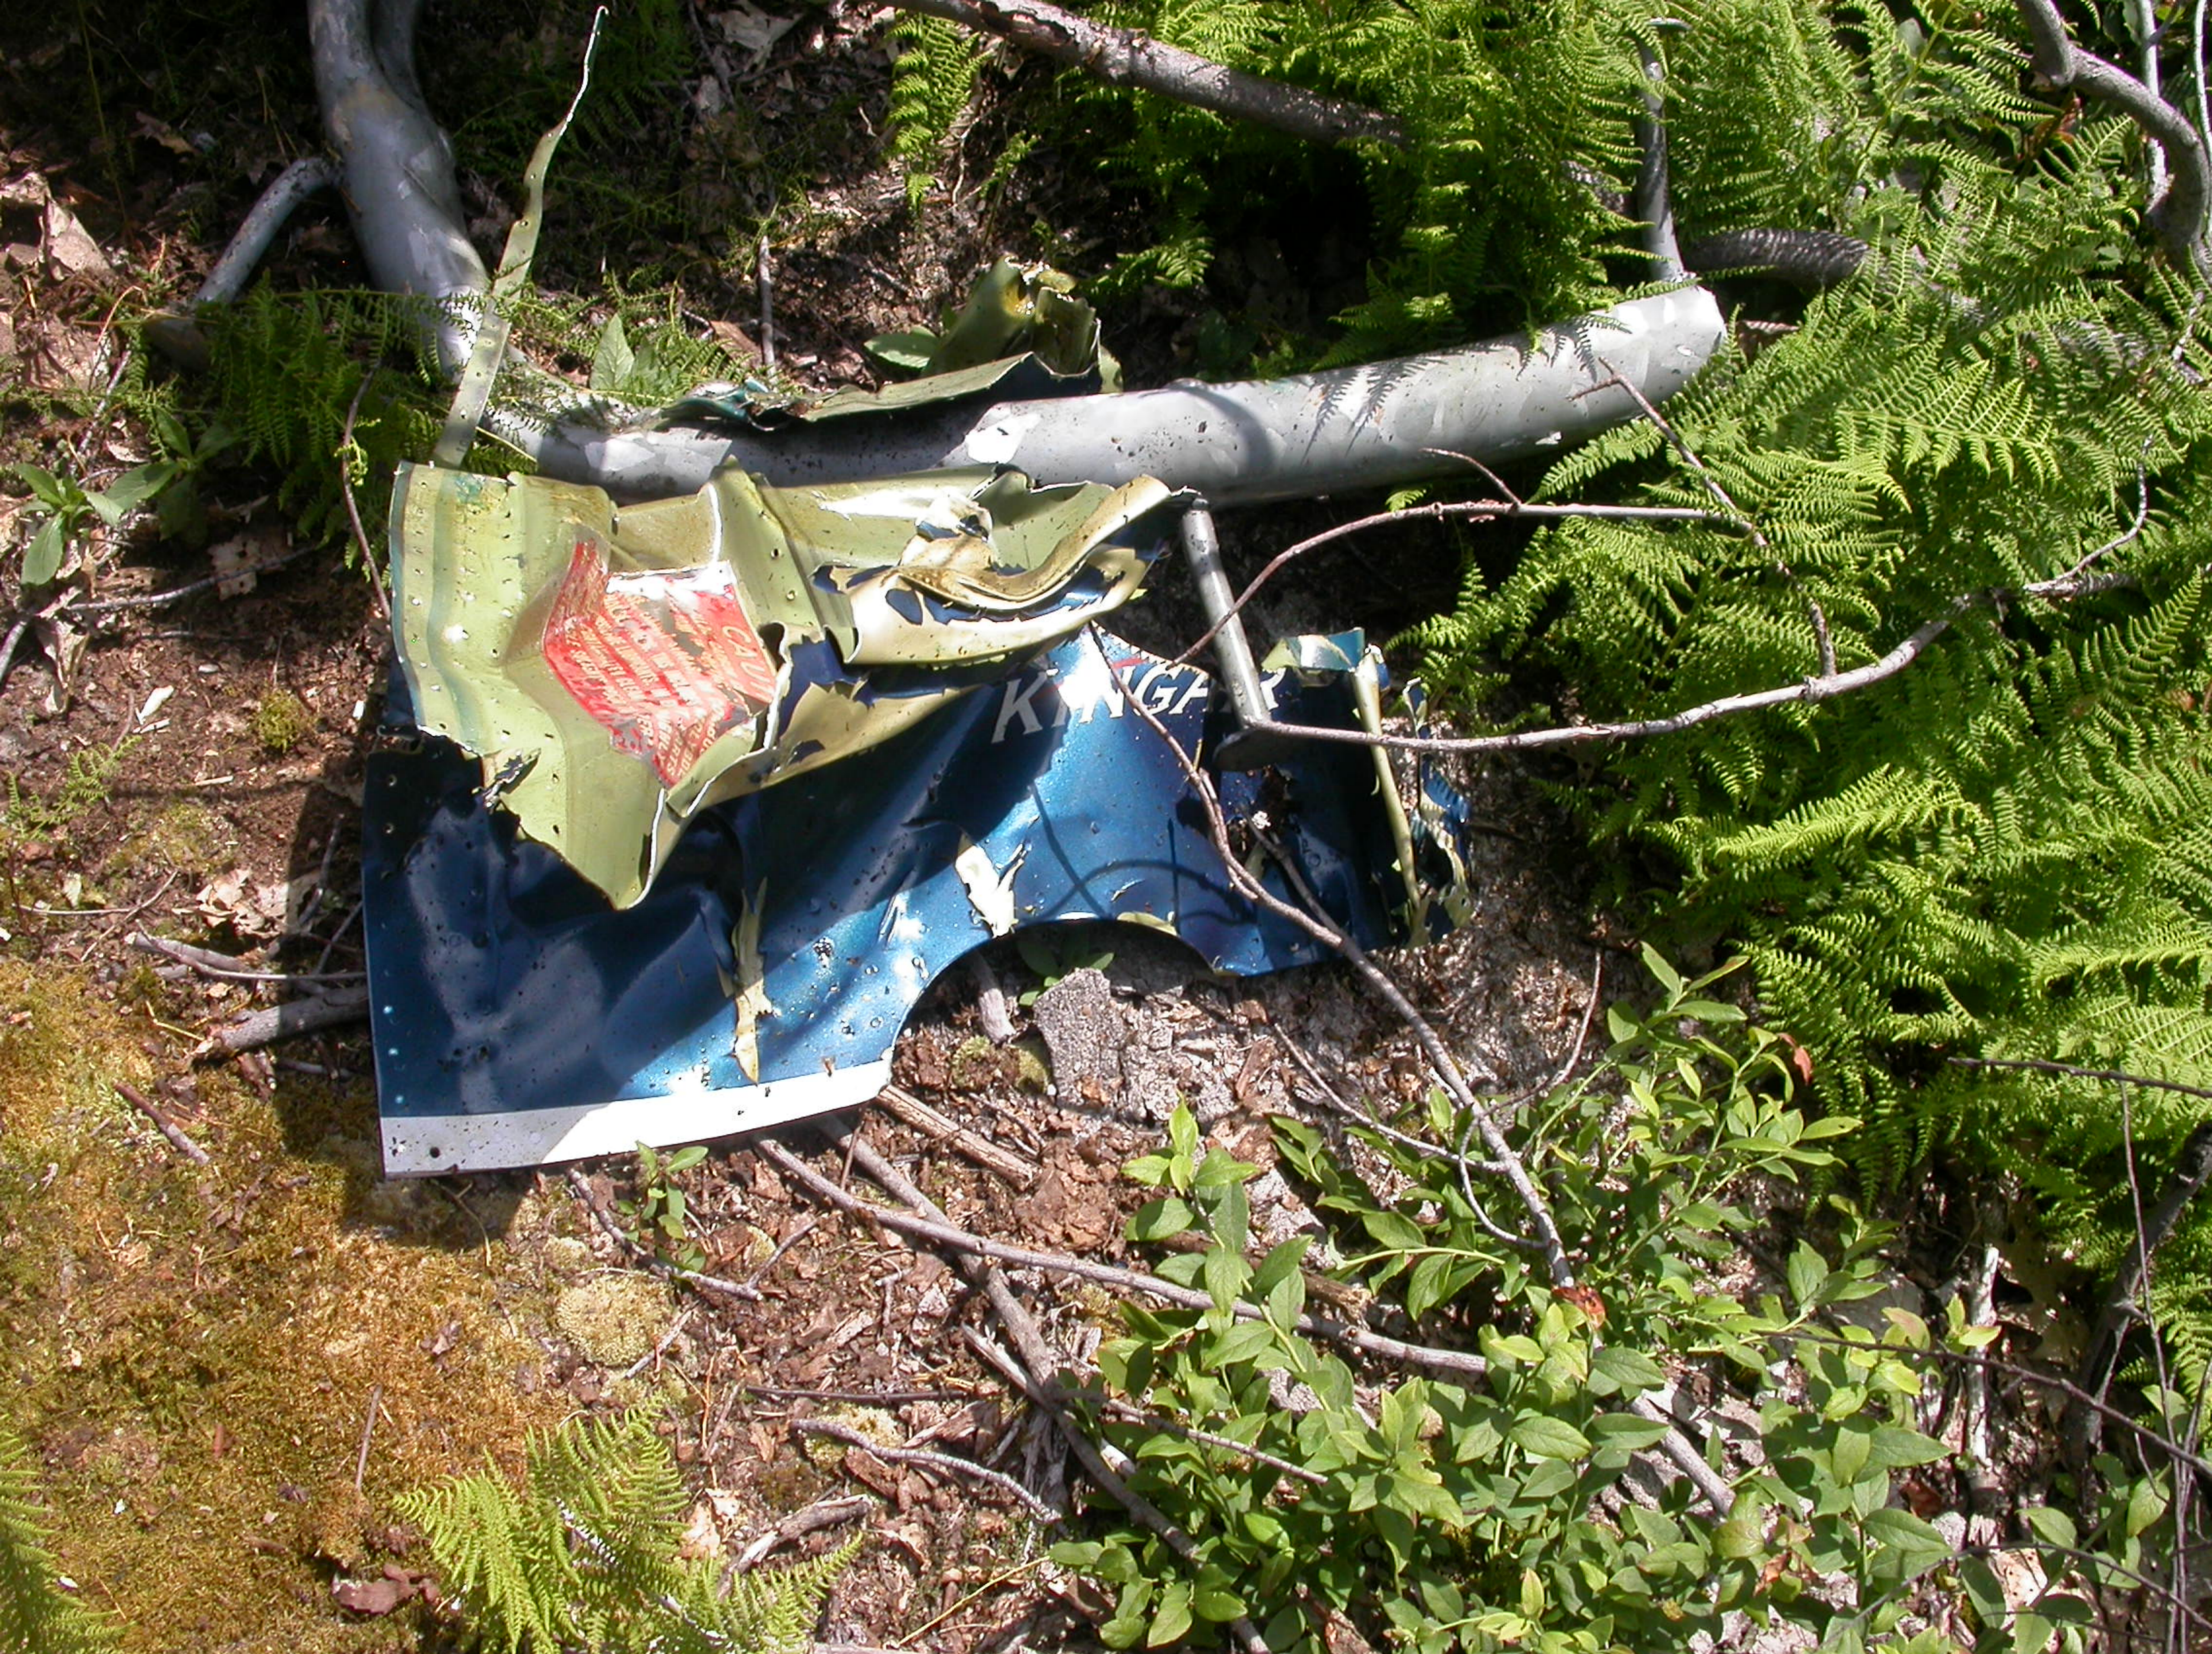
Photo 14: Antenna Beacon Mast with Portion of Right Engine Cowling
