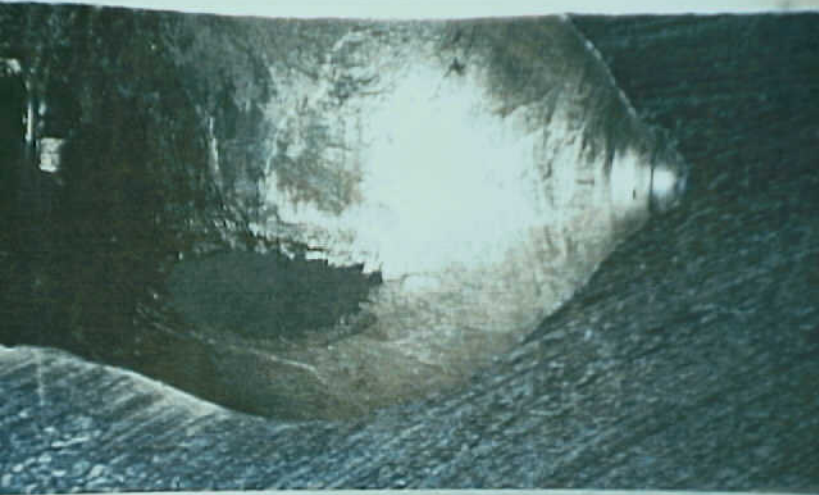
Photo 15. Hole adjacent to hole #1A drilled with HSS to failure by increased cutting data and without coolant. BEA has been performed.
