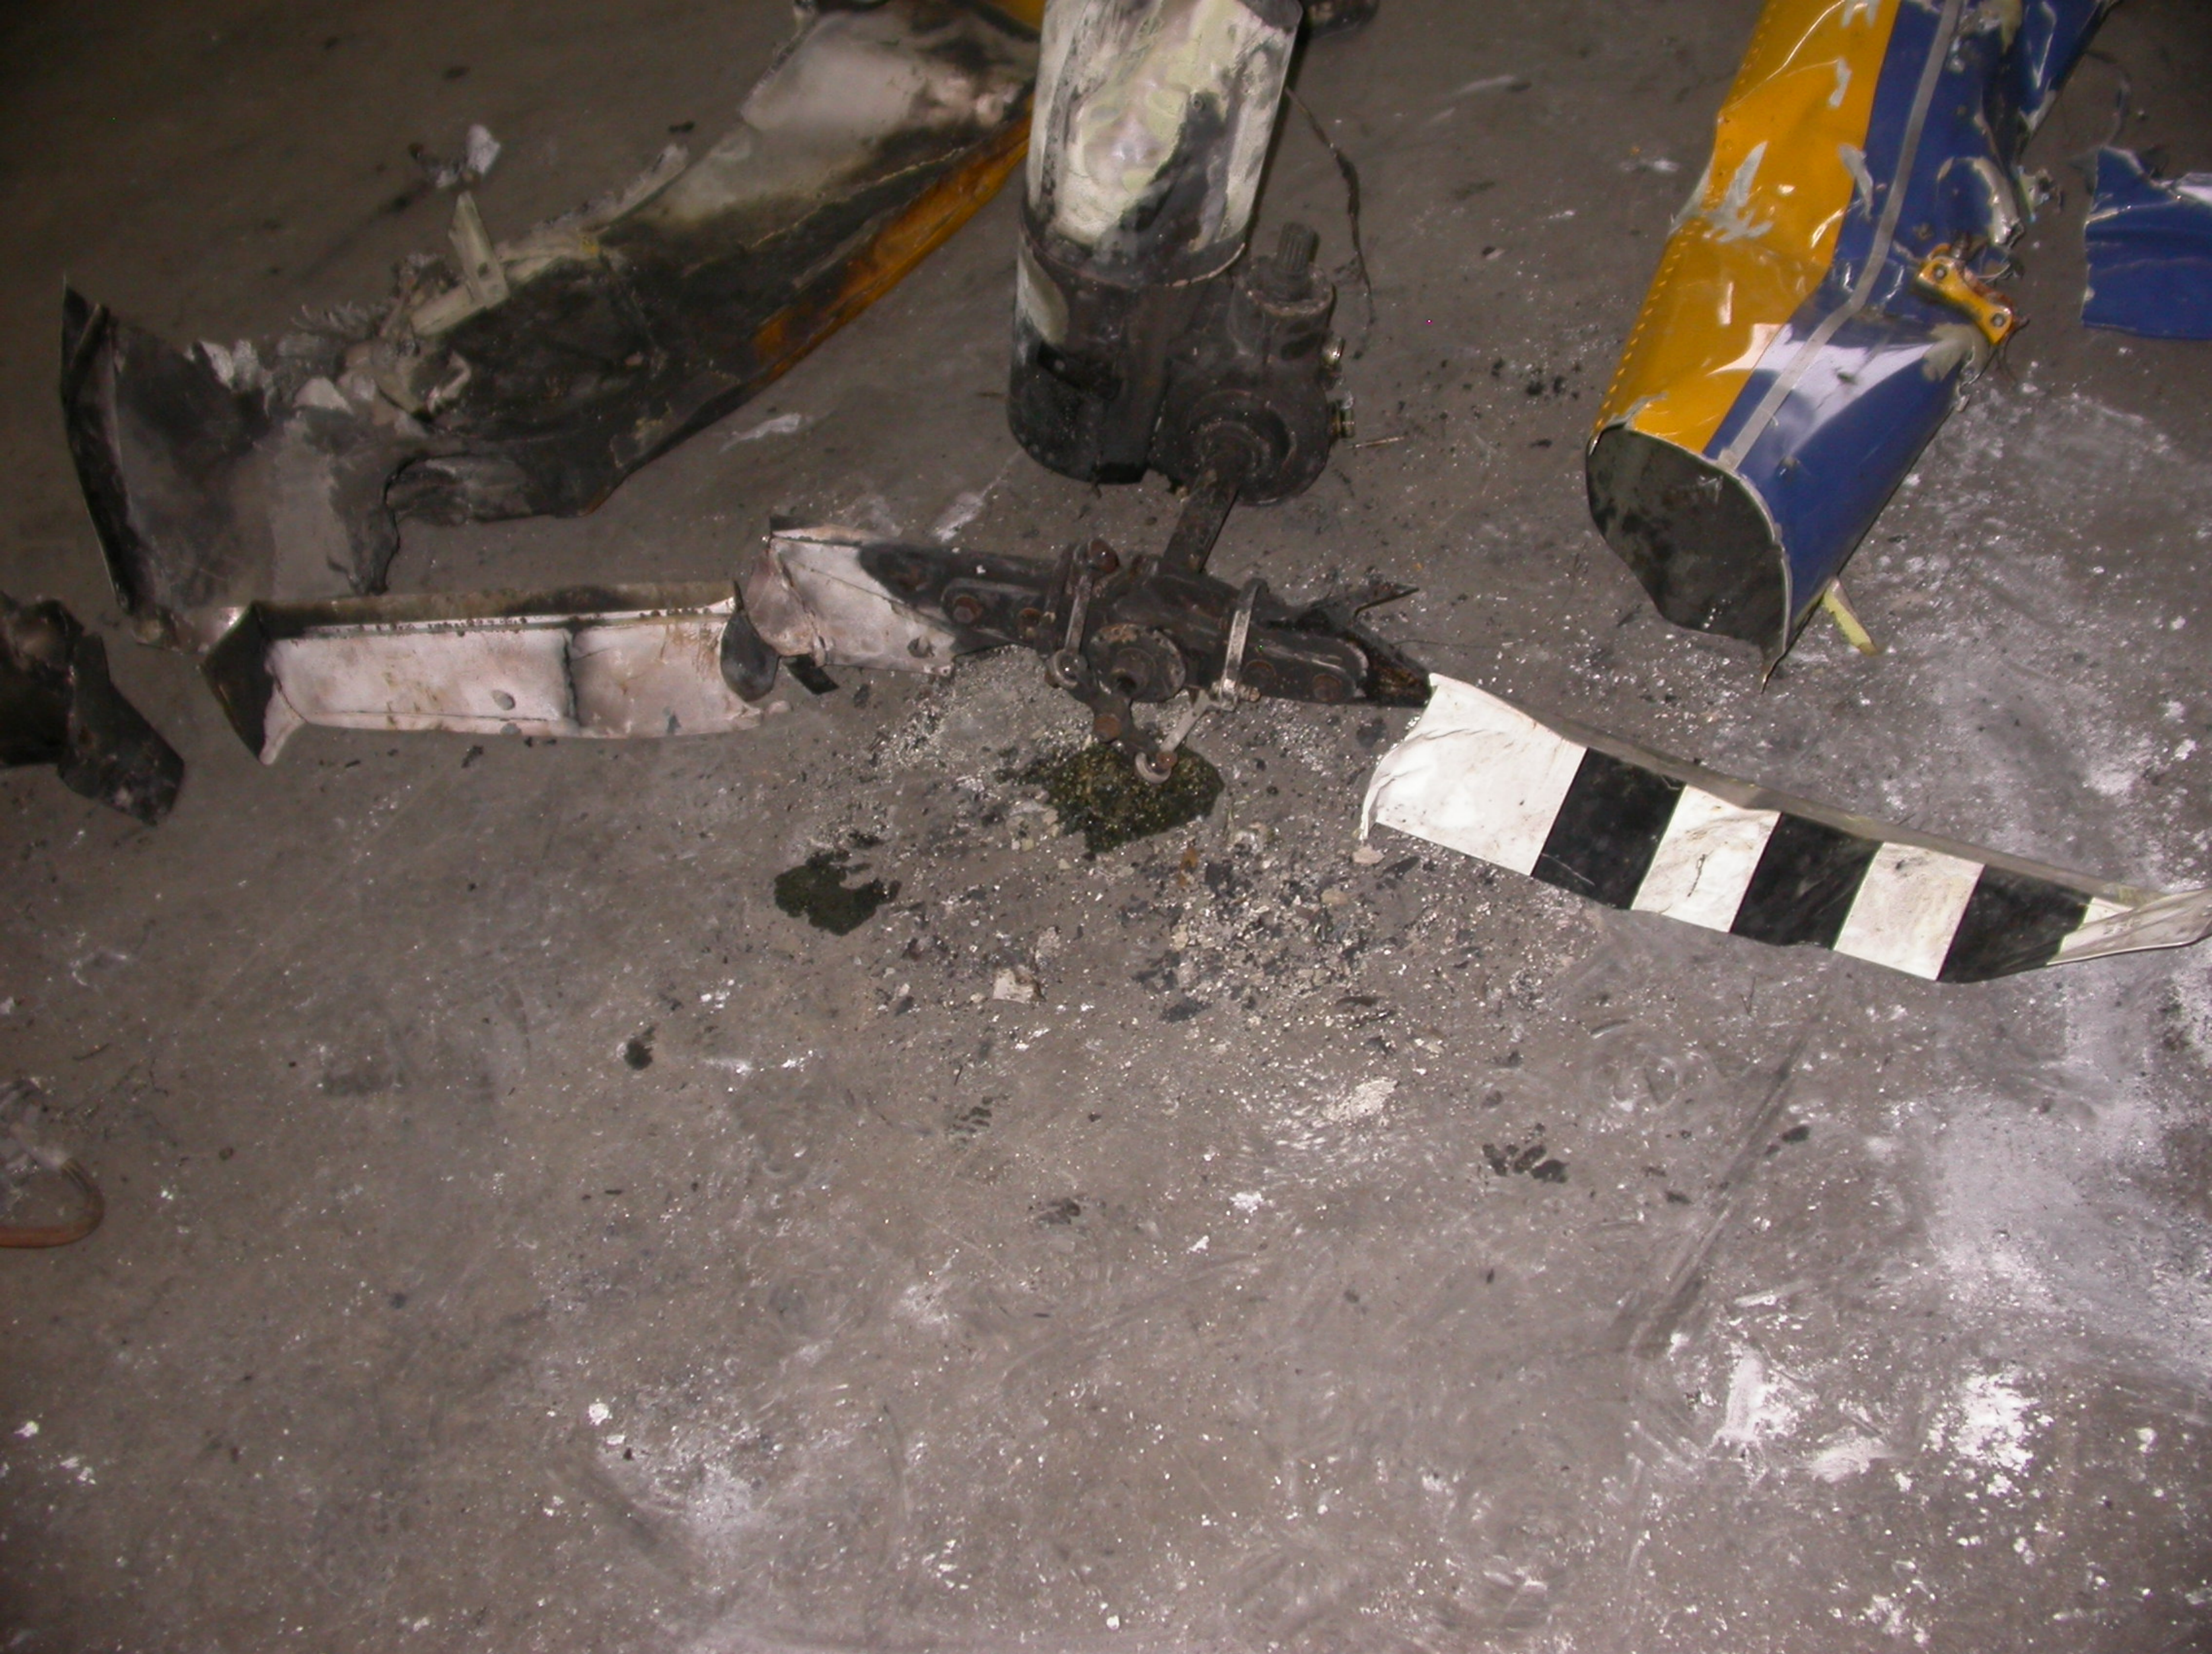
Photo 16) View of the Thermal and Impact damaged Tail Rotor Assembly. Photo by NTSB.
