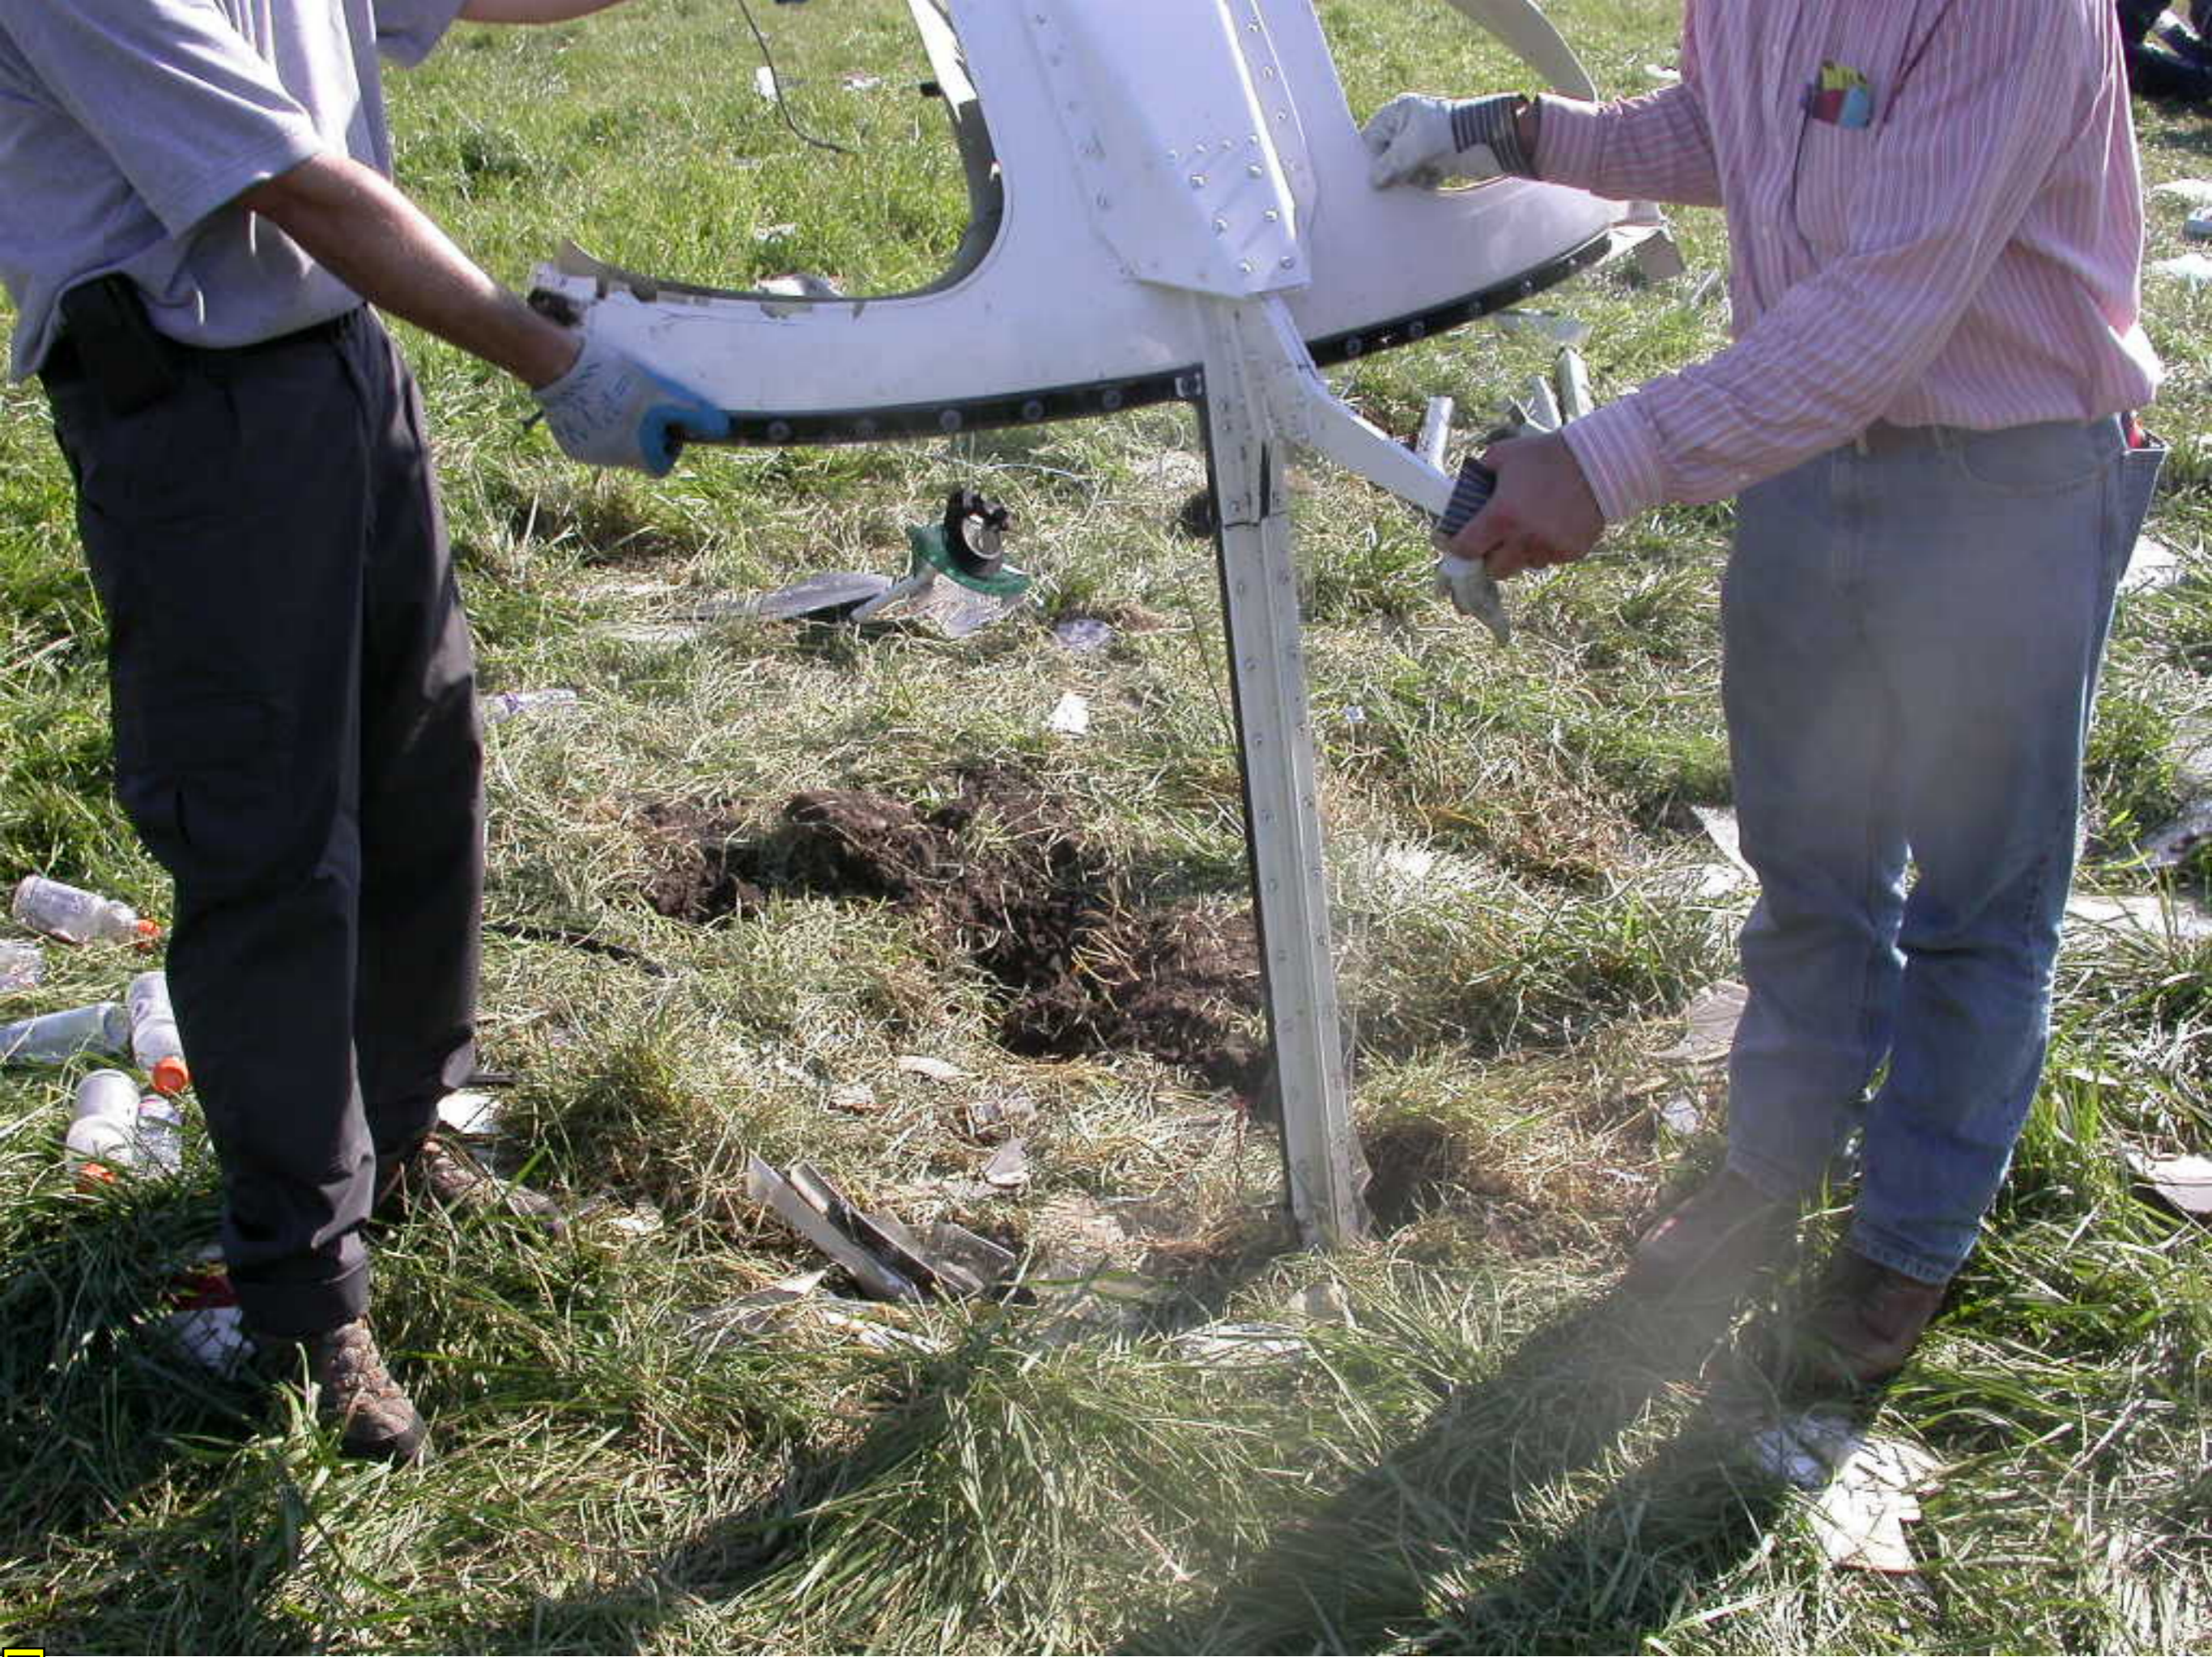
Photo 17: View of the windshield frame oriented over the initial point of impact
