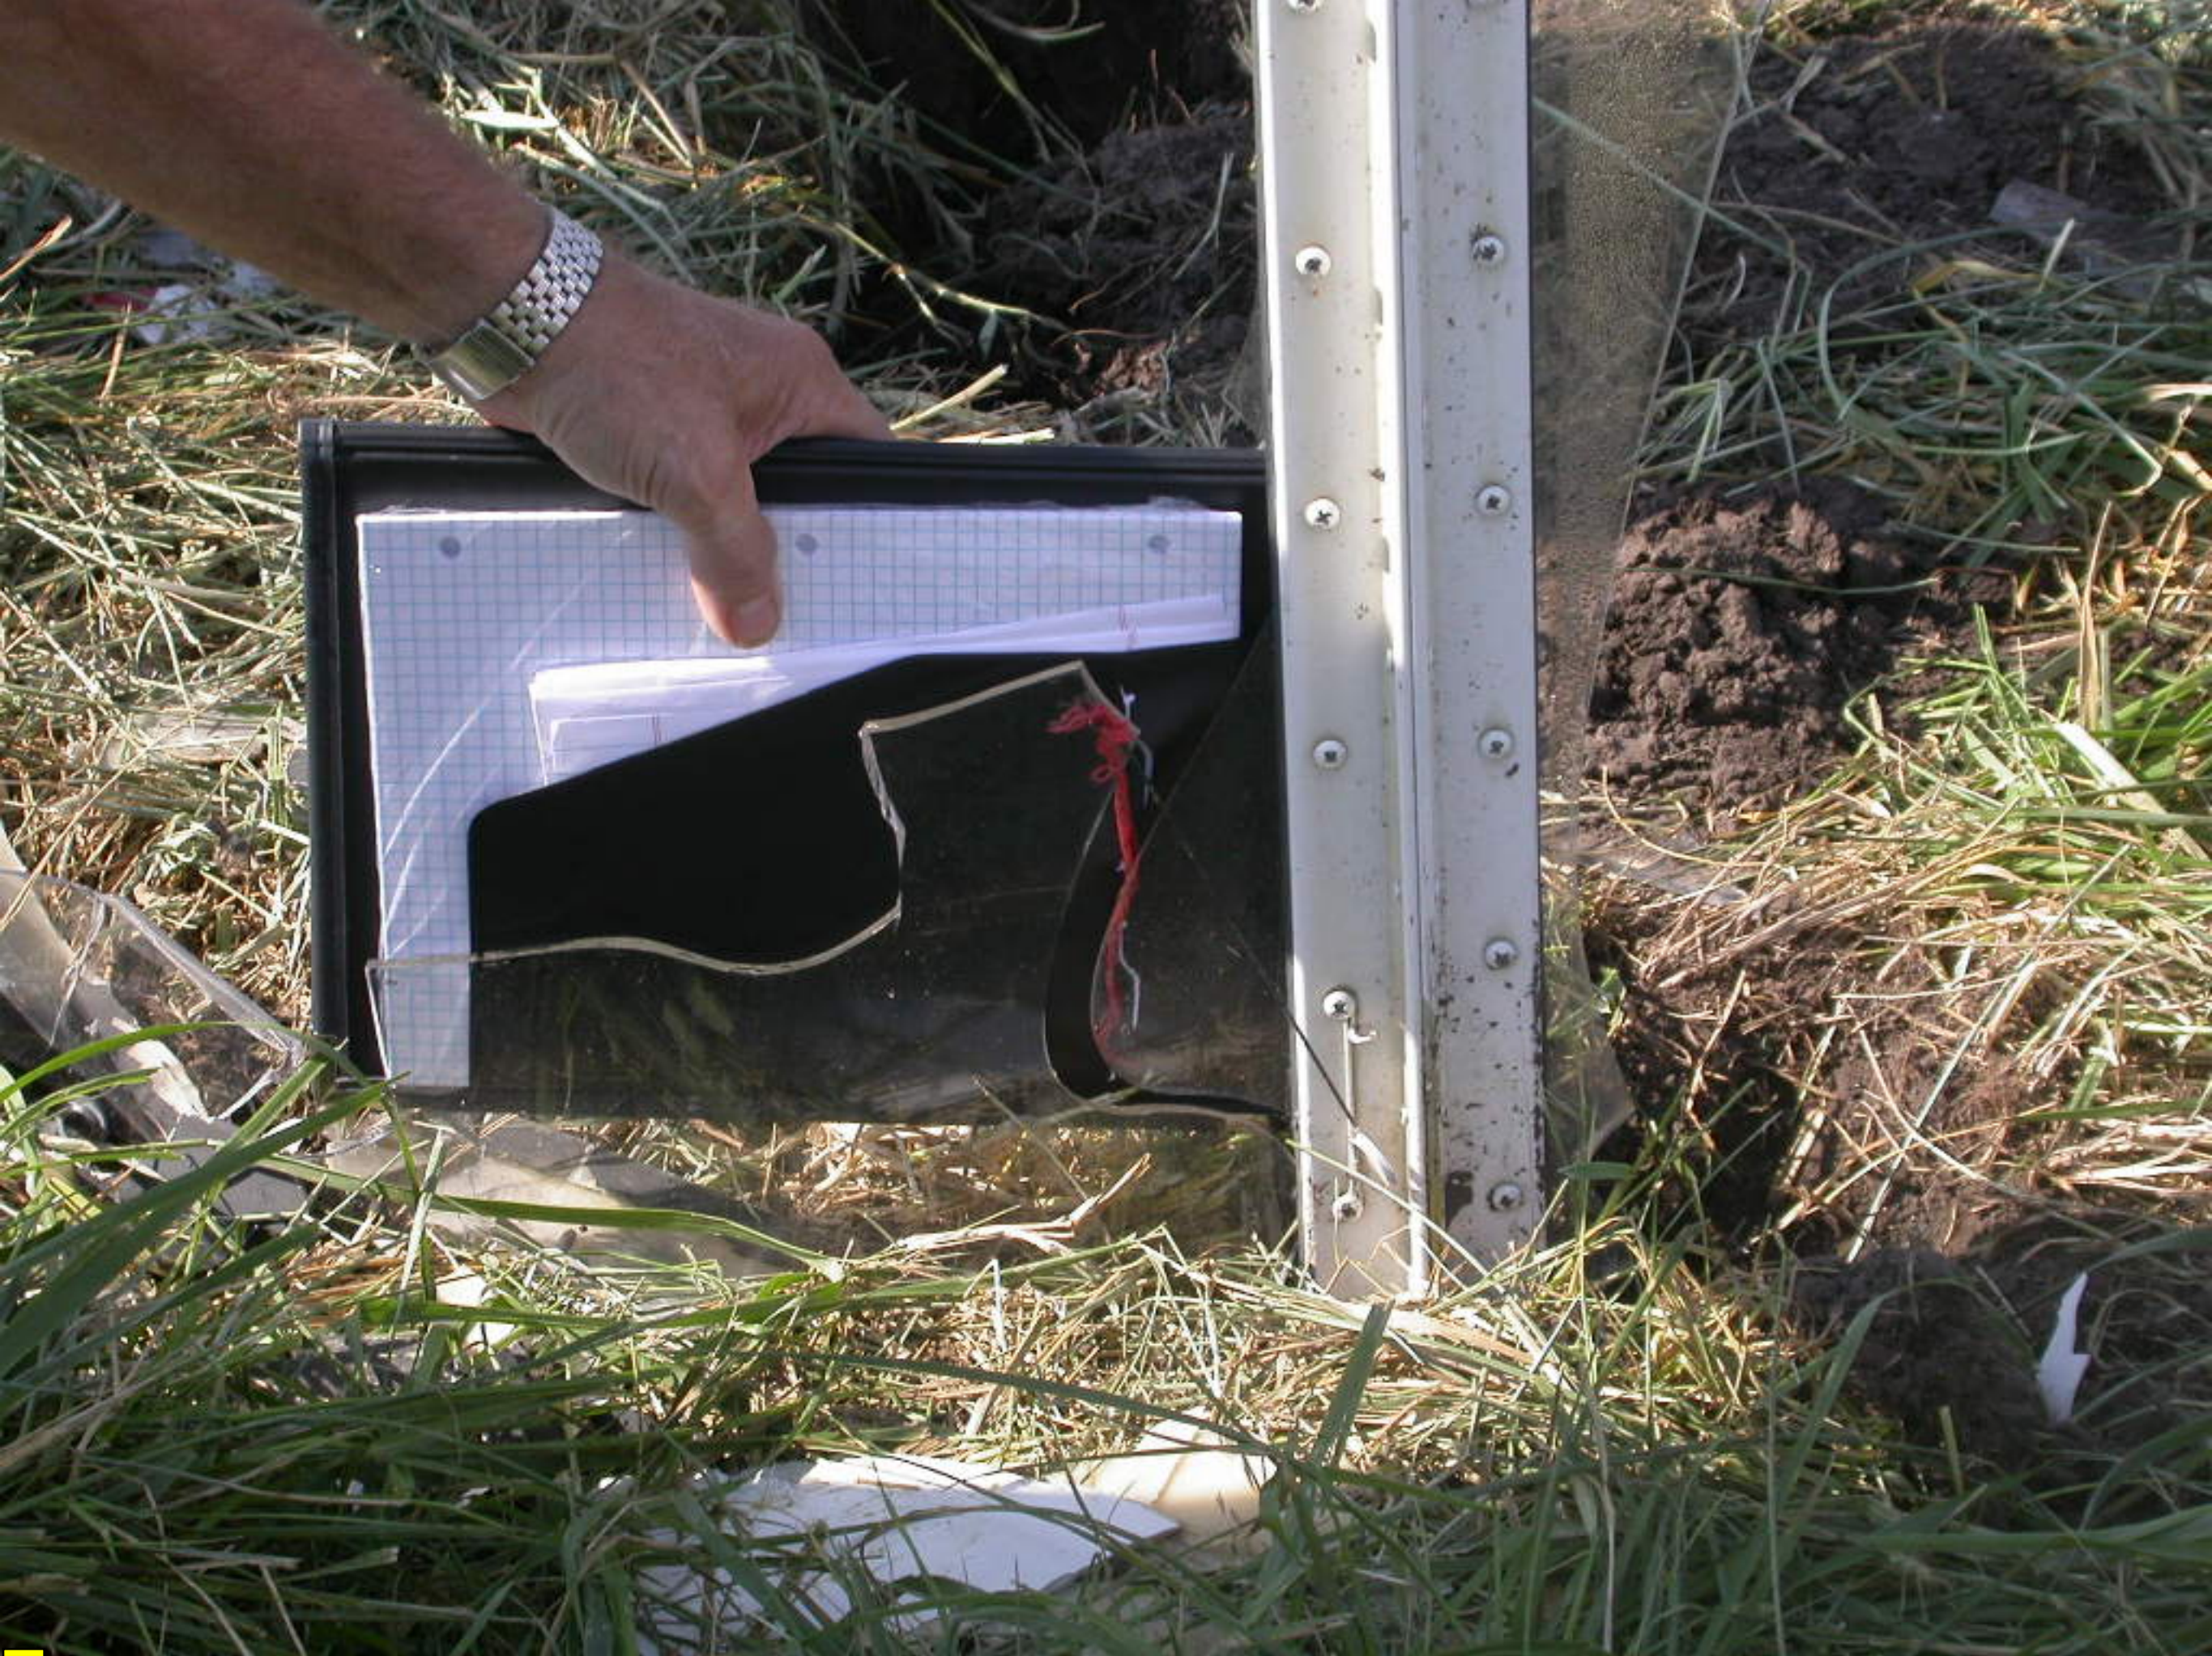
Photo 18: View of windshield frame at the initial impact point
