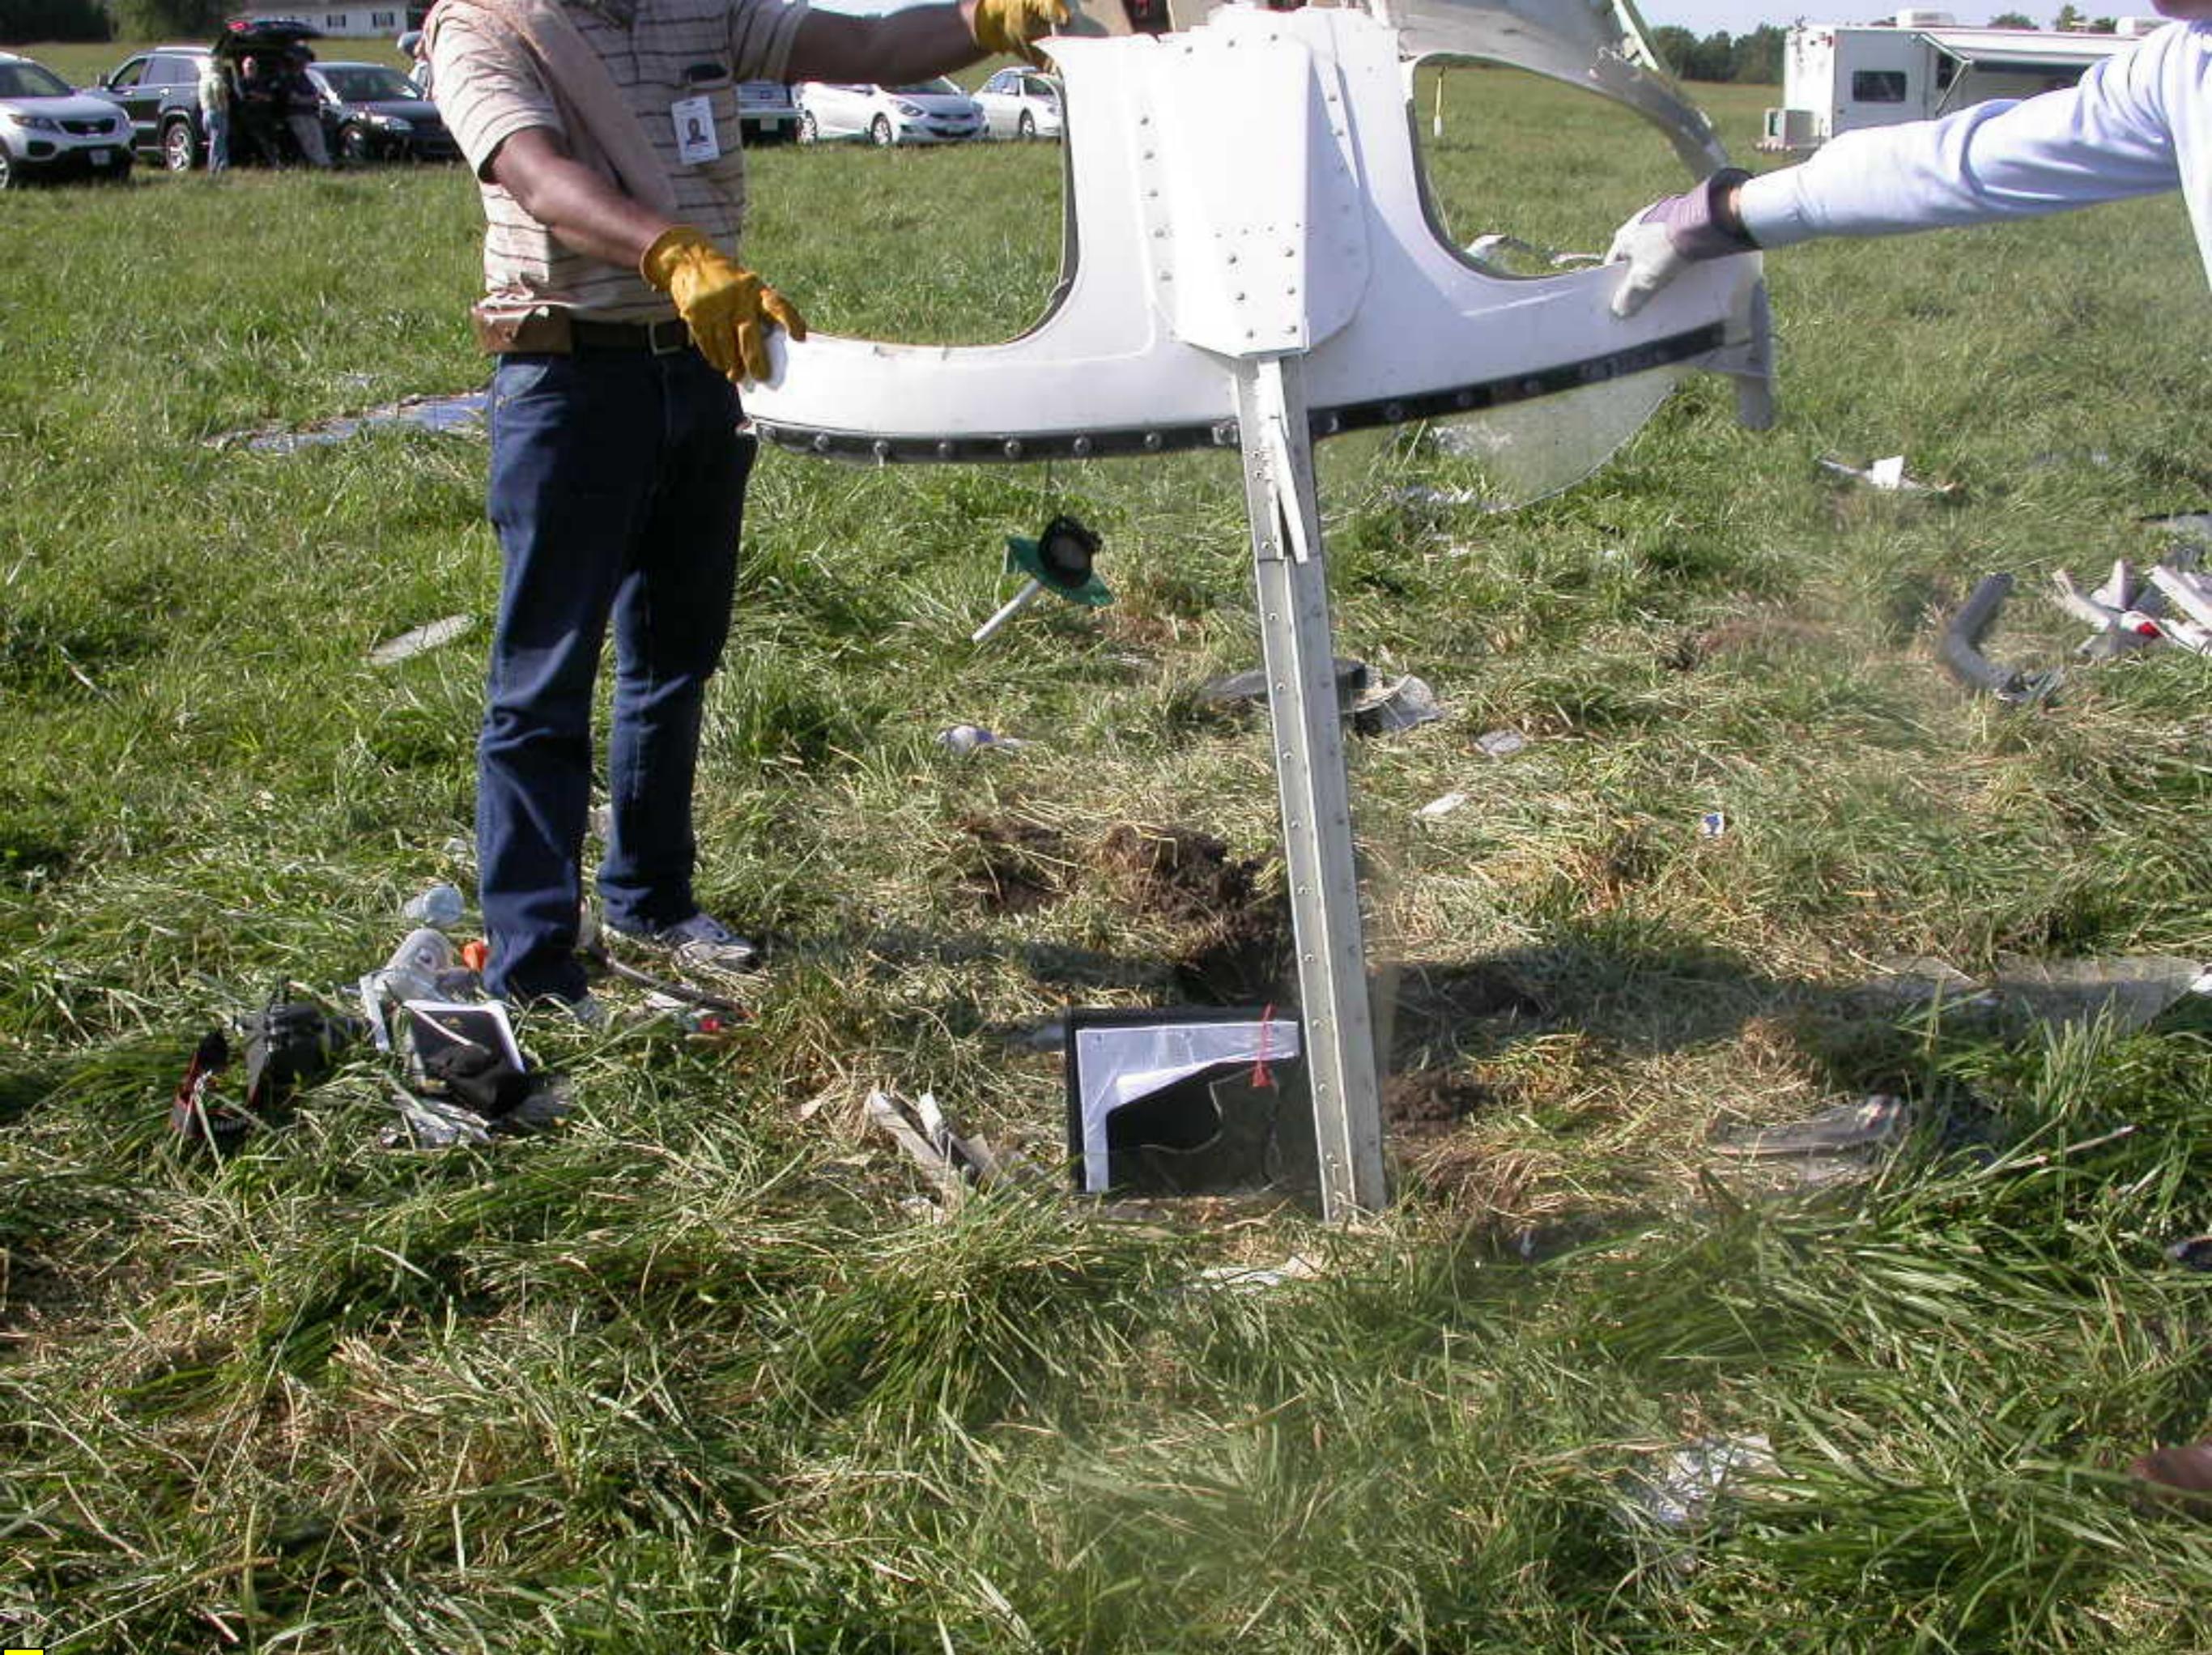
Photo 19: Winshield frame at the initial impact point
