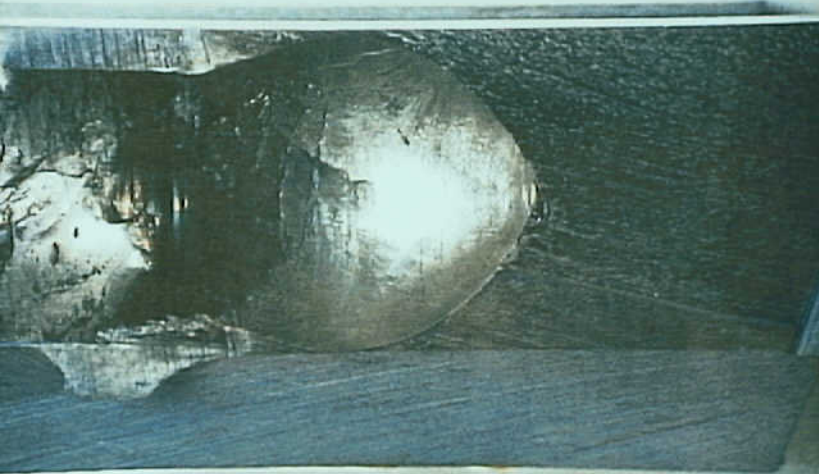
Photo 19. Hole adjacent to hole #1B drilled with HSS to failure by increased cutting data and without coolant. BEA has been performed.
