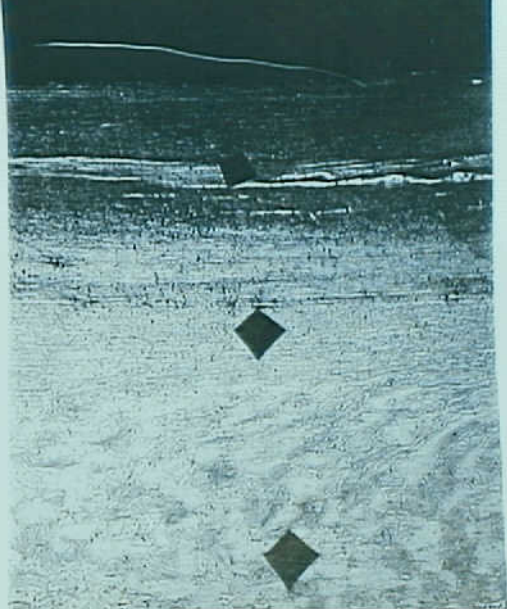
Photo 2. Cross section of hole #2B, quite close to the location of the drill breakdown, showing similar microstructure as JT8-hub failure. Hardness impressions on the photo represent 53 HRC, 37 HRC and 31 HRC, almost identical hardness as failed hub.
