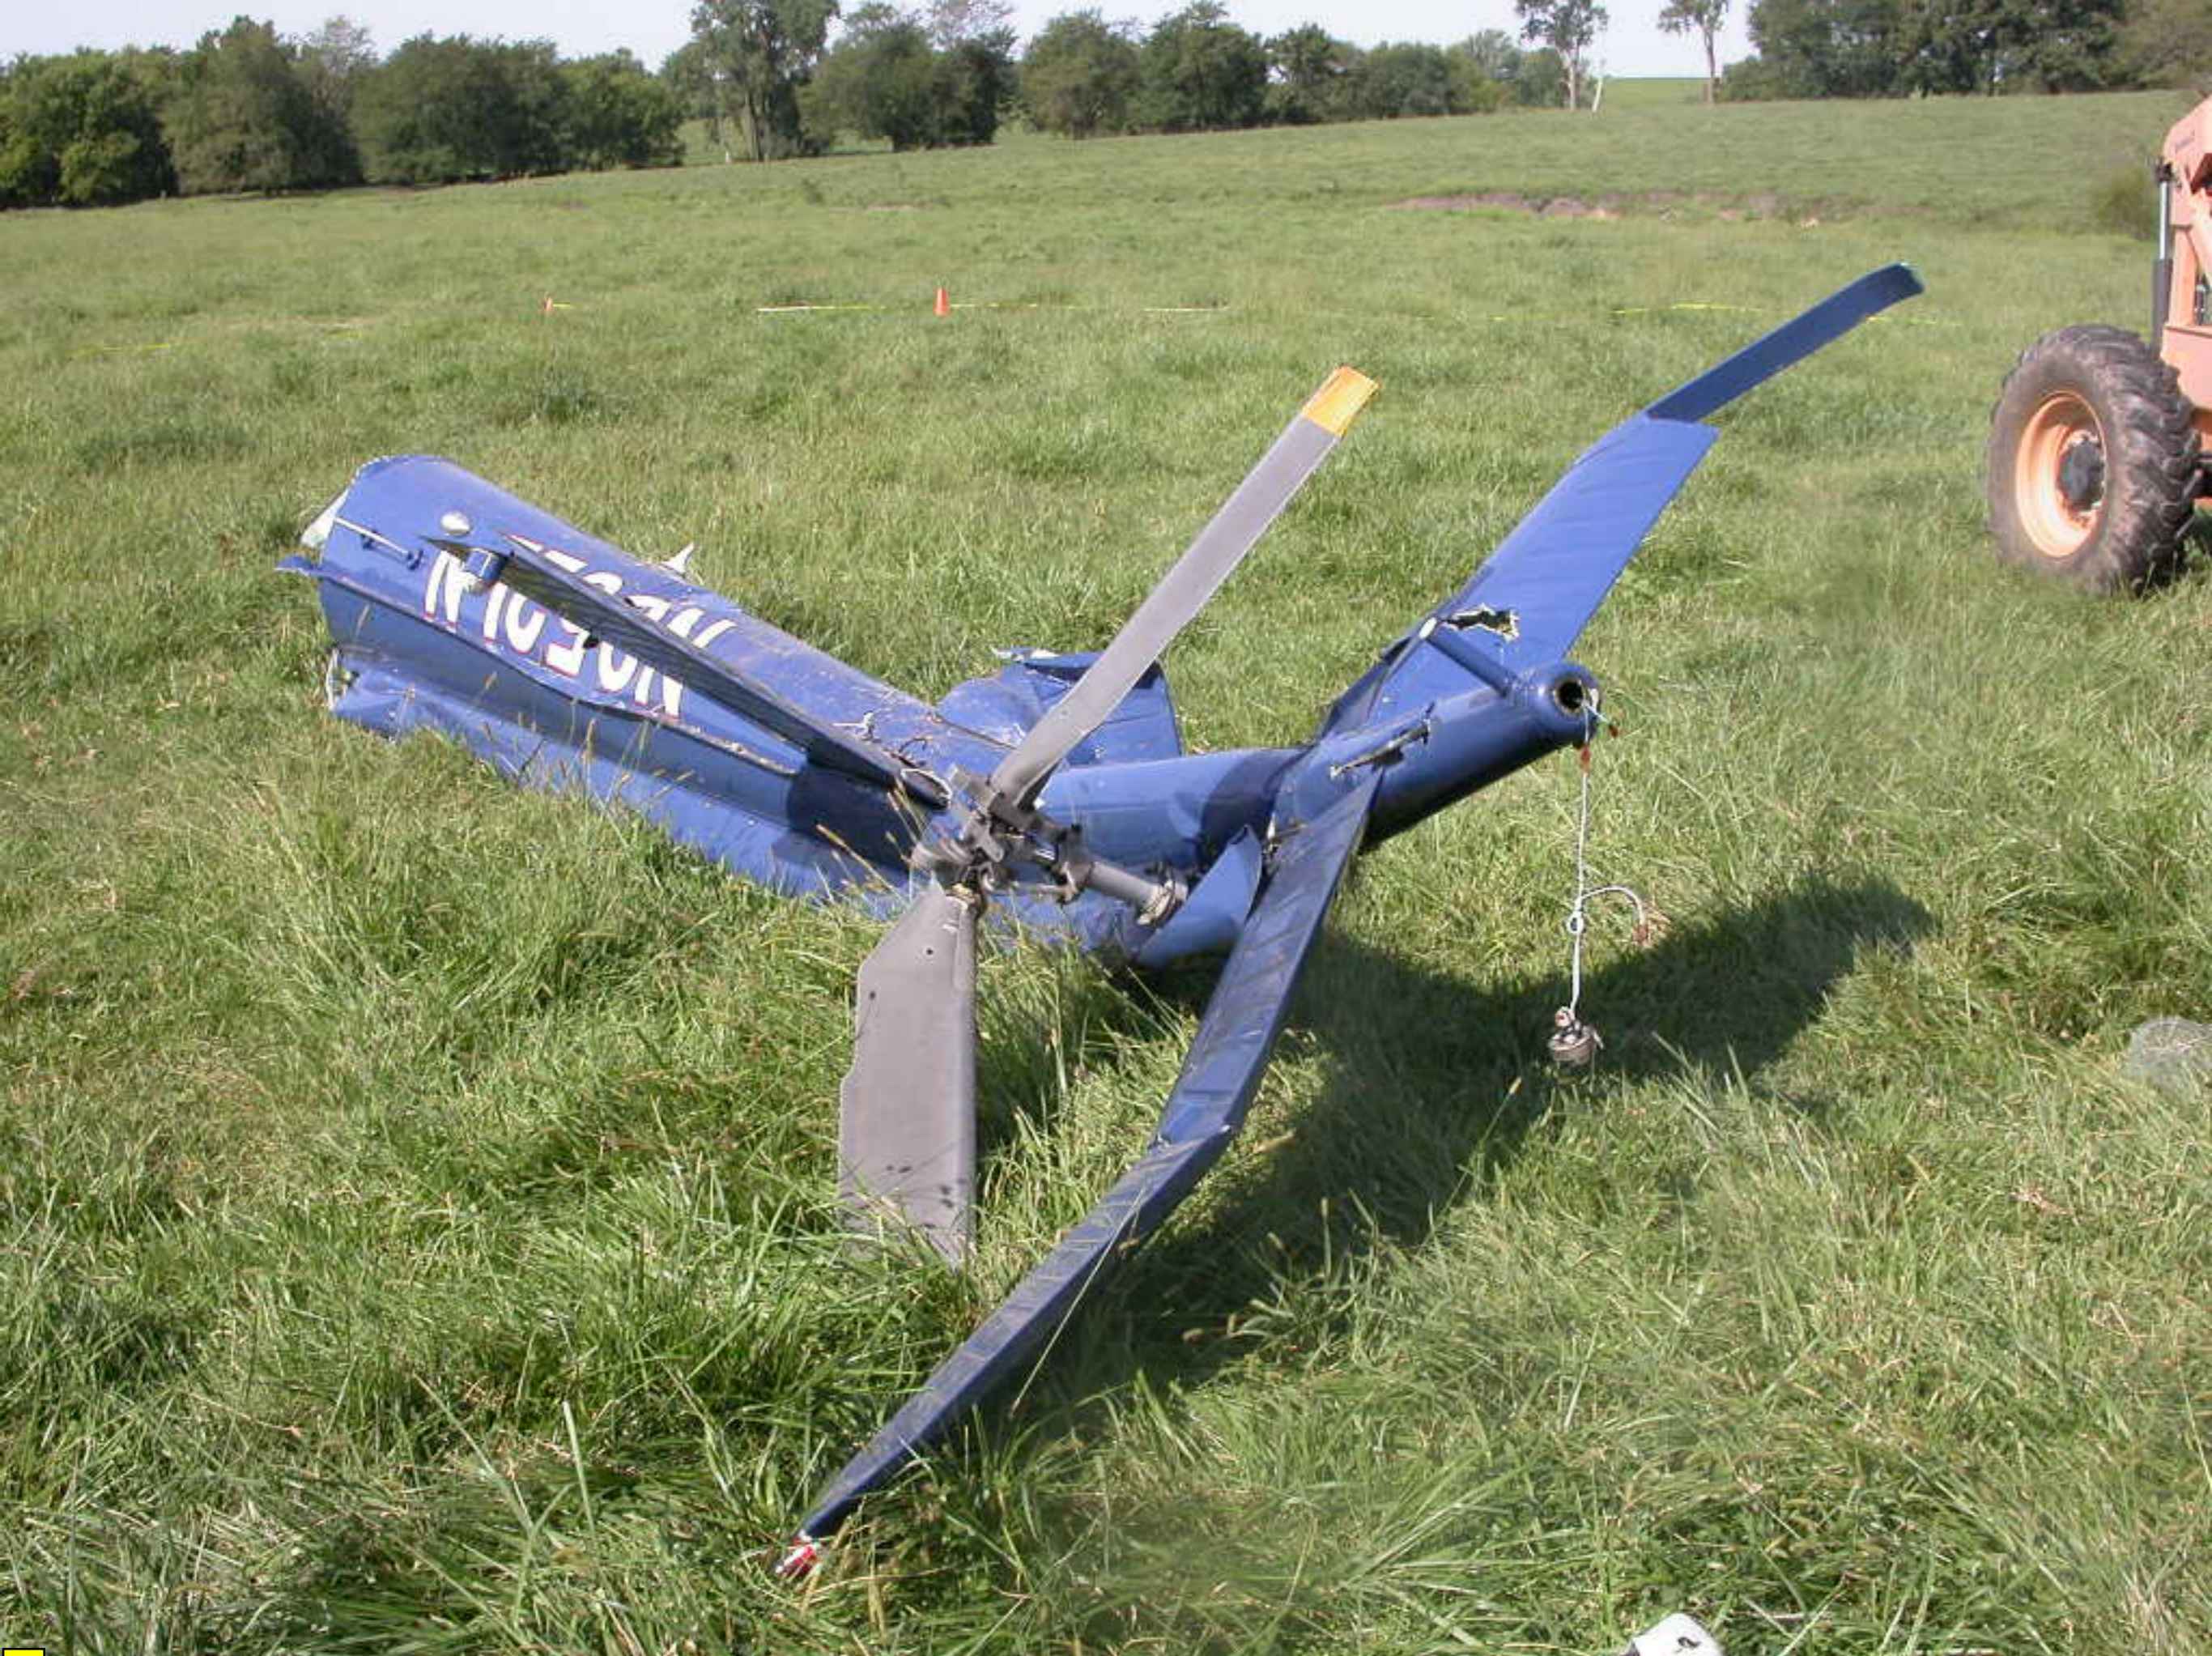
Photo 20: View of tail boom, tail rotor, and empennage removed from the main wreckage
