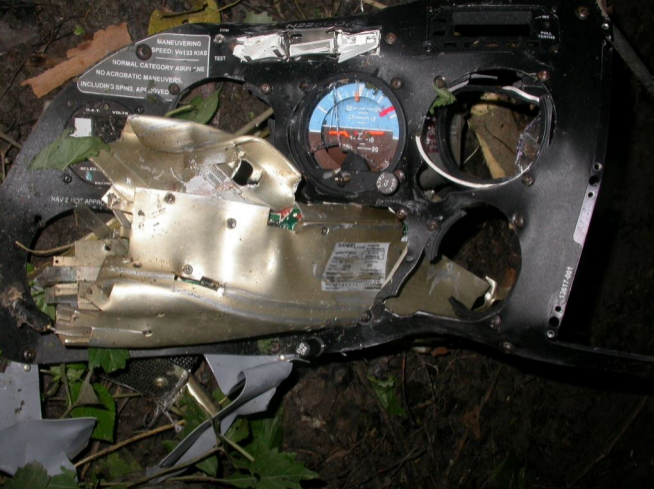
Photo 20. View of the instrument panel with the attitude gyro still attached.
