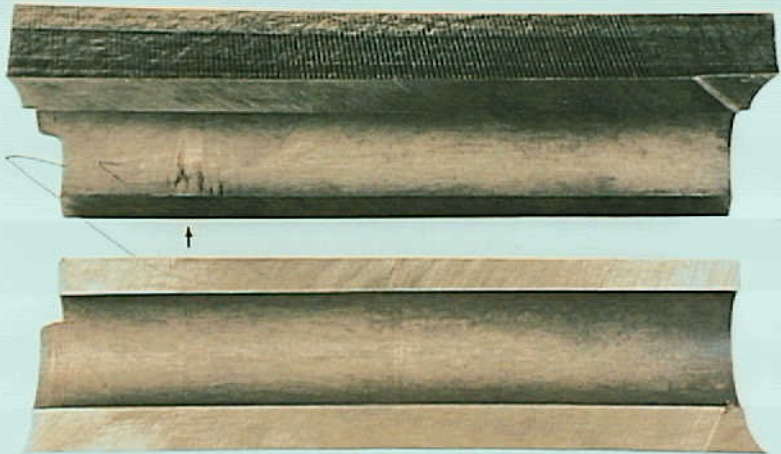
Photo 22. Hole #57 drilled with increased cutting data with HM to breakdown. The hole has also been fine bored and honed. BEA shows a white-grey indication in the drill breakdown area.
