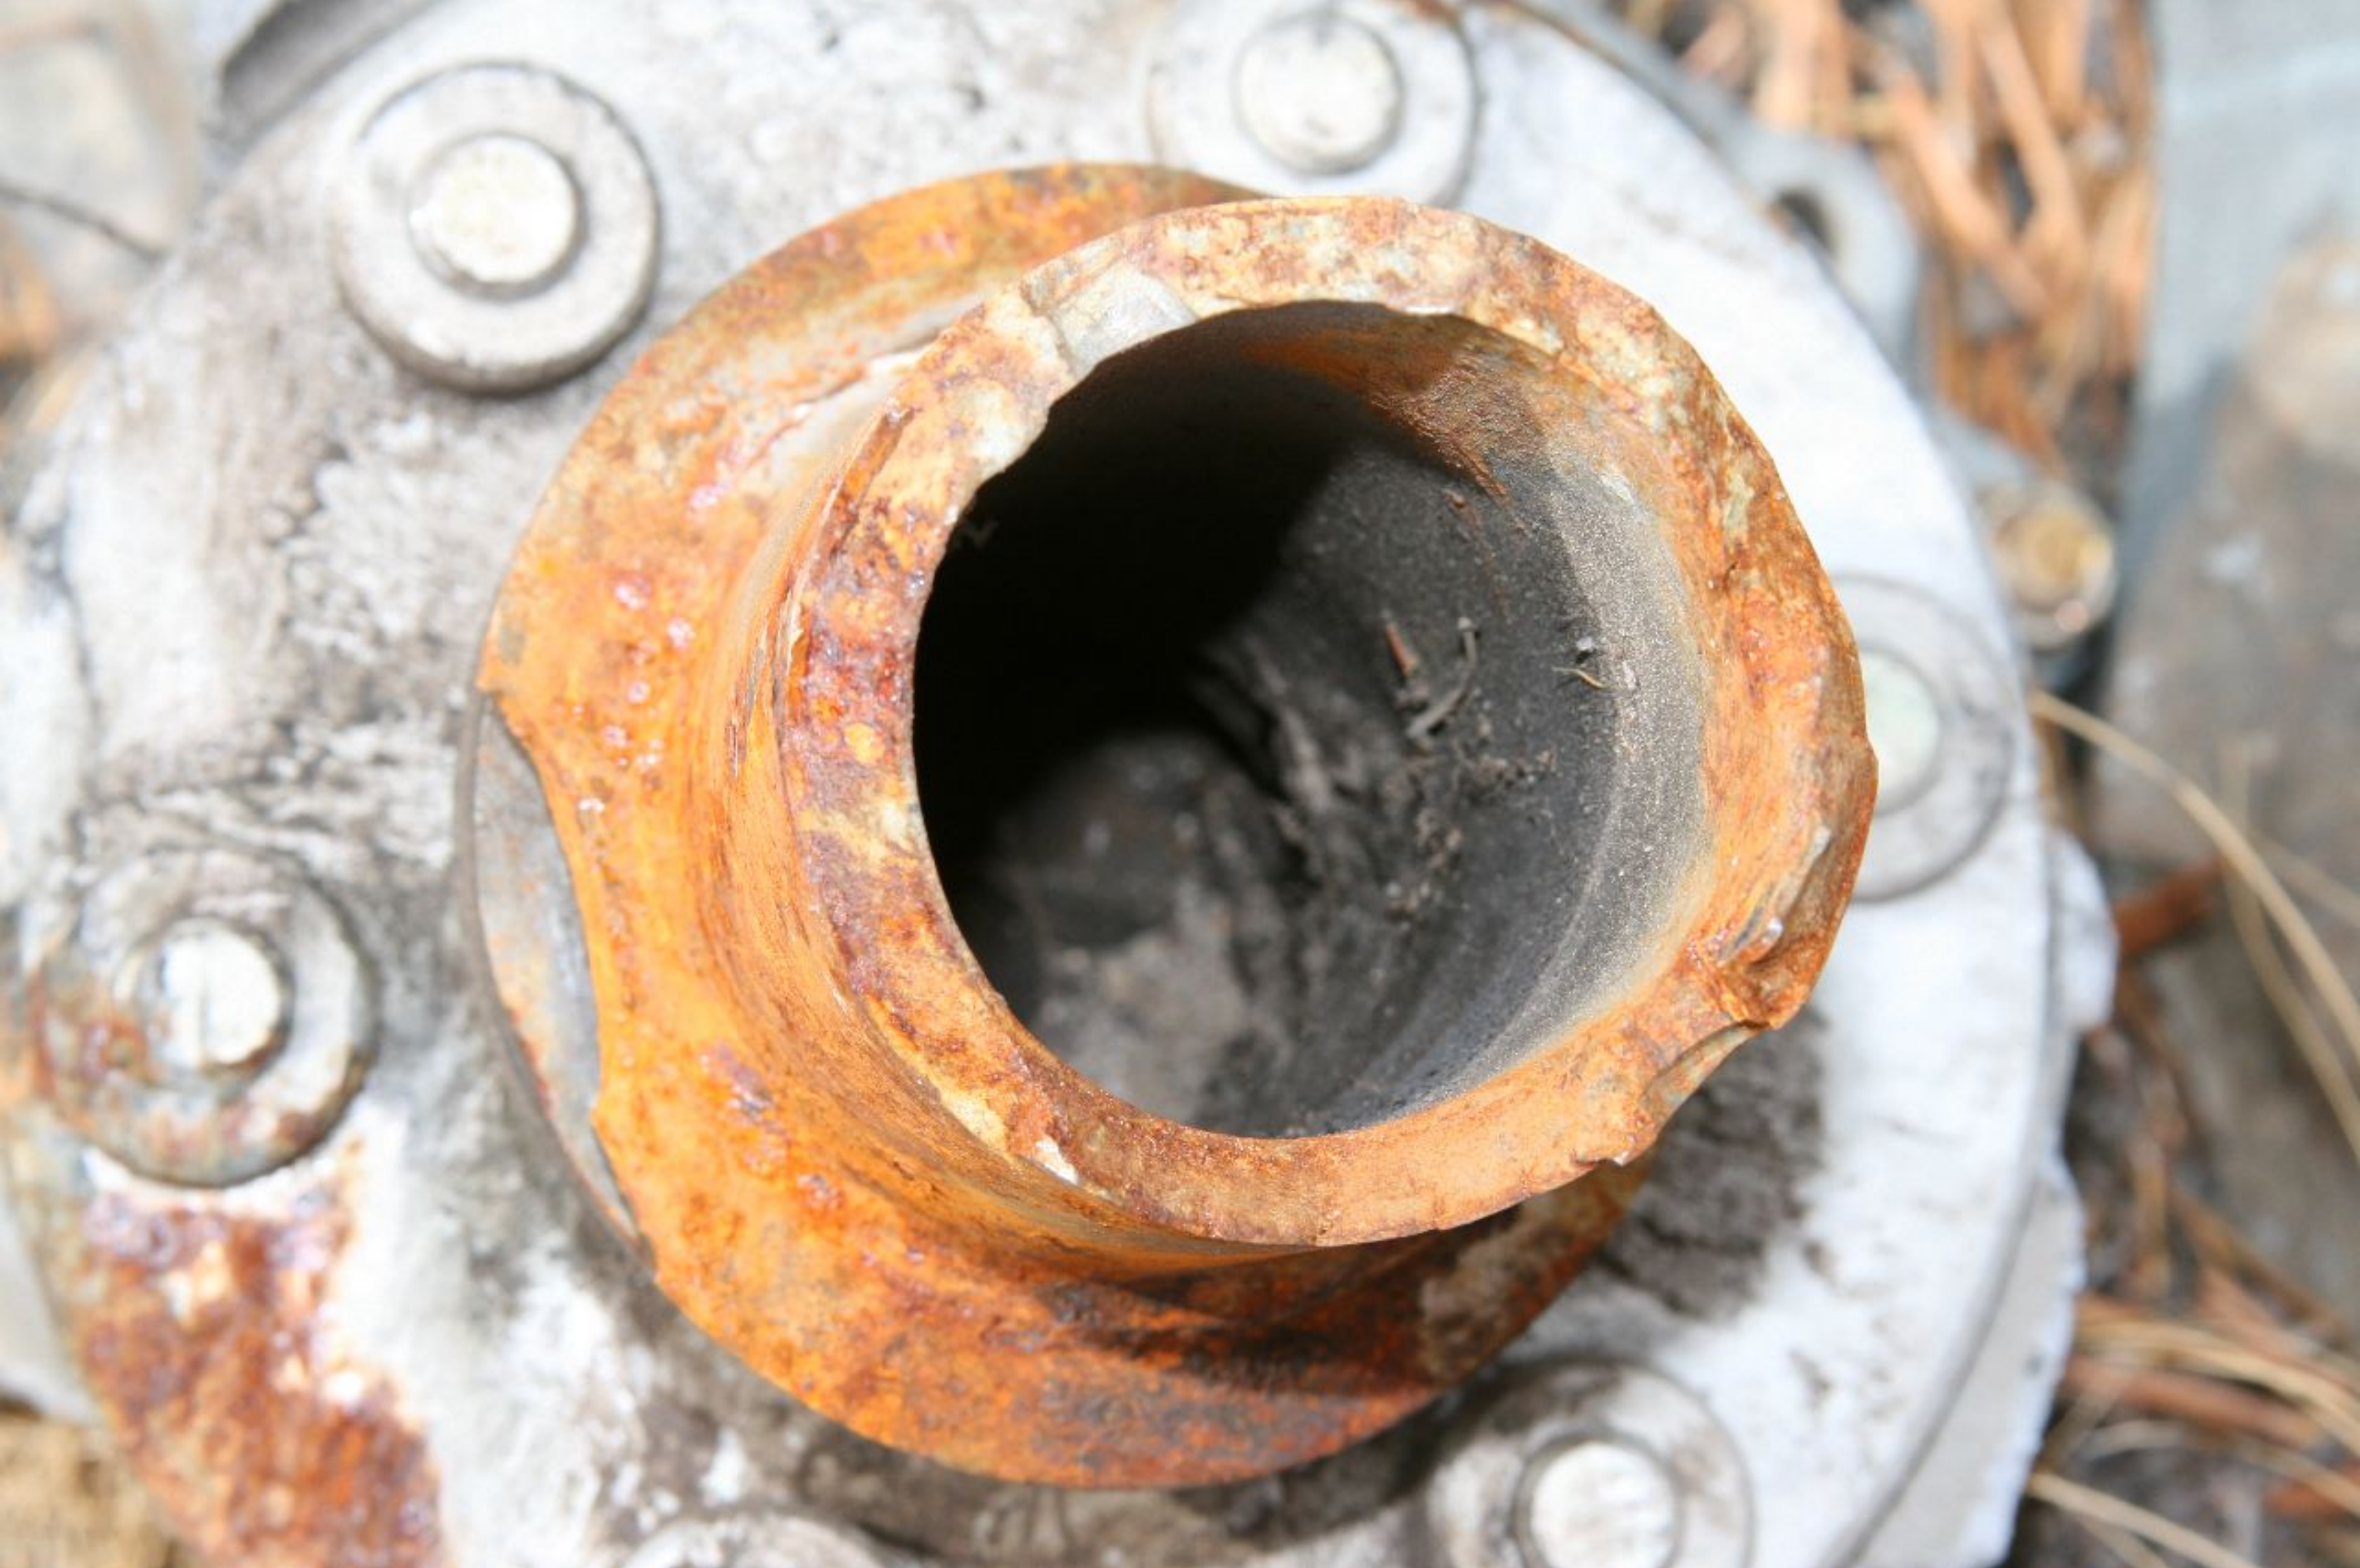
Photo 22. Crankshaft fracture surface.
